# Hayle Harbour Building, Structures & Archaeological Remains: An Inventory

ING RED UK (Hayle Harbour) Limited

Edition 181107.

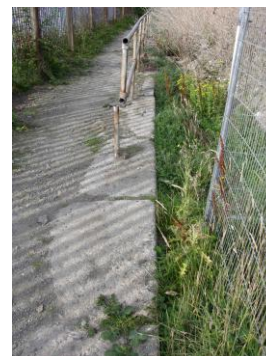
**Description:** Quay edge of Carnsew Pool of granite coping stones now partially covered by earth and rubble and the water edge is now over 3 metres from the remains of the quay. Some of these coping stones are missing, probably stolen by local gardeners. This quay is quite an extensive structure and a local historian (Rob Lello) suggests that it is of fine dressed granite.

**Baseline Condition:** Much of the features condition is unknown, apart from hearsay evidence as it is mostly buried. The coping stones which are above ground are in very good condition but some are missing presumed stolen.

**Proposals:** To leave as found

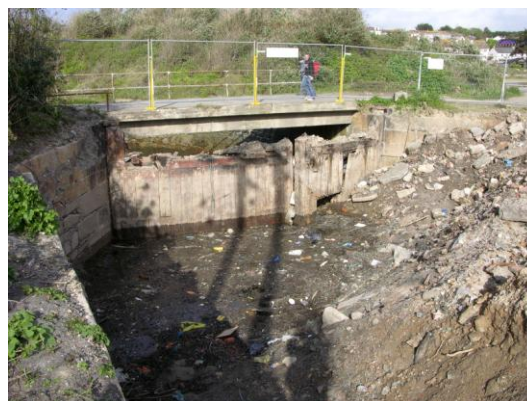
**Description:** Area to the extreme south-east of the Pool, lock type structure with the remains of two lock gates now in a ruinous condition. The area is partially filled in..

**Baseline Condition:** Good

**Proposals:** To undertake any necessary repairs, to install a barrier and modern controlled sluicing system and to create a channel to the main body of water in the Pool.

**Necessity of change:** The installation of an efficient modern sluicing system is part of the process of bringing the harbour back into effective use. The major part of the structure will survive and be enhanced; the old gates are in a very bad condition and beyond repair and conversion to modern requirements.

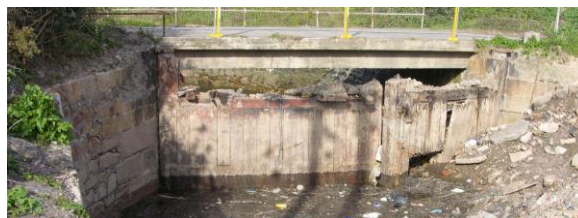
**Description:** Two lock type gates at the extreme south of the dock complex, now in a ruinous condition. The gates are in a lock type area, which has been partially filled in.

**Baseline Condition:** One gate is in an extremely poor condition and is unlikely to withstand any attempt at moving it the other is also in a very poor condition but might be repairable to a state where it could be used as interpretation material.

**Proposals:** One of the gates will be scrapped and an attempt will be made to repair the other after an evaluation, to use as possible interpretation.

**Necessity of change:** : There is a need to replace the present gates, as they are in too bad a condition to be used, with a modern structure that can be use to sluice the area.

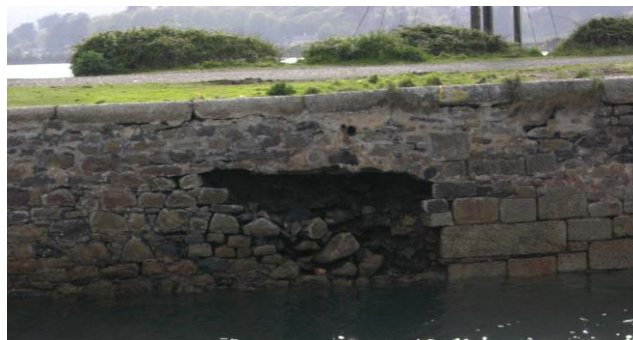
**Description:** Quay walls on each side of a causeway between Carnsew Pool and the South Quay Pool. Lined with granite blocks, some with granite ashlar probably filled with rubble. The quay surface is difficult to read because of the current 'dusty' surface but the original probably lies beneath. The wall line extends beyond the sluices (CQ10) and still listed at that point, although the wall to the west has largely gone – see especially photograph DSCN 0229.

**Baseline Condition:** Mixed - parts of the wall are in good condition, parts fair but with areas of collapse.

**Proposals:** To repair where necessary and rebuild the collapsed areas.

**Necessity of change:** The walls of the harbour of necessity require repair.

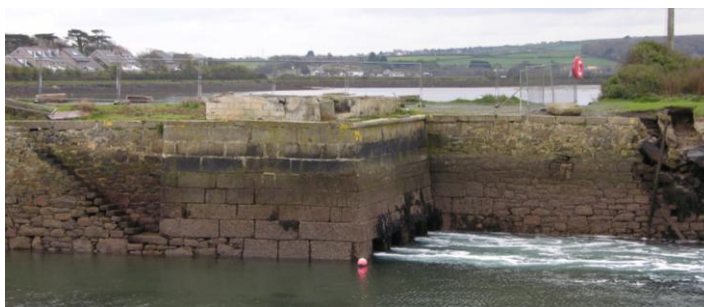
**Description:** Sluices were created to wash the channel of the harbour to keep it clear of silt and sand. This sluice was added to improve the effect of the sluicing. On the Carnsew Pool side two tunnels take the water to the sluices on the South Quay side of the quay. On the South Quayside there is a projecting structure faced with granite ashlar with four openings to the harbour channel. There does not appear to have an associated training wall. On the Carnsew Pool side of the sluice a weir was

added at the time of the installation of the pipe line to the North Quay [1940] to help keep water back for water extraction (see CQ15). There are the remains of concrete control house on the top of the structure.

**Baseline Condition:** Fair

**Proposals:** To repair the sluice and restore it to its original function as part of the scouring system of the estuary. This involves the replacing the present mechanism with efficient modern sluice gates within the historic structure. The major change to the outward appearance of the structure is the need to have a control mechanism mounted on the top of the old sluicing structure.

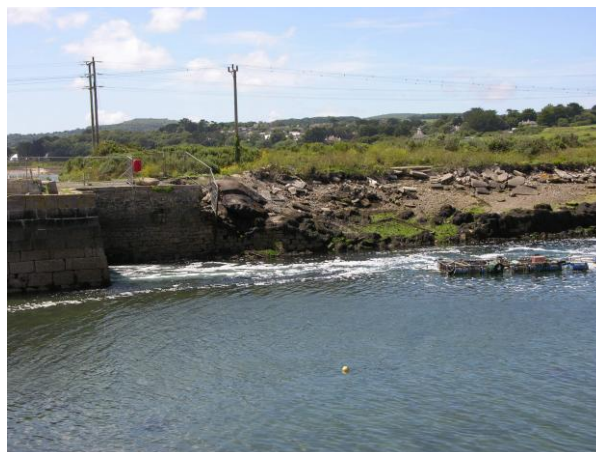
**Description:** The Quay wall ends just beyond the sluice with a damaged area. The bank is made from a mixture of stone, rubble and earth embankment.

**Baseline Condition:** Poor.

**Proposals:** To retain as found.

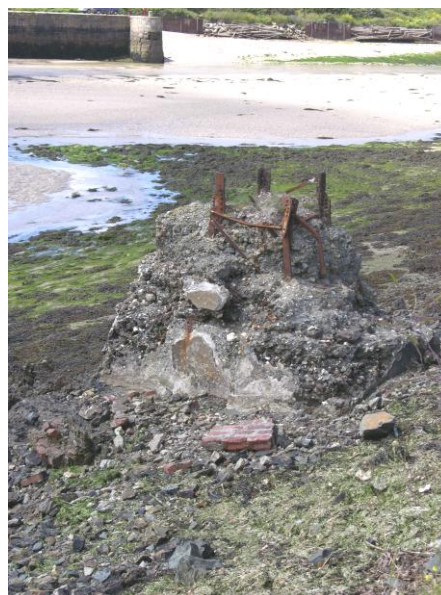
**Description:** Remains of a concrete stump with metal 'legs' embedded in top possibly the remains of a pylon.

**Baseline Condition:** Very poor.

**Proposals:** To be left as found.

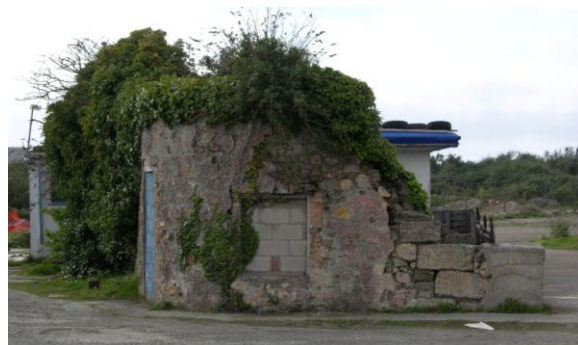
**Description:** Attached to Blue Hayes (SQ7) Two walls are still standing forming the 'garden' of the adjoining house. The walls are of irregular (rubble) stone blocks with red brick window openings; there is a curved part to the wall at the southeast corner.

**Baseline Condition:** Very poor.

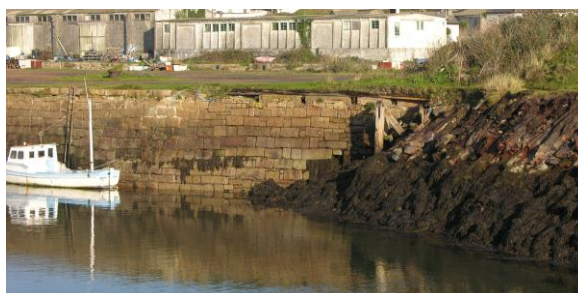
**Description:** The quay walls beyond (to the northwest) the point where the walls have been damaged and the filling in of the Pool has begun they form three sides of the ‘peninsular wharf’. The construction is of irregular shaped granite blocks – some of the granite coping stones are tied together with iron ties. The plan is scoloped, especially on the Penpol side to ensure more boats could tie up – it allowed the bowsprits of the sailing ships to overlap. There are steps on the extreme north end and slots in the Quay wall to take loading shoots. (There is a fuller description of the east side at SQ17.)

**Baseline Condition:** Fair to very poor.

**Proposals:** To repair and retain.

**Necessity of change:** The harbour wall is in need of repair to leave in its present condition is to invite collapse as has happened to parts of the east side of the quay.

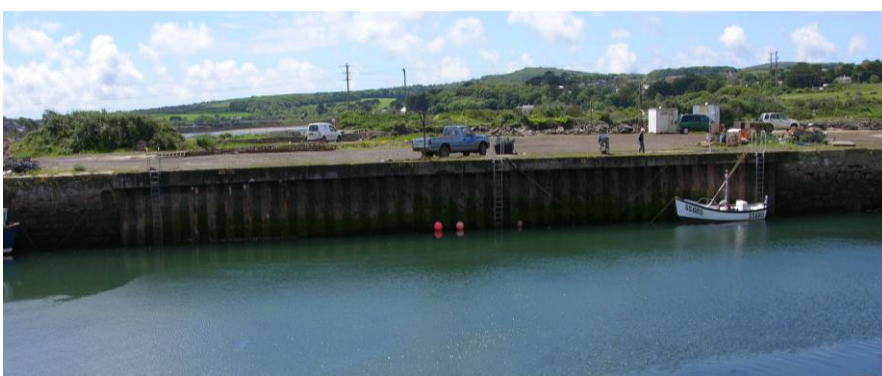
**Description:** The Quay wall runs north and south for 440 metres and turns at the extreme north end running west for 25 metres. The construction is largely of irregular blocks of granite with series of cargo slots (separate entry). The wall has collapsed just over 200 metres from the southern end, and there is some replacement metal piling

just beyond the collapse – it is because of the poor state of the wall partly due to the possible internal collapse of the tunnel (SQ16). There is a set of stone steps down to the water at the extreme north west corner.
