hayle harbour :: regeneration South Quay

Harbour Wall Condition Survey

Extract from Harbour Wall Condition Survey

Job no 027802 December 2010

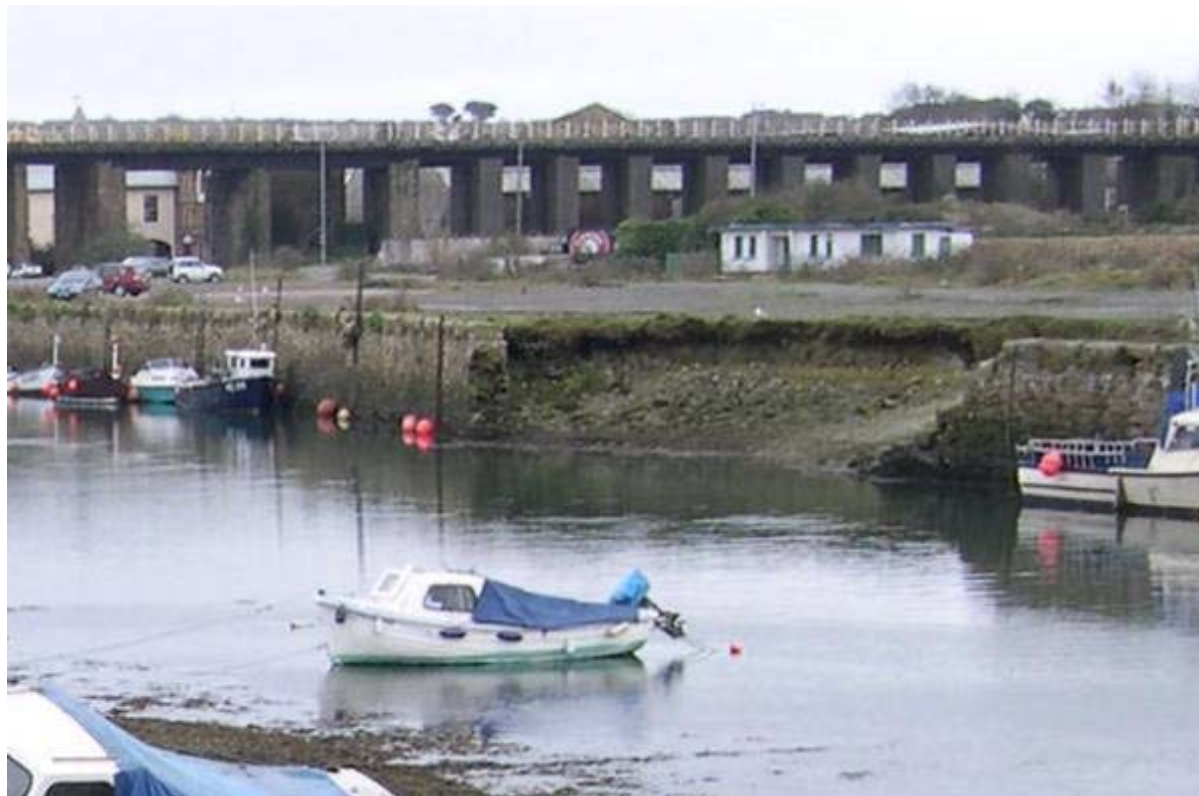
Collapsed section of wall between chainages 230 to 275m (see Listed Building Consent)

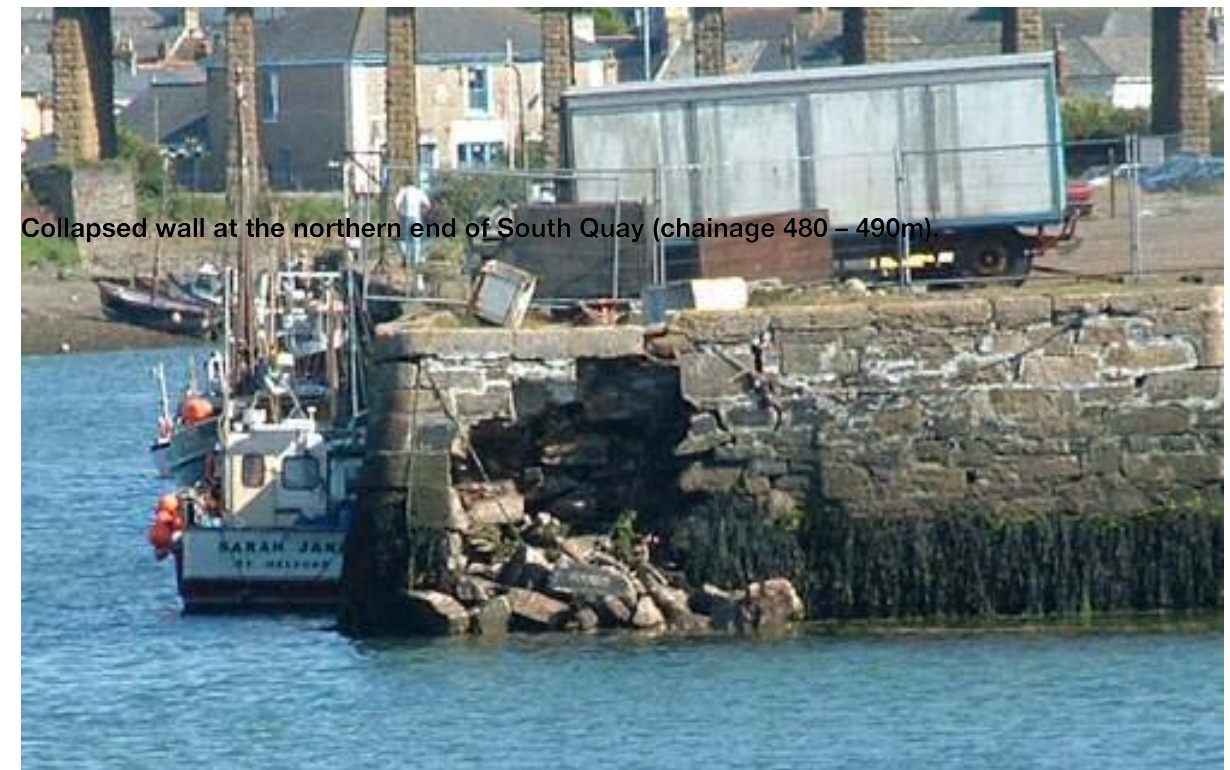
Collapsed wall at the northern end of South Quay (chainage 480 – 490m)

South Quay wall collapse (chainage 480 – 490m) 2004 – Now repaired (refer Page 55 & 56)

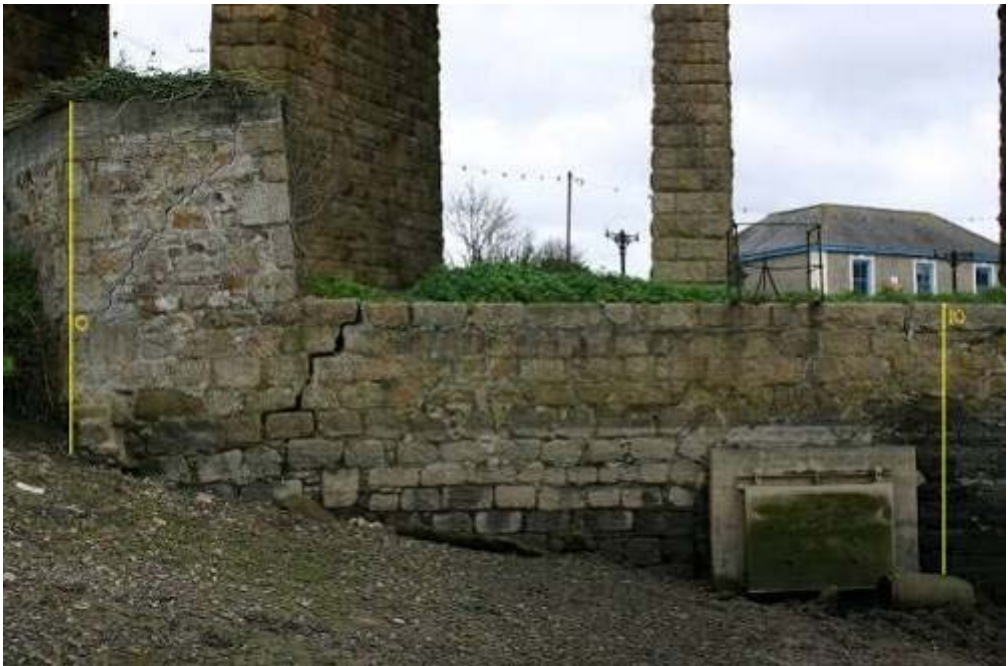
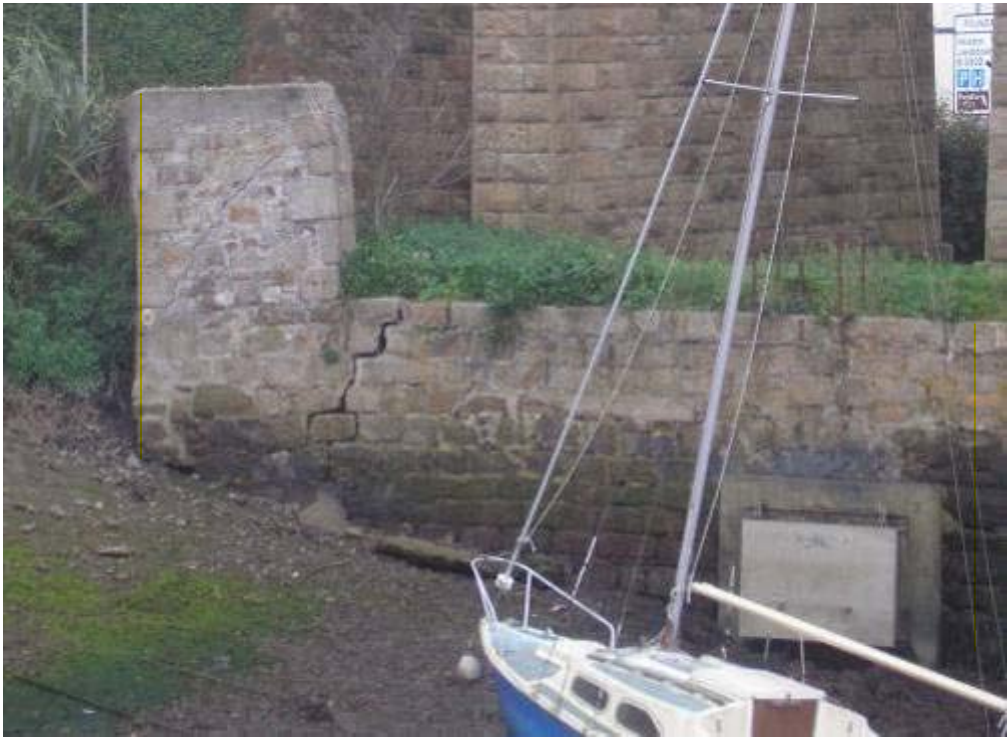
Location: SOUTH QUAY – Chainage 0 – 10m

| Chainage | Item | Depth | Description |
|---|---|---|--|
| 0-2.60 | | - | Diagonal crack extending to surface of free standing wall, 2.34m high above general quay level no change but less vegetation on wall section |

| Chainage | Item | Depth | Description |
|---|---|---|---|
| 9.5m | | 0.3 | Vertical crack (minor) no change |
| 2.0-3.2m | | 0-2.05 | Very open diagonal crack no change |
| 0.5m | | | Block missing at base not visible |

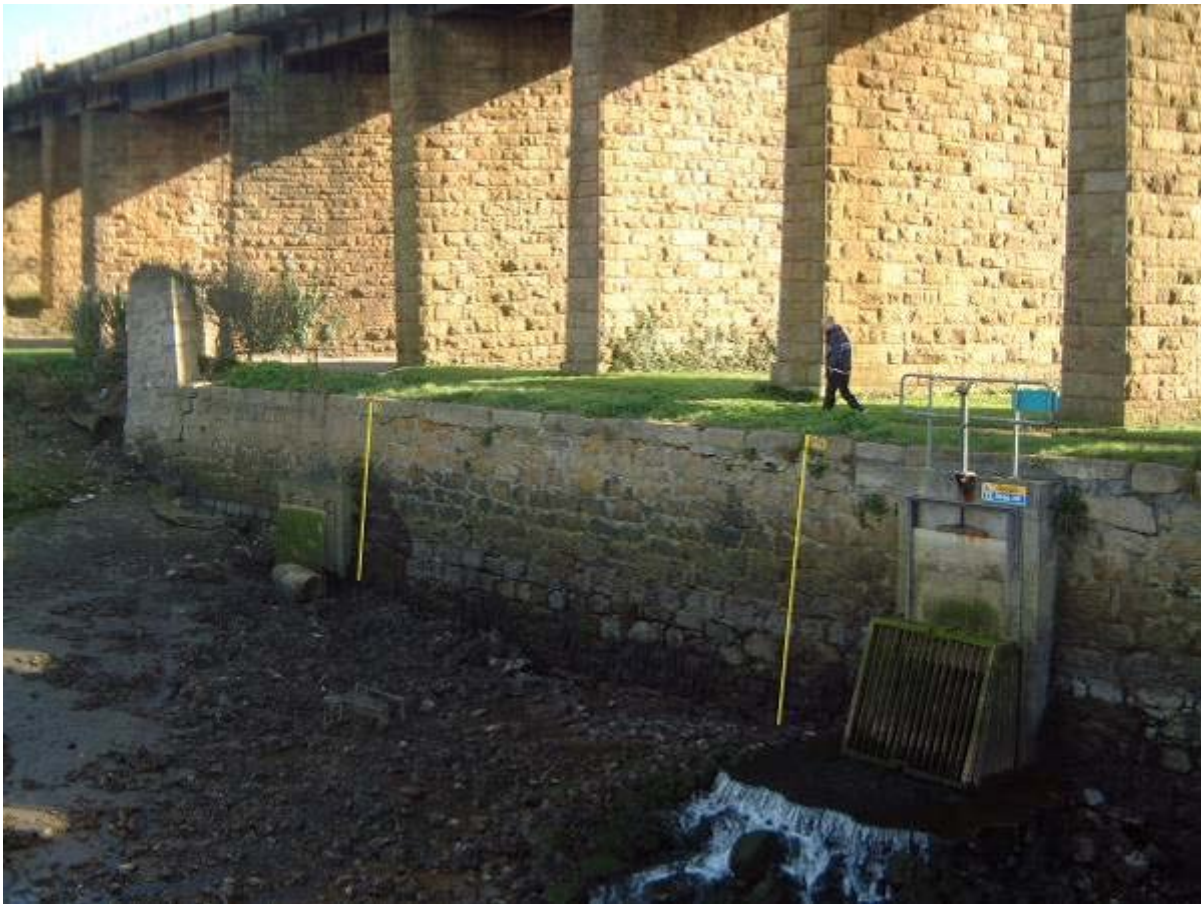
Location: SOUTH QUAY – Chainage 10 – 20m

| Chainage | Item | Depth | Description |
|---|---|---|---|
| 13 | | 0 – 1.10 | Vertical crack |
| 13 | | 2.30 & below | Random open joints |

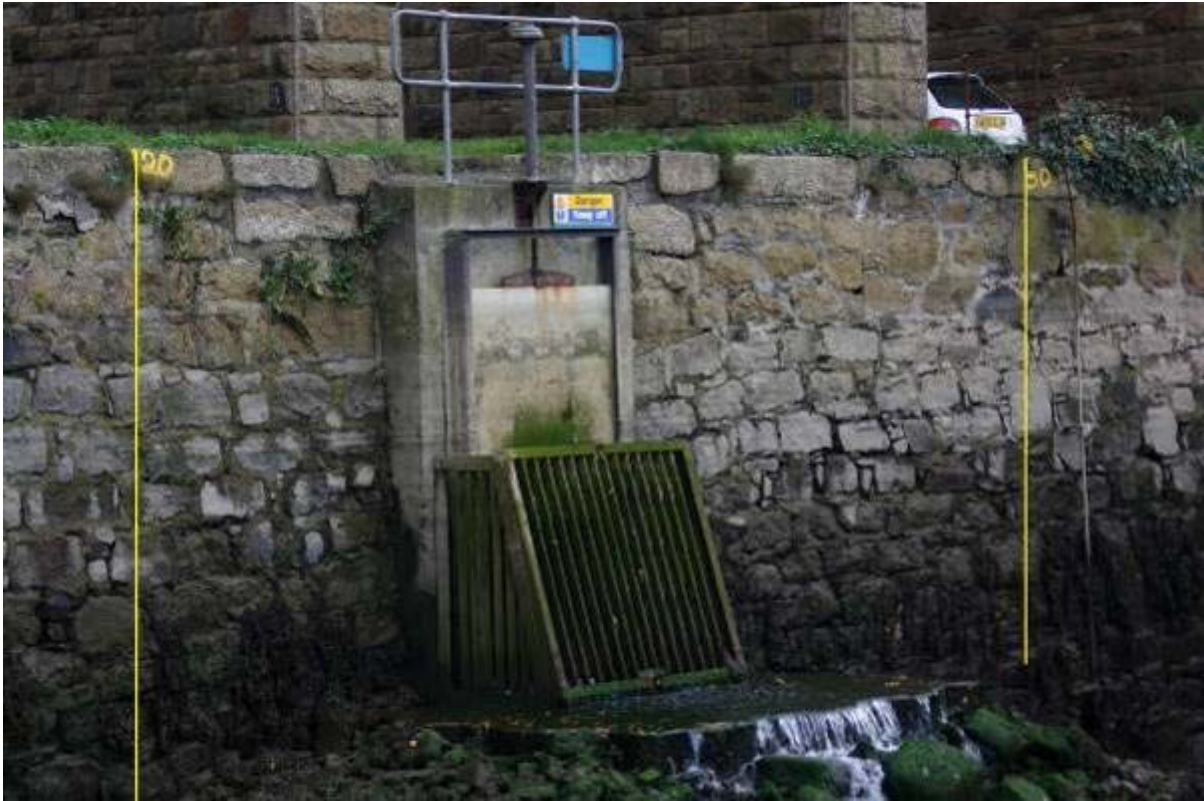
Location: SOUTH QUAY – Chainage 20 – 30m

| Chainage | Item | Depth | Description |
|---|---|---|--|
| 26.5-30 | | 1.90 & below | Randomly spaced open joints 1.90 to bottom |
| 29.50 | | | Thin rusty handrails and remains of spindle is badly bent. |

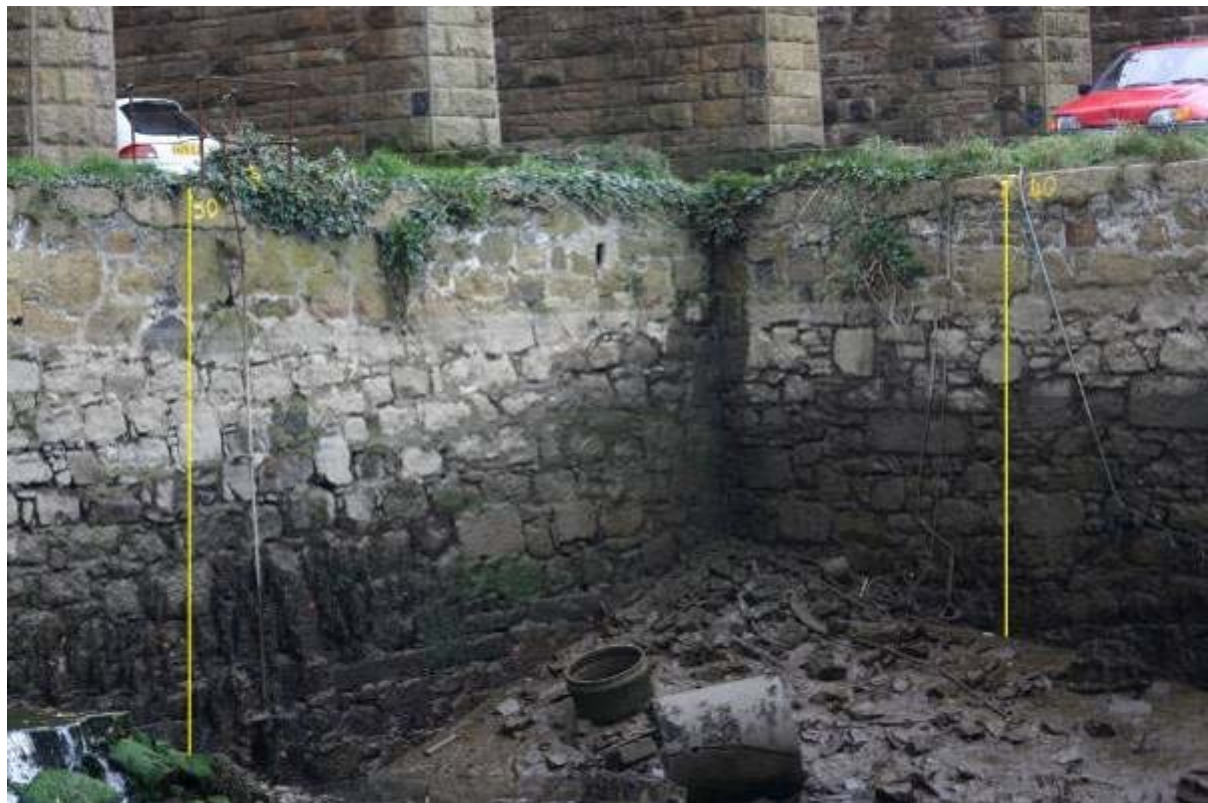
Location: SOUTH QUAY – Chainage 30 – 40m

| Chainage | Item | Depth | Description |
|---|---|---|---|
| 30m | | 4.5m | 225 pipe with penstock open (rusted) |

| Chainage | Item | Depth | Description |
|---|---|---|---|
| 34.5m | | 0.5m | Missing block possibly drainage hole |
| 30 – 40m | | | Randomly spaced open joints to bottom |

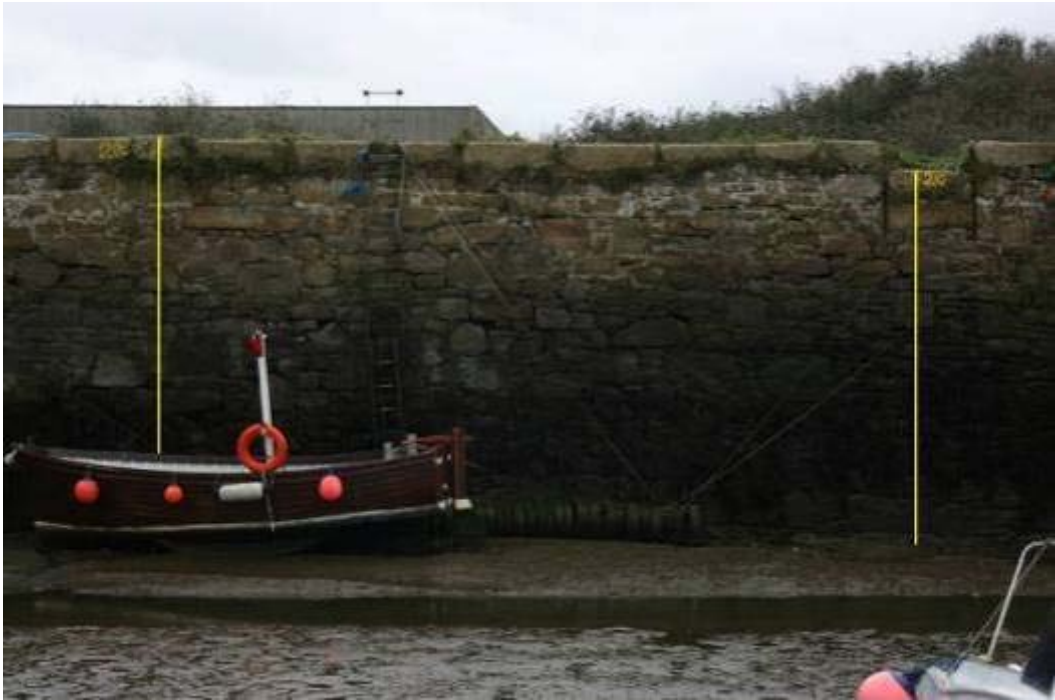
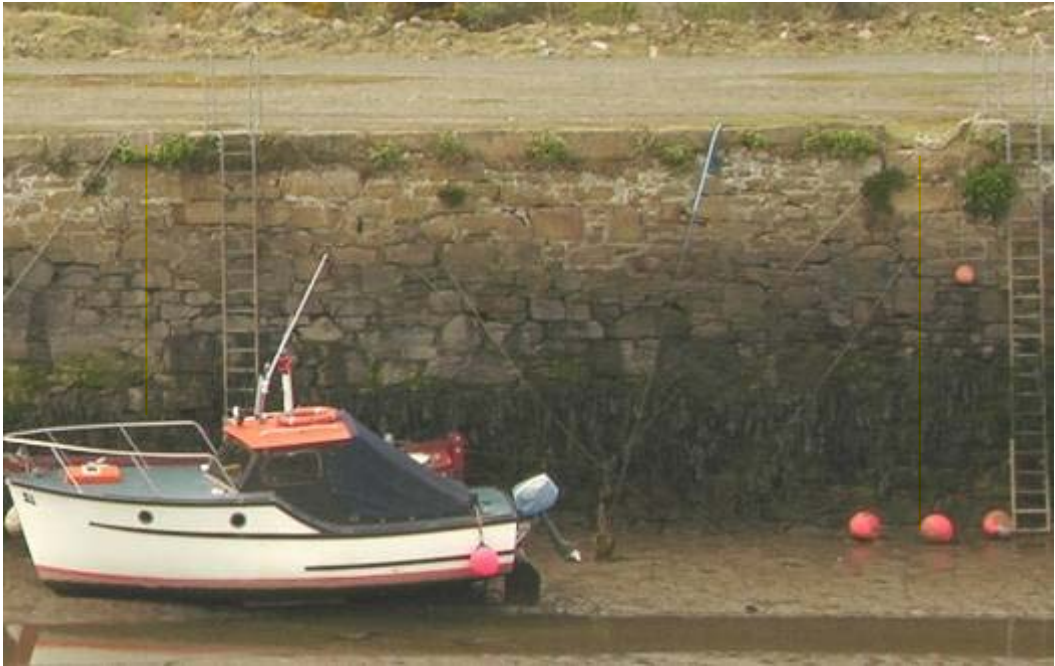
Location: SOUTH QUAY – Chainage 200 – 210m

| Chainage | Item | Depth | Description |
|---|---|---|--|
| 209.5 - 210 | 0.7 -bed | | Coping block missing No change Vegetation (see image) No change. Seaweed growth line from around 4.0m. Open joints below coping stone level No change, repointing needed. Boat in the way No change |

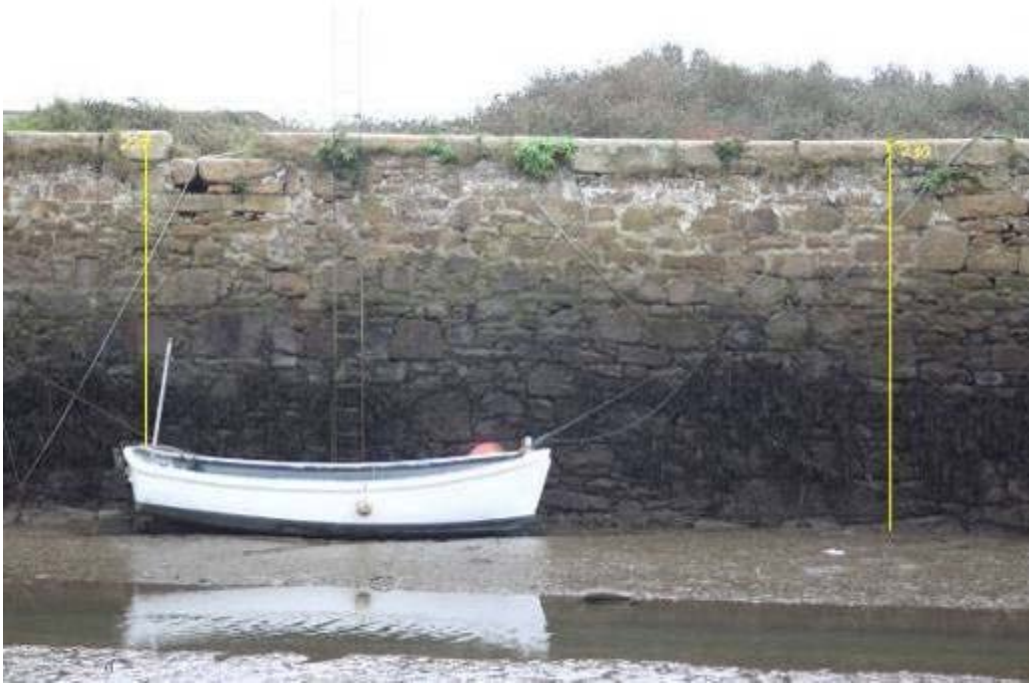
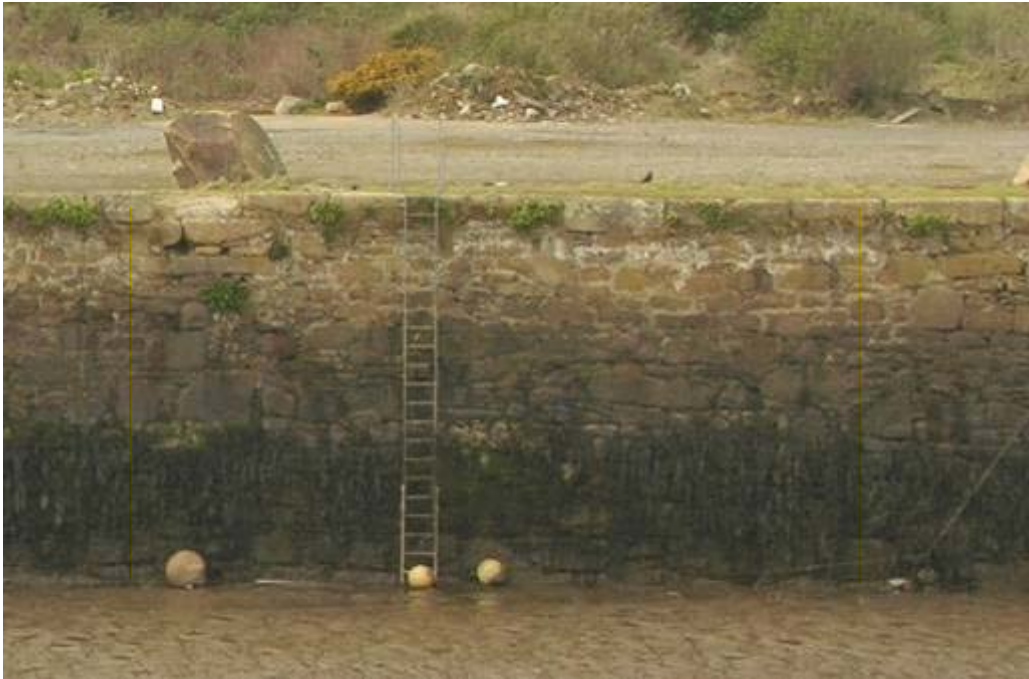
Location: SOUTH QUAY – Chainage 220 – 230m

| Chainage | Item | Depth | Description |
|---|---|---|---|
| 221.0 | | | Missing coping stone 1.25m width with adjacent depression. No change |

| Chainage | Item | Depth | Description |
|---|---|---|---|
| 220.2 – 201.2 | | | Coping stone missing No change Joints below coping stone vegetated / open, need repointing No change |
| 200 – 201.5 | | 0 – 1.20 | Blocks missing & open joints No change |

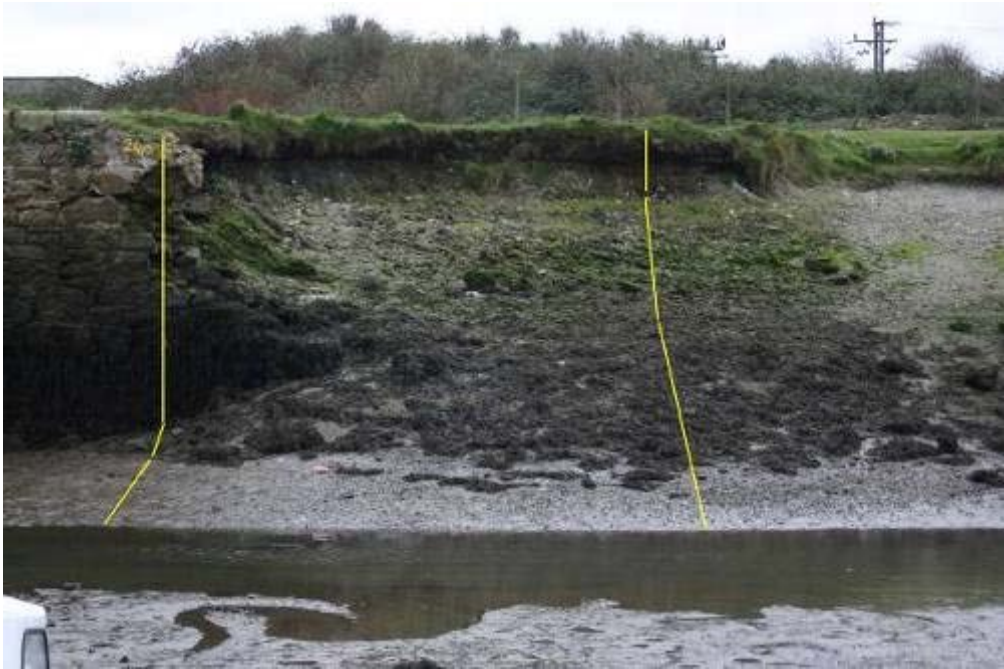
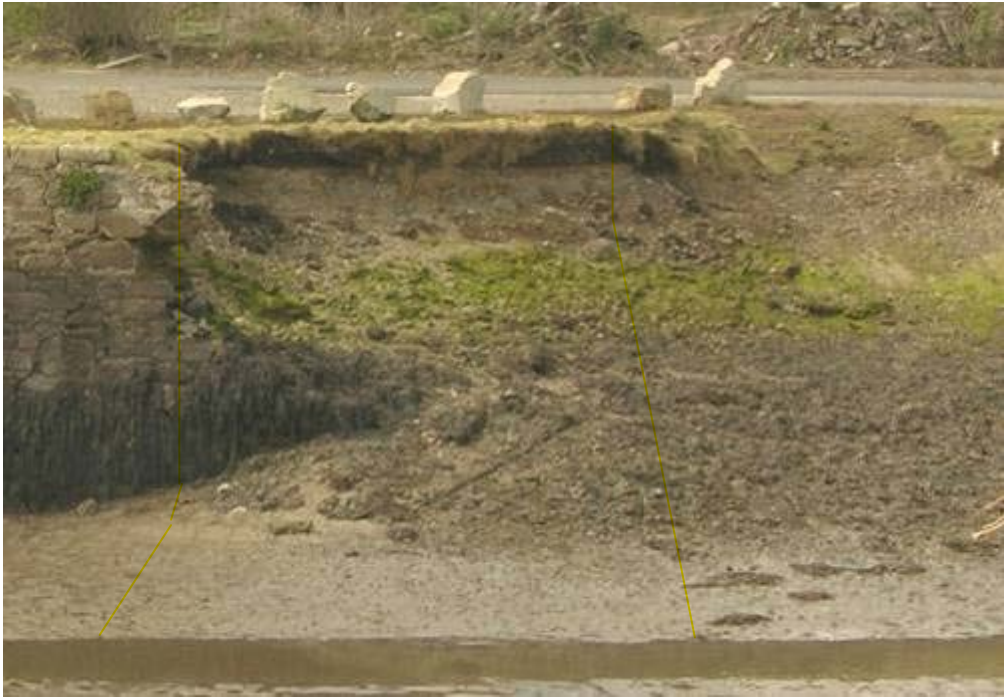
Location: SOUTH QUAY – Chainage 240 – 250m

| Chainage | Item | Depth | Description |
|---|---|---|---|
| 231 - 240 | | | Open joints below coping / vegetation No change Wall gets progressively worse with displacement until present breach is reached Cracking before collapse but no obvious disintegration. Appears to slope downwards towards breach |
| 239 | | | Vertical crack Block missing at start of collapsed section. |

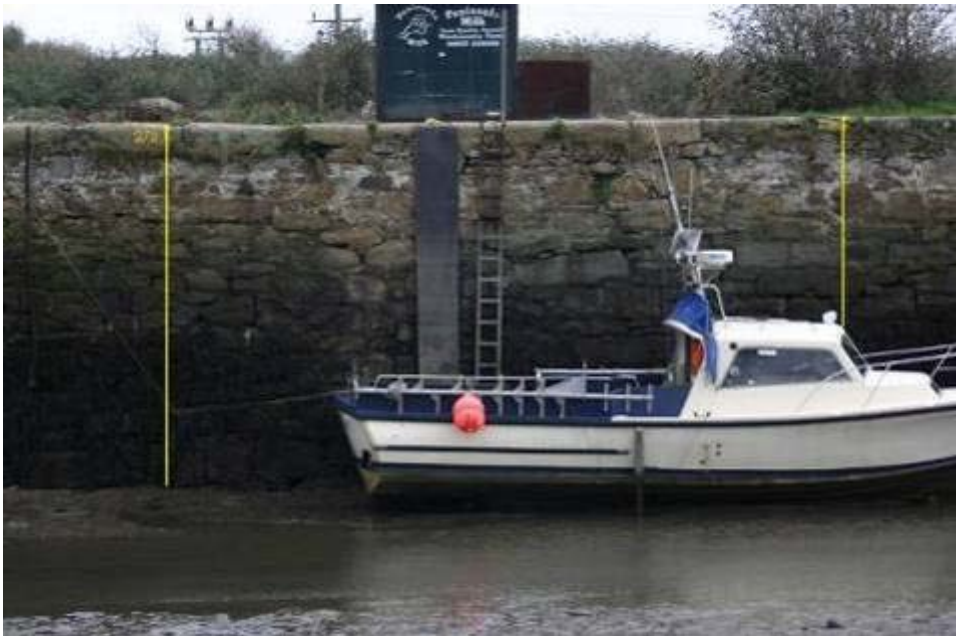
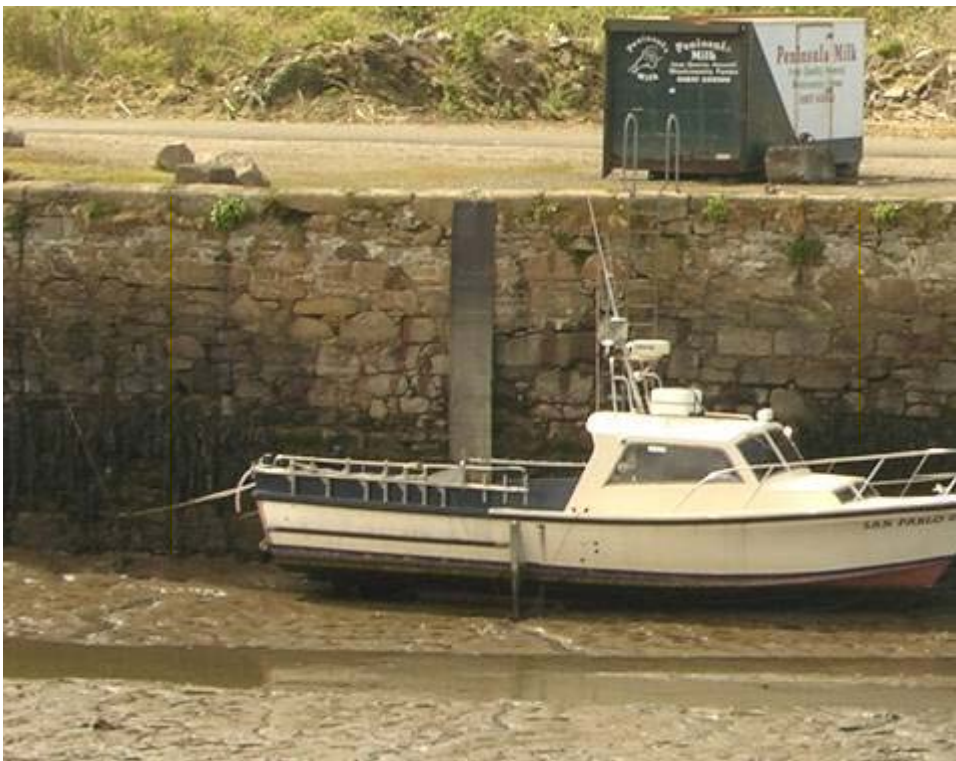
Location: SOUTH QUAY – Chainage 270 – 280m

| Chainage | Item | Depth | Description |
|---|---|---|--|
| 270 - 277 | | 1.30 – 1.70 | Vegetation between and under open joints around coping All copings have metal pins in this area Horizontal crack, some recent repairs on top 1m approx of wall No change |
| 277 | | 1.00 | Block missing No change Randomly spaced open joints throughout No change Boat in way – lower sections not surveyed No change |

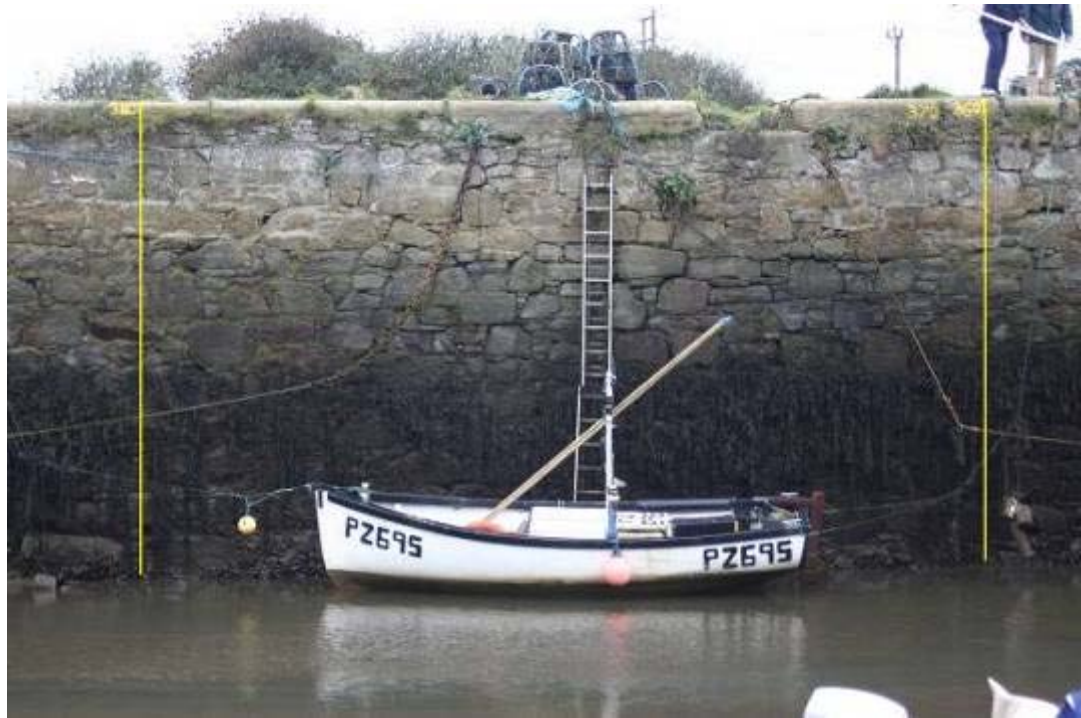
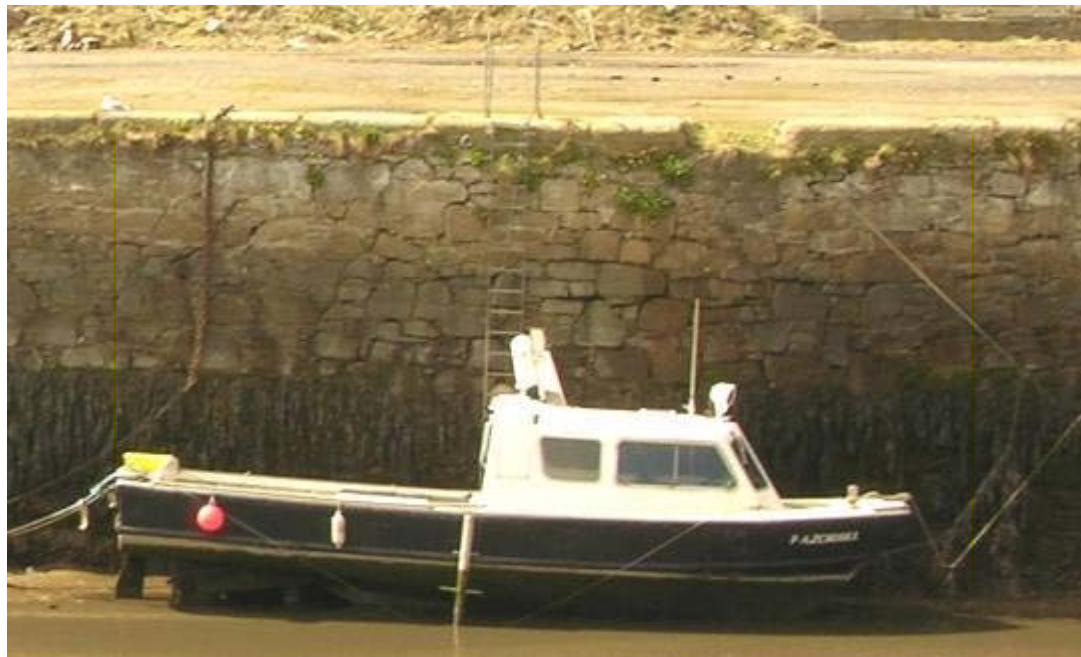
Location: SOUTH QUAY – Chainage 360 – 370m

| Chainage | Item | Depth | Description |
|---|---|---|--|
| 365 | | | Very rusty mild steel ladder New ladder with handrails at top. |
| 367.70 - 370 | | | Missing coping stone 1.10 wide No change |

| Chainage | Item | Depth | Description |
|---|---|---|---|
| 365 – 367 | | | Vegetation / open joints below coping No change Small bulge in wall, i.e. looking on plan Unclear. Occasional open joints No change |

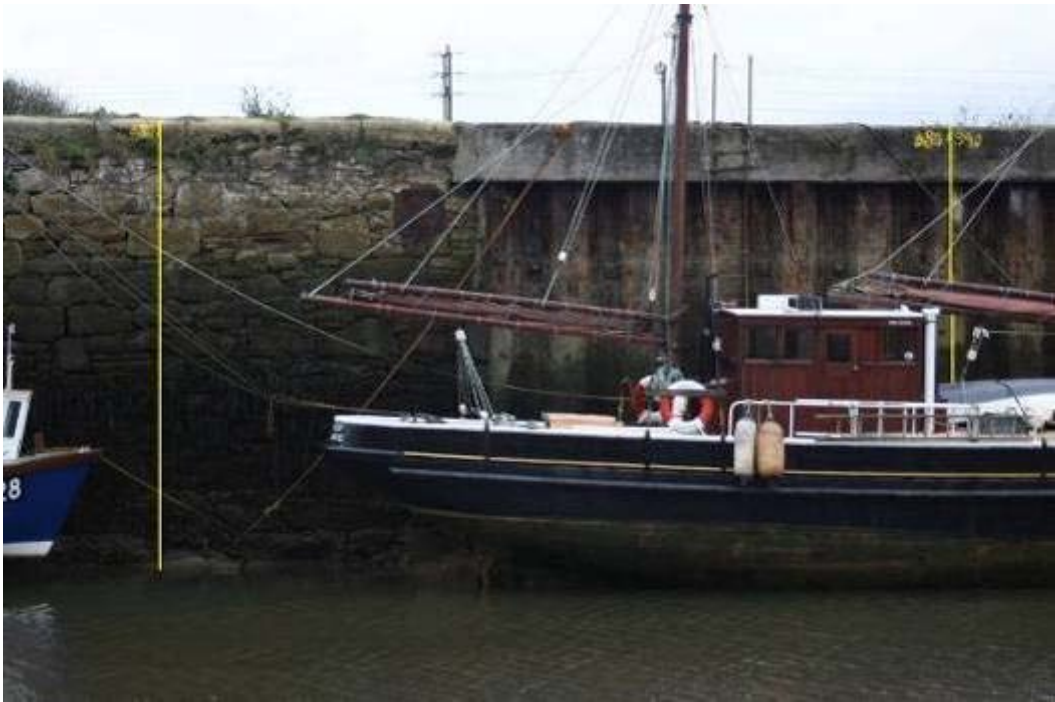
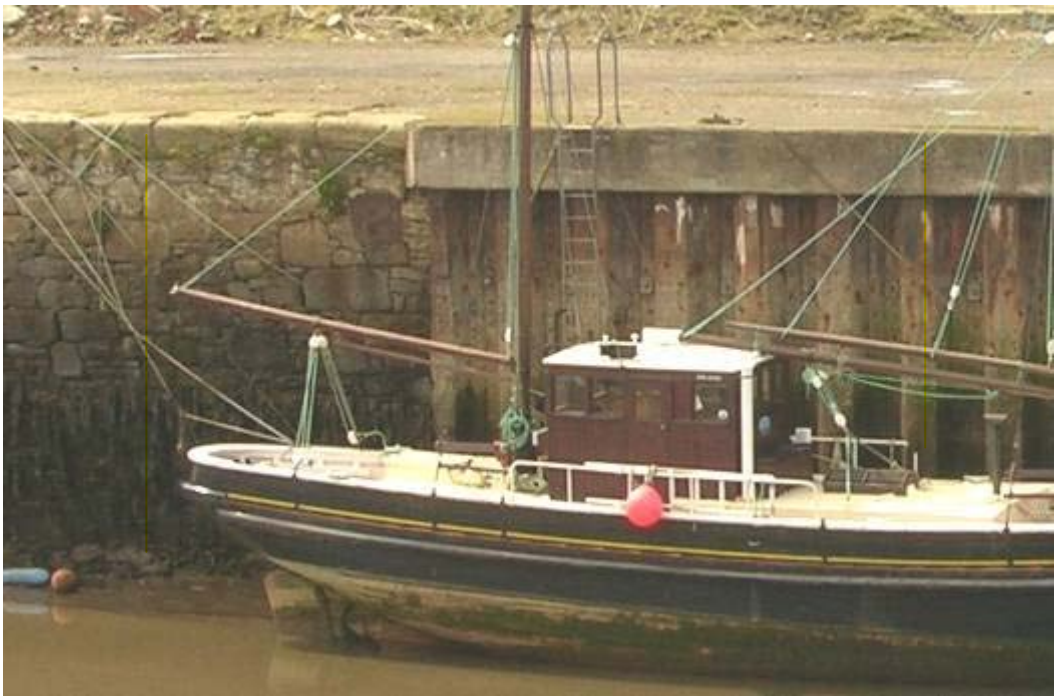
Location: SOUTH QUAY – Chainage 380 – 390m

| Chainage | Item | Depth | Description |
|---|---|---|---|
| 380 – 383.70 | | | Vegetation crack below coping Small amount of vegetation. |

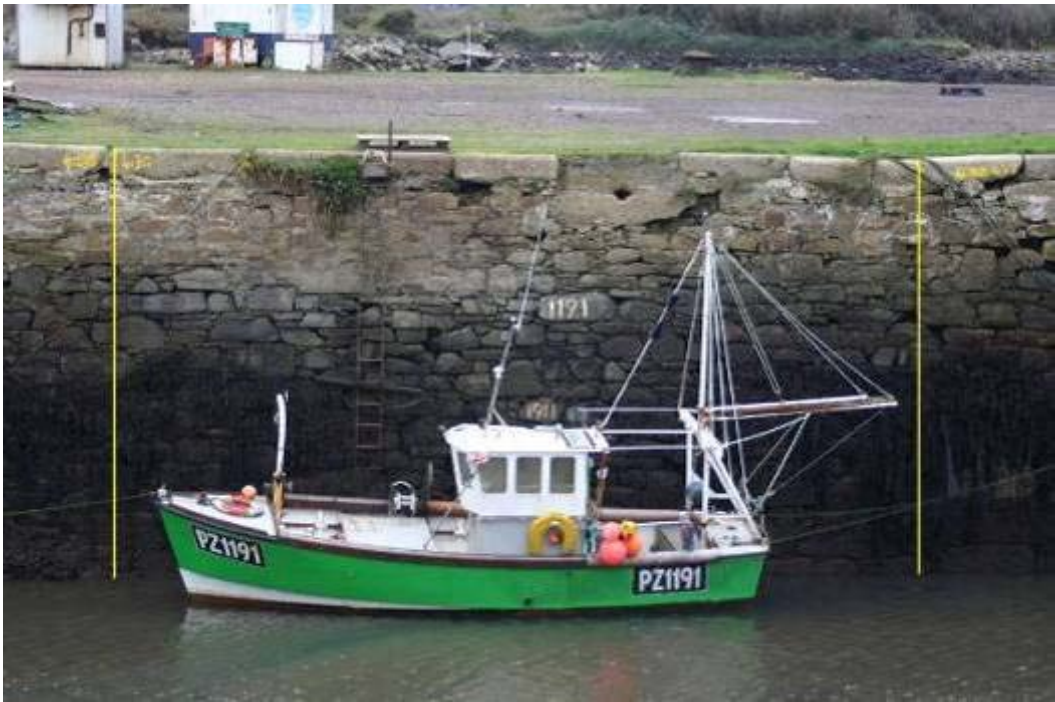
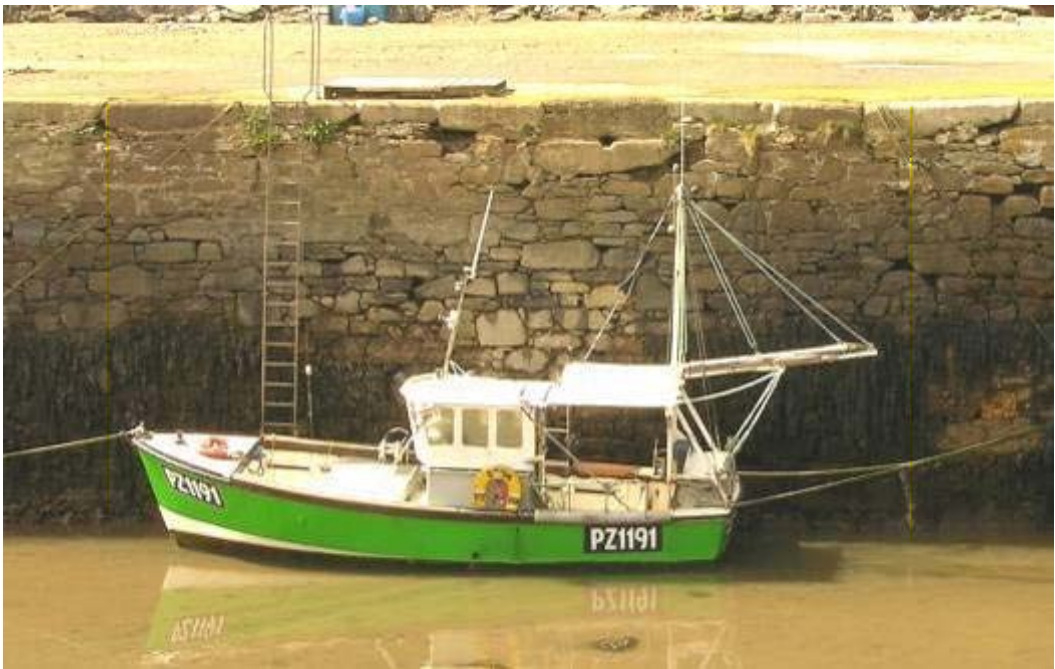
Location: SOUTH QUAY – Chainage 430 – 440m

| Chainage | Item | Depth | Description |
|---|---|---|---|
| 433 432.5 | | | Rusty mild steel ladder New ladder with handrails at top. |

| Chainage | Item | Depth | Description |
|---|---|---|--|
| 434 | | 0.4 | Hole / block missing, probably drainage hole No change |
| 436 | | | Coping gone replaced by rough concrete No change |
| | | 0.4 – 1.0 | Blocks missing No change |
| 430 - 435 | | 1.4 | Some previous repairs over part of wall No change |
| 440 | | 2.0 | Blocks missing No change |
| | | | Signs of previous movement No change |

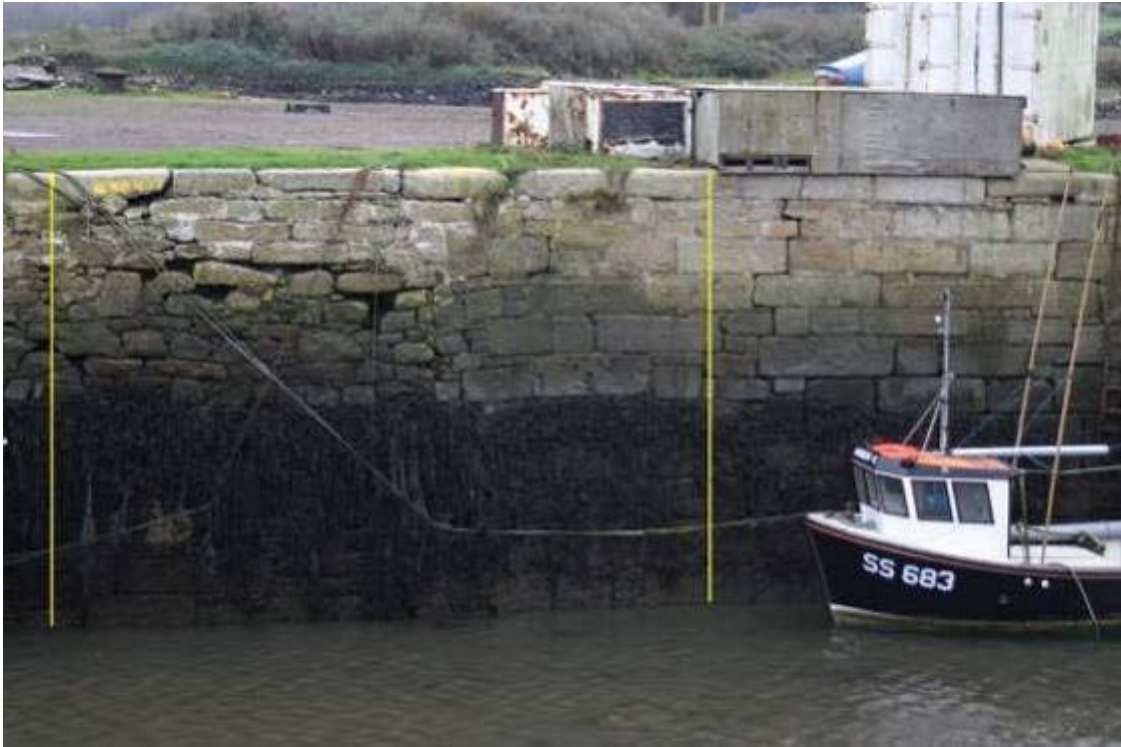
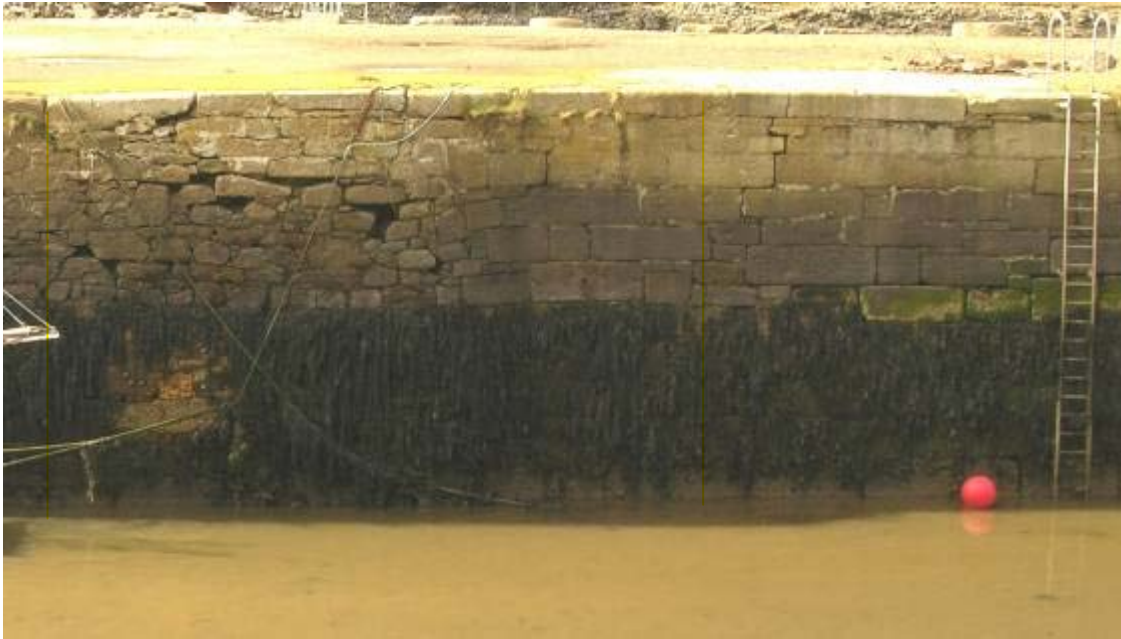
Location: SOUTH QUAY – Chainage 440 – 450m

| Chainage | Item | Depth | Description |
|---|---|---|--|
| 410.5 | | 0.3 | Blocks missing below coping No change |
| 414 | | 1.0 | Large open horizontal crack No change |
| 413 | | 1.8 | Missing block No change |
| 412 | | 1.0 & 1.4 | Missing blocks No change |
| 449 / 450 | | 0 – 2.80 | Vertical crack at least to seaweed level Unclear |

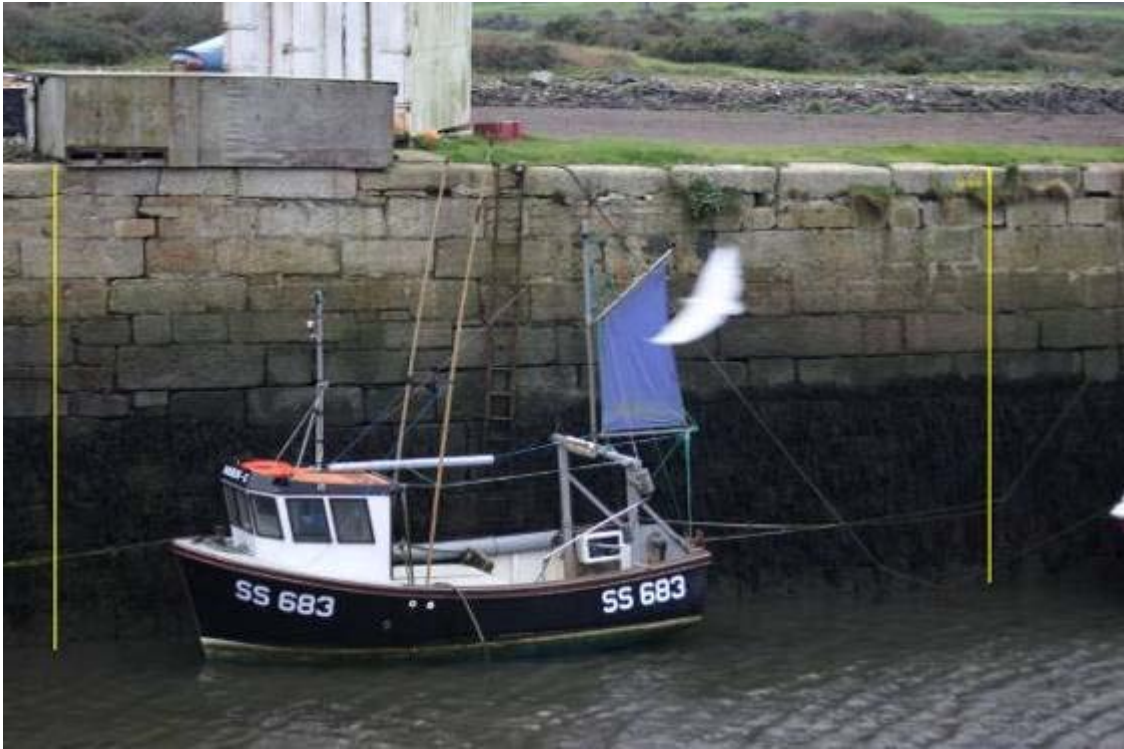
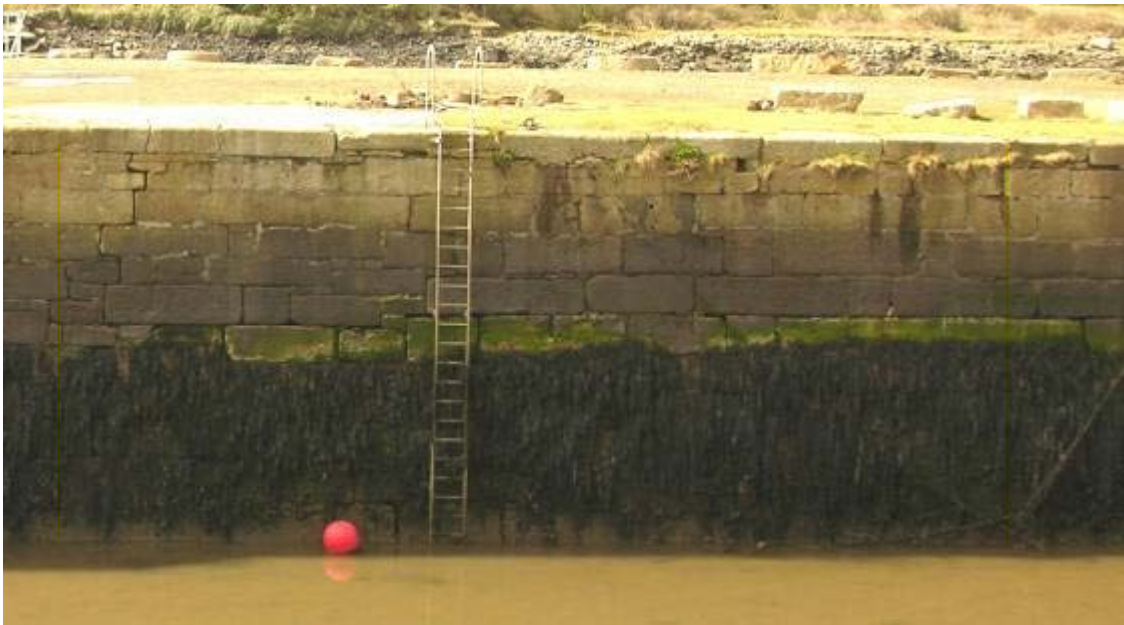
Location: SOUTH QUAY – Chainage 450 – 460m

| Chainage | Item | Depth | Description |
|---|---|---|---|
| 454 | | | Rusty scaffold type ladder New ladder with handrails at top |

| Chainage | Item | Depth | Description |
|---|---|---|--|
| 450 - 460 | | Around 3.0m | Vegetation cracks under copings No change Seaweed growth line, condition difficult to confirm |
| 457 | | | Small hole possibly for drainage No change |

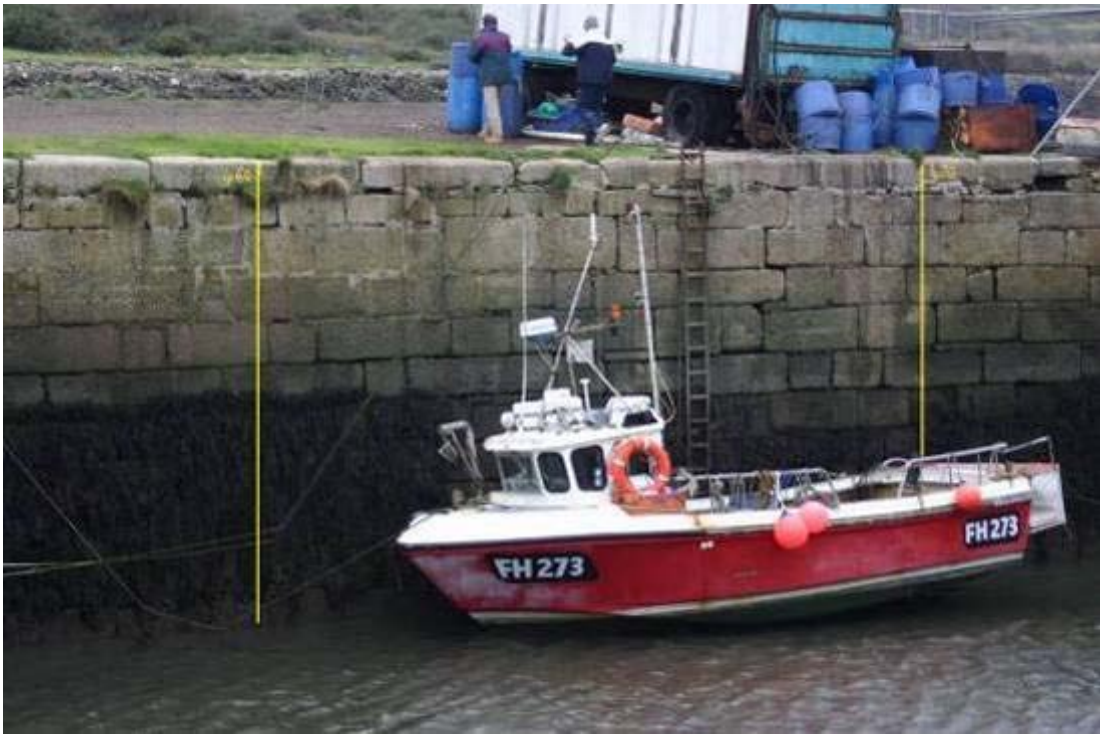
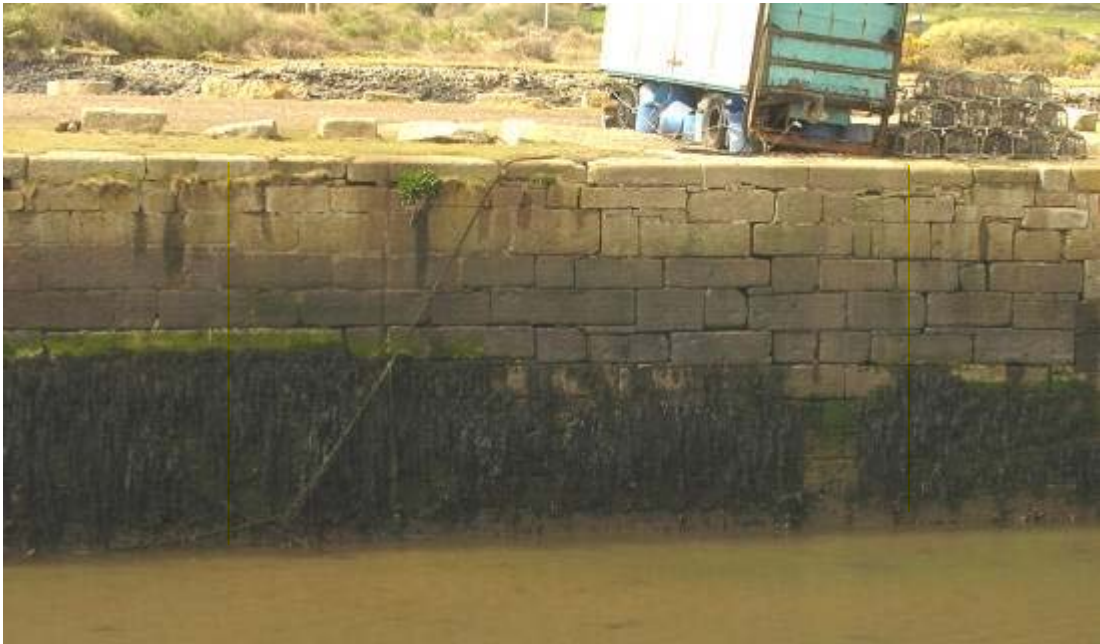
Location: SOUTH QUAY – Chainage 460 – 470m

| Chainage | Item | Depth | Description |
|---|---|---|---|
| Approx. 466 | | | 2004 Rusty scaffold type ladder, no longer present 2009 |

| Chainage | Item | Depth | Description |
|---|---|---|--|
| 460-464.5 460 - 470 | | | Vegetation under coping Cracks under coping |
| 466 | | 0 – 2m plus | Large vertical crack No change |
| 468 | | 0 – 2m plus | Large vertical crack down at least to seaweed line No change |
