hayle harbour :: regeneration South Quay

Harbour Wall Condition Survey

Extract from Harbour Wall Condition Survey

Job no 027802 December 2010

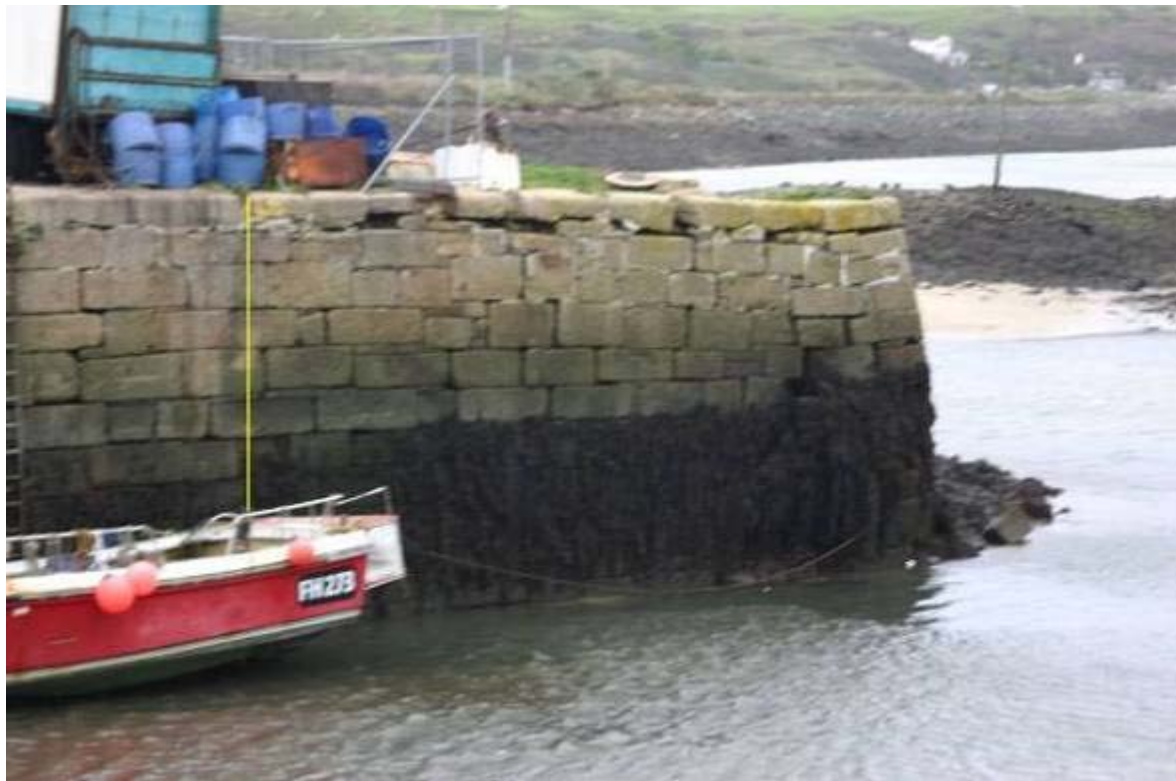
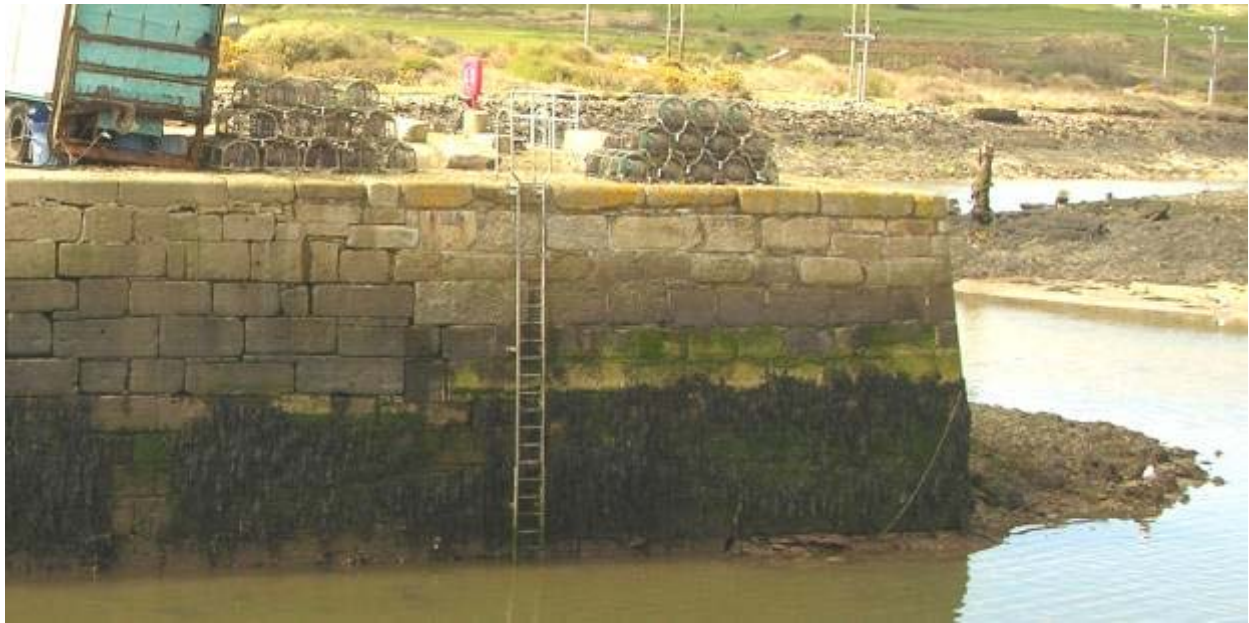
Location: SOUTH QUAY – Chainage 470 – 480m

| Chainage | Item | Depth | Description |
|---|---|---|--|
| 470 - 480 | | | From ch.470m wall gets progressively worse – considerable movement. Blocks or large open joints under coping Large open vertical cracks Wall repaired well, blocks repointed. |
| 480 | | 2m | Rotation of wall, one small block missing Repaired. |
