1999R043

Harvey's Foundry, Hayle, Cornwall
an
Archaeological Assessment

August 1999

CORNWALL ARCHAEOLOGICAL UNIT

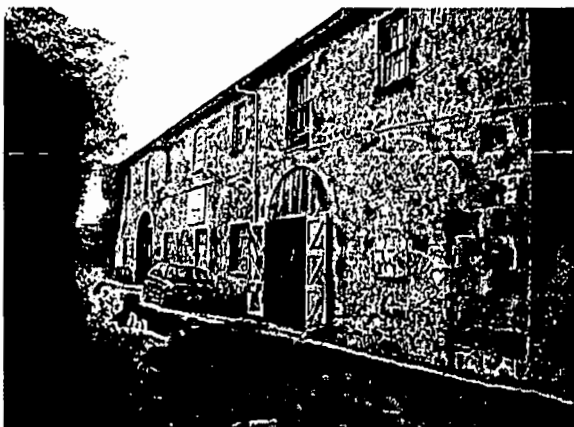
4.1 Trevithick's Stores

Now occupied as a garage and workshop by Ford Spares, Hayle. Map evidence shows that the building was in place by the 1850s, and is identified as a store on the plan of 1864. The structure is rectangular in plan, aligned roughly NW - SE, and is of rubble masonry under a hipped asbestos slate roof. Details include dressed granite quoins and a series of seven arches to the front at ground level. Of these, five are in-filled and two are open with wooden doors. A series of window openings at first floor level is

irregular in size and pattern, suggesting alterations in the past. The northern end of the building has a similar in-filled brick arch to those in the roadside elevation. The rear wall of the structure appears at one time to have continued to the north, but it is now truncated and represented by a ragged edge of unbonded masonry. The interior was not inspected. *(Photo shows the eastern elevation, from the north).*

The building appears to be in a sound basic condition. Conservation work should include repair and replacement of the fenestration. Consider adaptive re-use which would unblock all the arches in the front elevation. Produce photographic record of exterior and interior prior to remedial works.

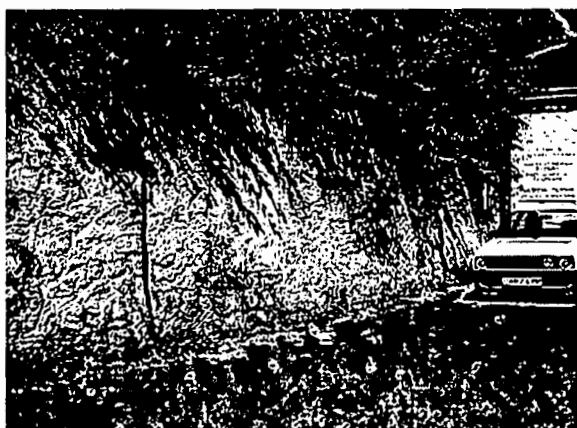
4.2 Cattle Houses

Identified from the plan of 1864 as cattle houses, the structure is now represented by roofless upstanding walls to a height of ca 2 to 3 metres. Construction is of rubble masonry, with evidence for door and window openings with brick detail on the eastern side. The interior of the structure is open to the lane on the west. *(Photo shows the eastern elevation, from the south).*

Remove vegetation and assess condition. Stabilise and re-point as required. Produce measured ground survey and photographic record before remedial works.

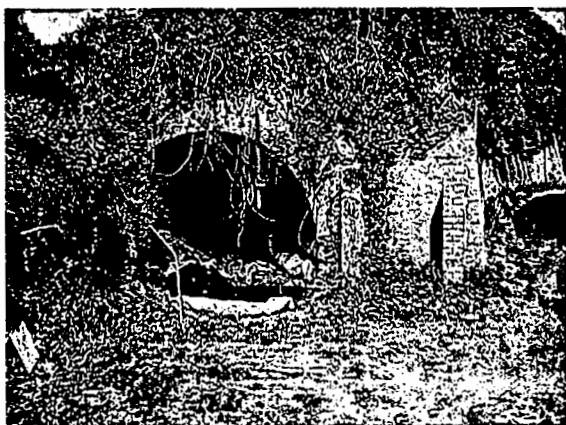
4.4 Tunnel

This tunnel has been constructed beneath the cattle houses (4.2) but does not seem to be associated with it. A brick-arched entrance leads into a tunnel which descends on a gentle slope for ca 10 metres. The tunnel then levels out and increases in width; this chamber is terminated by an end wall containing two smaller tunnels which run on into blind ends. Again, there is no clear indication of an original function or purpose. *(Photo shows the tunnel entrance from the south).*

Clear vegetation from the portal and tipped rubbish from the interior. Assess condition and consolidate as required. Gate the entrance to prevent further fly-tipping. Produce measured ground survey and photographic record before remedial works.

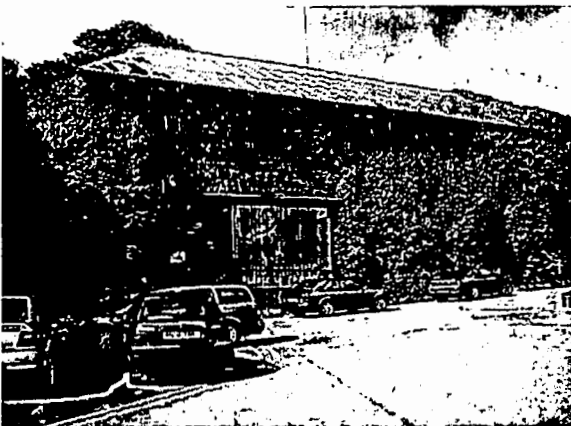
4.6 Pattern Store

A large hipped-roof structure, constructed of rubble masonry with granite quoins and brick detailing to some openings. The roof is covered in corrugated asbestos sheets, and at the southern end these have failed leaving the building open to the elements. The interior was not inspected. *(Photo shows the eastern elevation).*

Urgent remedial works are required to repair the roof. Vegetation should be removed from the walls and a full condition survey will be required prior to re-pointing and consolidation. Produce photographic record of exterior and interior prior to remedial works.

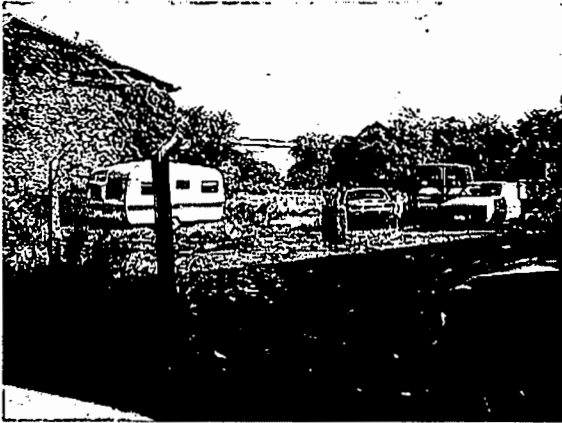
4.7 Reservoir

A reservoir is shown on the mapping of 1853 and 1864, which presumably supplied the boilers of the engine working the Boring Mill in 4.13 and other steam engines on the Foundry site. This area is now occupied by abandoned vehicles and debris, and it is assumed that the reservoir was in-filled after the Foundry closed in 1903. The most substantial remains of the reservoir today are on the east, where a massive granite retaining wall defines the structure as it abuts Booker's yard.

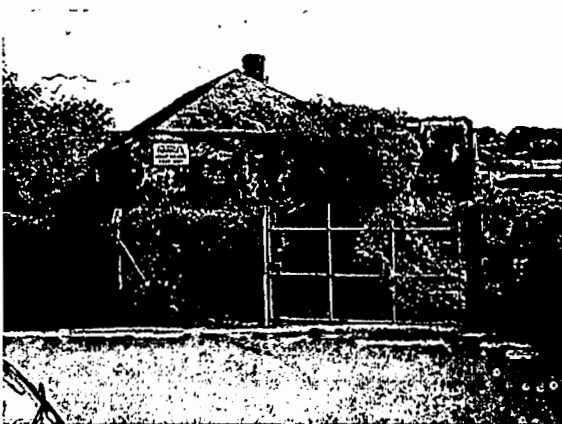
This building abuts the Foundry Barn at right angles, and is of brick and stone construction, with a rag-slate hipped roof. It is a typical early 19th century purpose-built range for the accommodation of horses and displays some excellent architectural detailing to the south, with arched openings. Inside, the wooden partitions, mangers, cupboards and fittings survive. At the front, a crude wood and galvanised iron lean-to has been added. The buildings around the Yard would have accommodated the Foundry's

numerous draught horses, which each working day delivered goods from Harveys to the whole of West and Central Cornwall. Huge engine beams and boilers were transported in this fashion to mines in the area, and to the harbour for shipment overseas. *(Photo shows the western end of the stable block).*

The building has suffered fire damage in the past, and as a result is mostly unroofed. Water penetration has led to further damage within the structure, and the wall facing onto the yard is close to collapse at the top. Clear vegetation, remove the lean-to, assess condition and produce a scheme for conservation which will preserve as much as possible of the interior fittings. Produce photographic record of exterior and interior prior to remedial works.

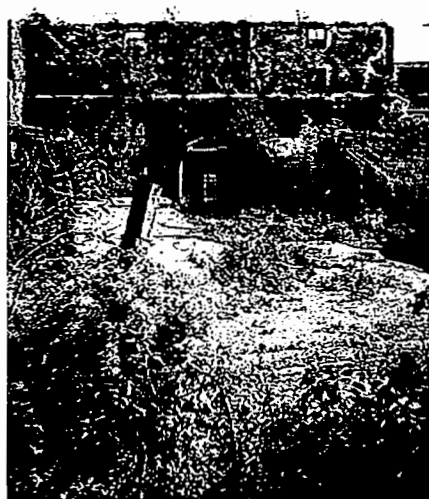
4.9 Farm Yard

The yard retains its cobbled surface in the western area and is enclosed on the south by a stone wall which incorporates some scoria block.

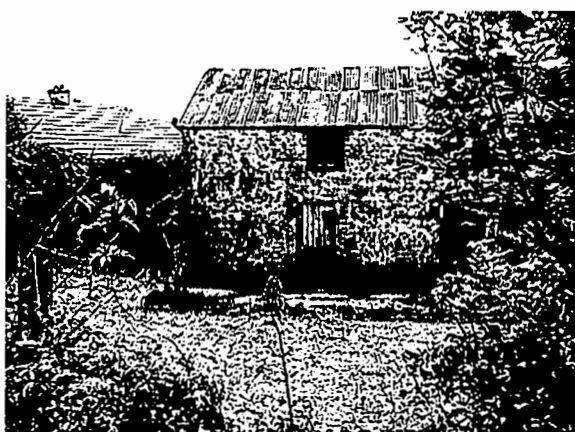
4.10 Stables

Built of brick with granite quoins and galvanised iron roofs, these stables are L-shaped in plan and are pre-1841 in date. They are of lesser quality than (4.8) but nonetheless add character to and enclose the Yard space. The interior was not inspected. *(Photo shows the northern elevation).*

Condition appears reasonable at present. Remove vegetation and assess condition. Produce photographic record of exterior and

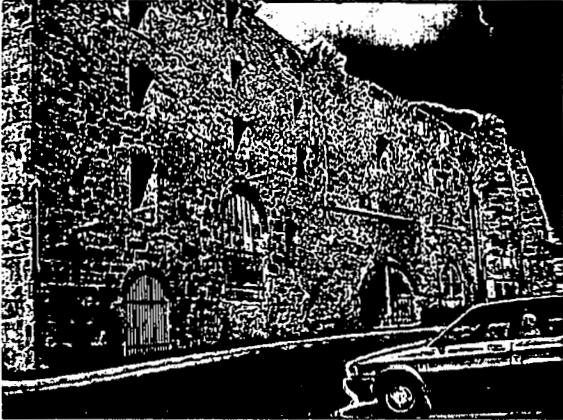
This building is impressive for its height and typical late 18th or early 19th century industrial design. It is of rubble masonry construction, with dressed granite quoins and brick detailing to door and window openings. The building is now unroofed. At ground level there are two arched openings which lead into vaulted chambers, whose function is unclear at present. The structure appears from map evidence to date from ca 1825. The upper floors were used to store provender (oats, hay, and straw) for the

Foundry horse teams, and there is access from the Farm Yard and Stables at the rear. Line-shafts on the upper floors probably provided power for sack hoists.

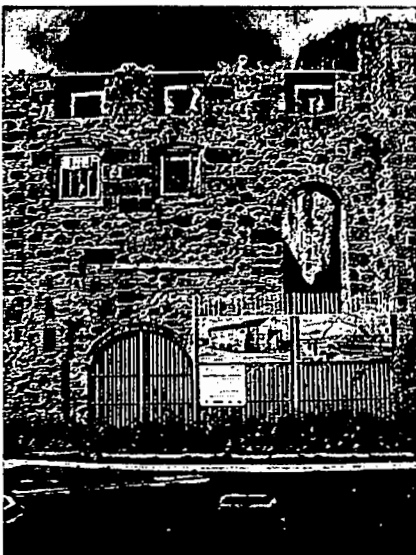
Now forms the northern end of the building known as the Foundry Barn. Originally this was part of the Boring Mill and former Erecting Shop, and should be interpreted as part of that structure. Construction is of rubble masonry with dressed granite quoins. There is a fine arched window to the front of the Engine House, another arch at ground level giving access to the boiler house and inside clear evidence of the flywheel position, supporting cross beam for the Bob, and the flue of the boiler house leading to an external chimney stack, of which the base survives at the rear. The floor above the boiler house may have provided office space; there are line-shafts to convey power from the engine on the upper floors. The power from the beam engine was transmitted from here directly to the Boring Mill

and via line-shafts to lathes, drills, and milling machines throughout the works. The engine

would appear to have been larger than was necessarily required for this purpose, and it is assumed that it formed a Foundry showpiece to be shown to potential customers.

The structure has recently been consolidated and re-pointed as part of the Guinness Trust housing scheme and is currently in sound condition. Schemes for adaptive re-use are at the planning stage. Produce photographic record of exterior and interior prior to remedial works.

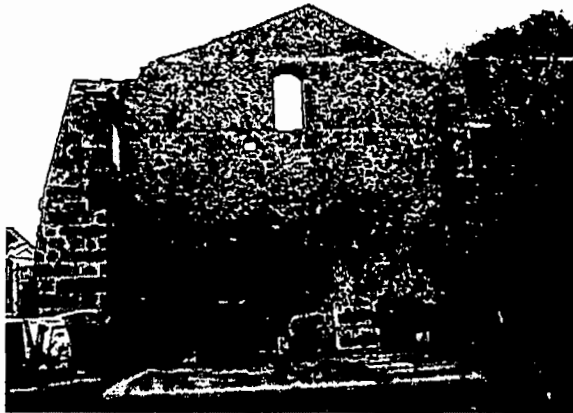
The south wall survives with one massive buttress representing the beginning of the eastern elevation, as does the stub of the rear wall. The walls are of rubble masonry with ashlar granite blocks in the quoins and openings. The floor space of the original building is now tarmac and in use as a car-park. This building was the second Boring Mill on the Foundry site, and replaced the earlier water-powered Boring Mill in the Hammer Mill complex. Here large cylinders (up to 144 inches) were bored to finished

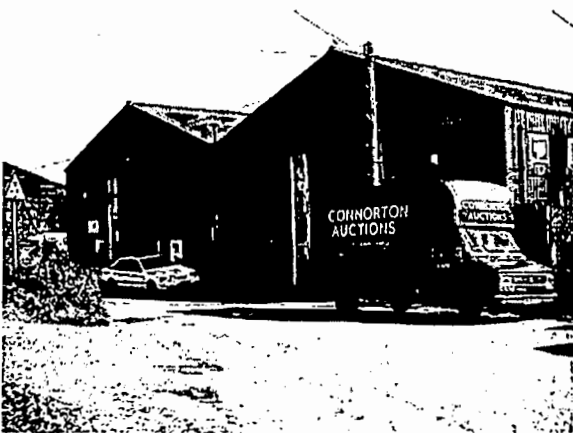
A post-1945 sectional building which has been inserted into an area of the site which was previously a yard. The structure is steel-framed and clad with corrugated asbestos, and is currently occupied by a firm of auctioneers and a car spares business.

The structure is not part of the Harvey's Foundry complex and has no historic significance. Map evidence suggests that this area was always an open space during the Foundry's operation, and there should
