Hayle Causeway Bridge, Cornwall

Archaeological Assessment

A Report for the Design and Maintenance Consultancy, Cornwall County Council

Report No: 2004R015

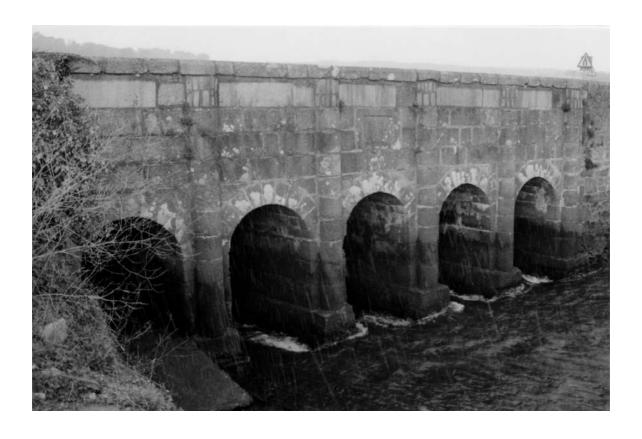
The bridge is constructed of dressed granite and comprises five round arches, each divided by decorated semi-circular piers on a square base which makes up the individual cutwaters. The paved arch floor of the westernmost arch is interestingly raised above the level of the other four.

Above the arches, there are three courses of the original walling. This is made up of granite blocks, each about 0.4m in height. Incorporated into these courses is a decorative plaque which dates the bridge to 1825. From this point, the parapet has been increased in height. A further single course of granite block (also measuring 0.4m) has been added with the original chamfered granite coping stones re-used on the top of the wall. This addition is visible, due to its distinctly lighter colour, while the semi-circular pier extensions at this level are replicated out of small killas pieces, set vertically in concrete.

Figs 7 and 8 The Hayle Causeway Bridge pictured in 2004.

Either side of the south-facing frontage of the bridge there are the retaining walls, which have been variously patched in the recent past.
