No 24 Foundry Square, Hayle, Cornwall

Historic Building Analysis

November 2004

Report No: 2004R062

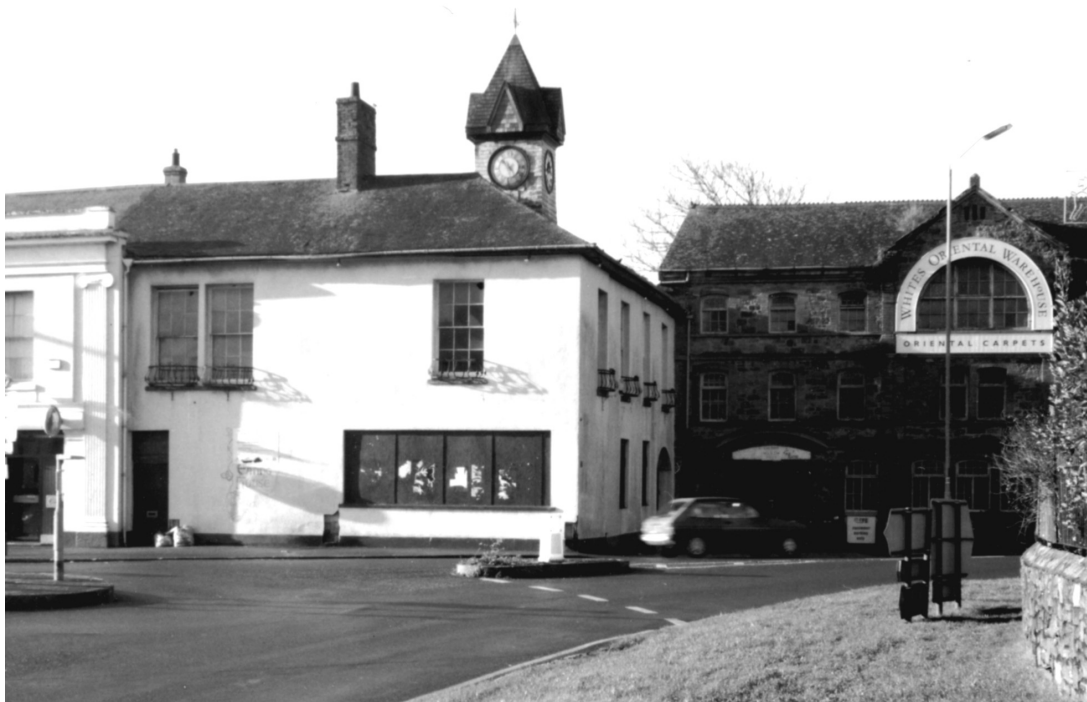
Cover illustration

No 24 Foundry Square and its distinctive clock tower, before refurbishment of the building (November 2002).

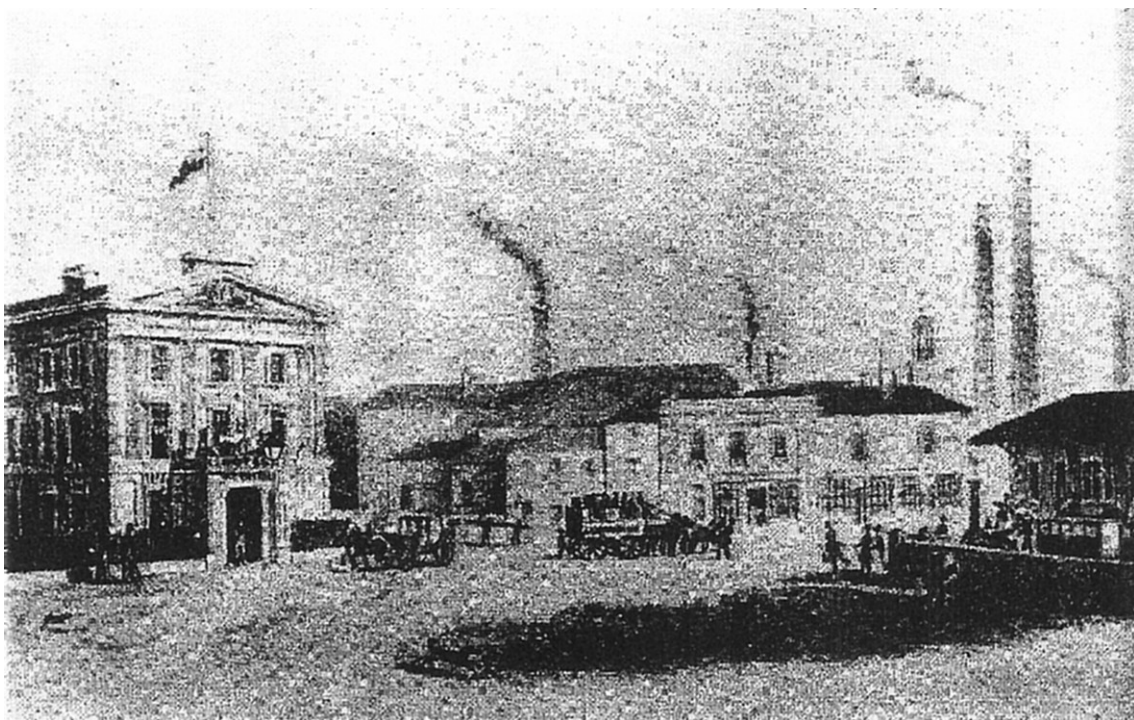
Fig 5 Engraving of Foundry Sq 1845

The shopfront of No 24 is visible behind the station (from PLA 2002)

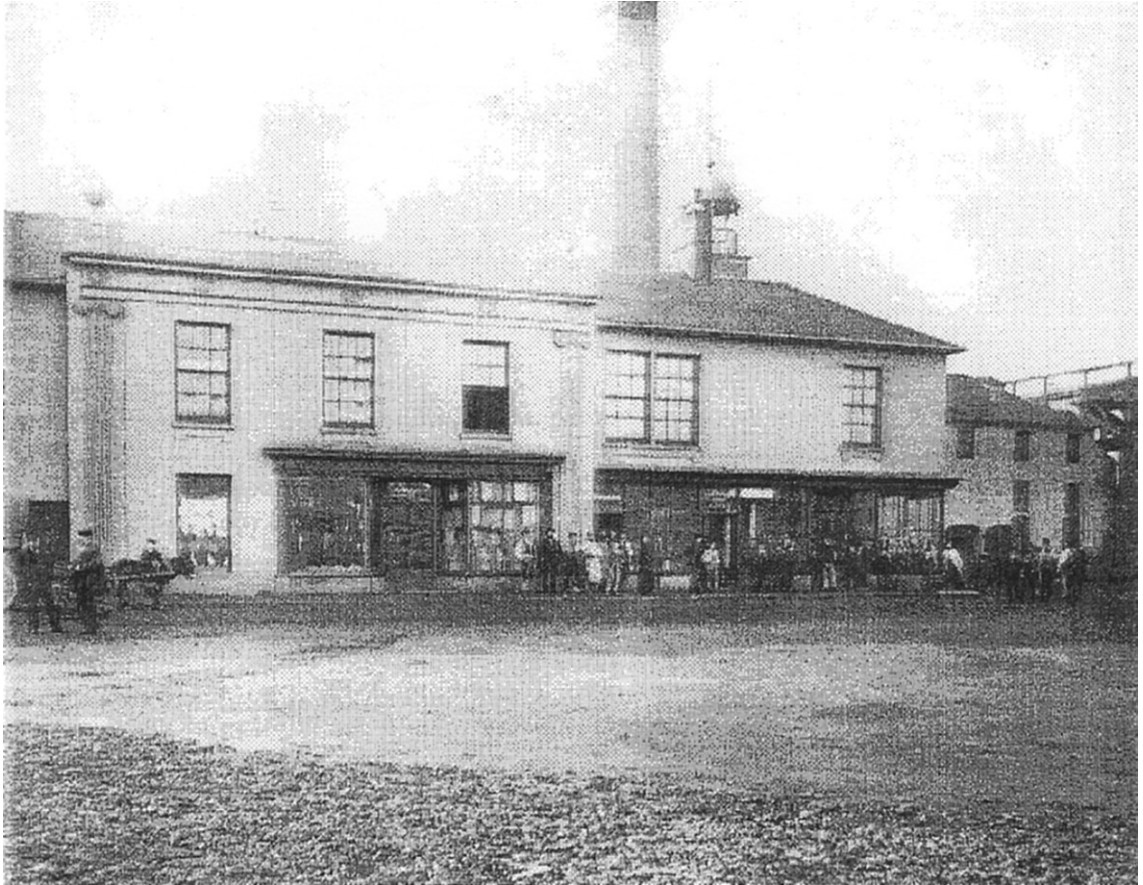
Fig 9 View from Foundry Square c1880

Note the cupola on the office roof (from PLA 2002)

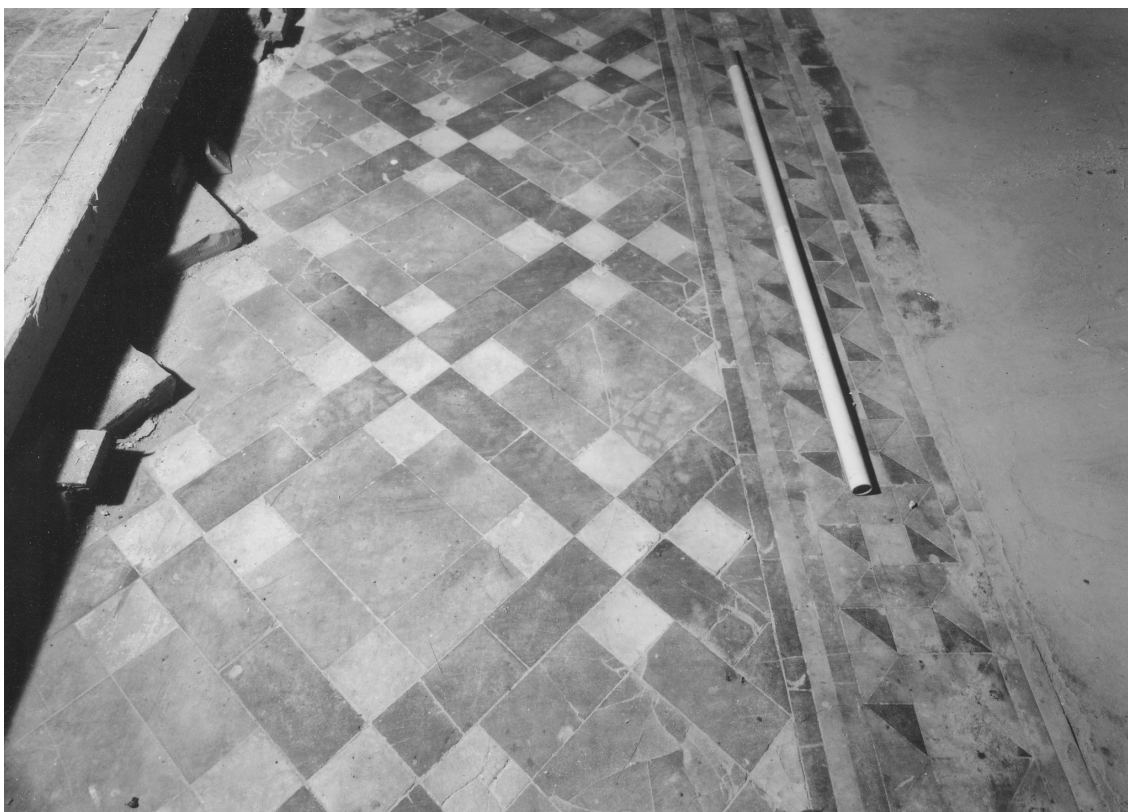
Fig 15 Photo of tiled floor

Removal of debris and boarding revealed the extent of a tiled floor within the former shop area (see Fig 15). This comprised a pattern of cream and red-brown square tiles laid in a diagonal pattern within a rectangular border of smaller similar tiles. These tiles, and their pattern, resemble those often found in entrance halls of late 19th century houses. The floor extended from the former entrance in the late 19th century shop front (visible in a 1880 photograph) to the rear of the shop where a doorway gives access to the rear granite cobbled passageway. The tiled floor and rear doorway are noticeably aligned with the doorway to the principal stairs. It therefore seems that this was the main thoroughfare in the ground floor of the building in the later 19th century. The tiled floor was partly overlain by an area of tongue and groove floorboarding supporting on joists, probably laid here when the shop was used as a grocery store in the 1930s. Refurbishment plans for the shop included extending this later floor to the full width of the shop area, which would retain the tiled area.

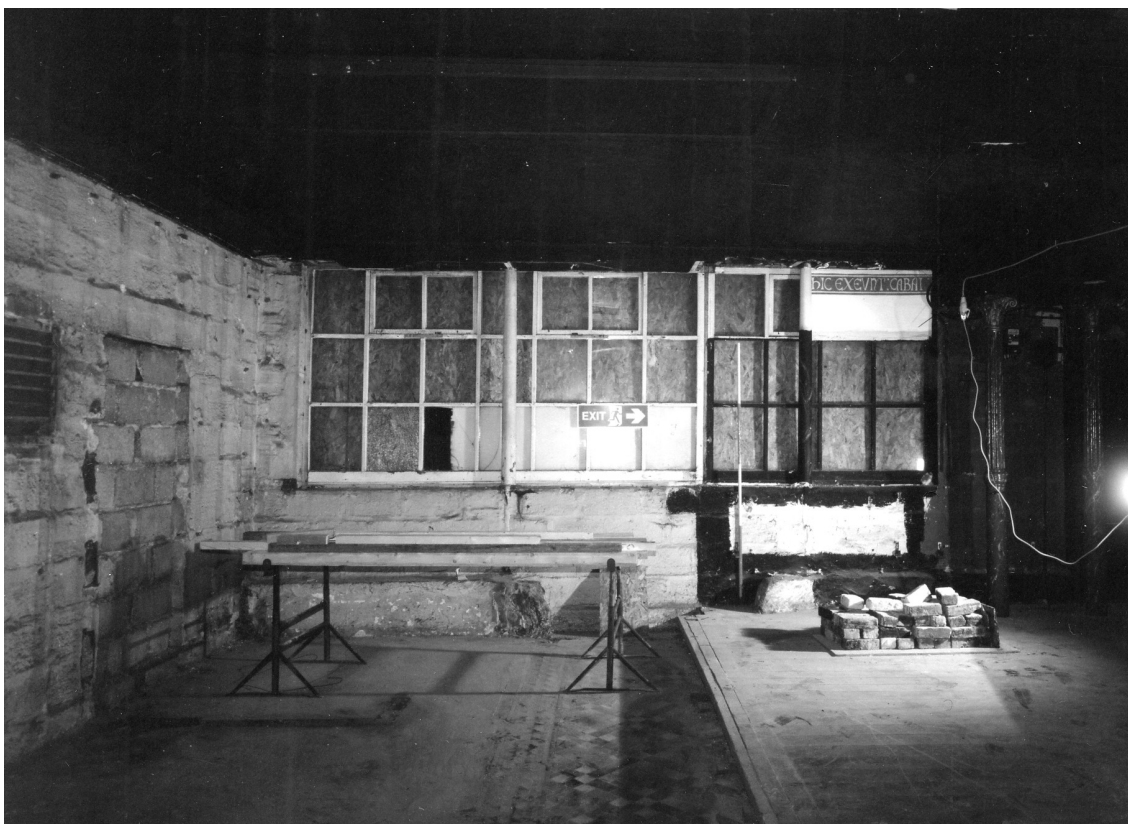
Fig 16 Photo of infilled shopfront

The extent of the former shopfront at the north corner of the building, and extending along the eastern side, could easily be seen after 1980s alterations and disguising work were removed (Fig 16). The upper floor of the building in this area (built of lightweight timber framing and lath and plaster cladding) is supported on decorative cast-iron columns.

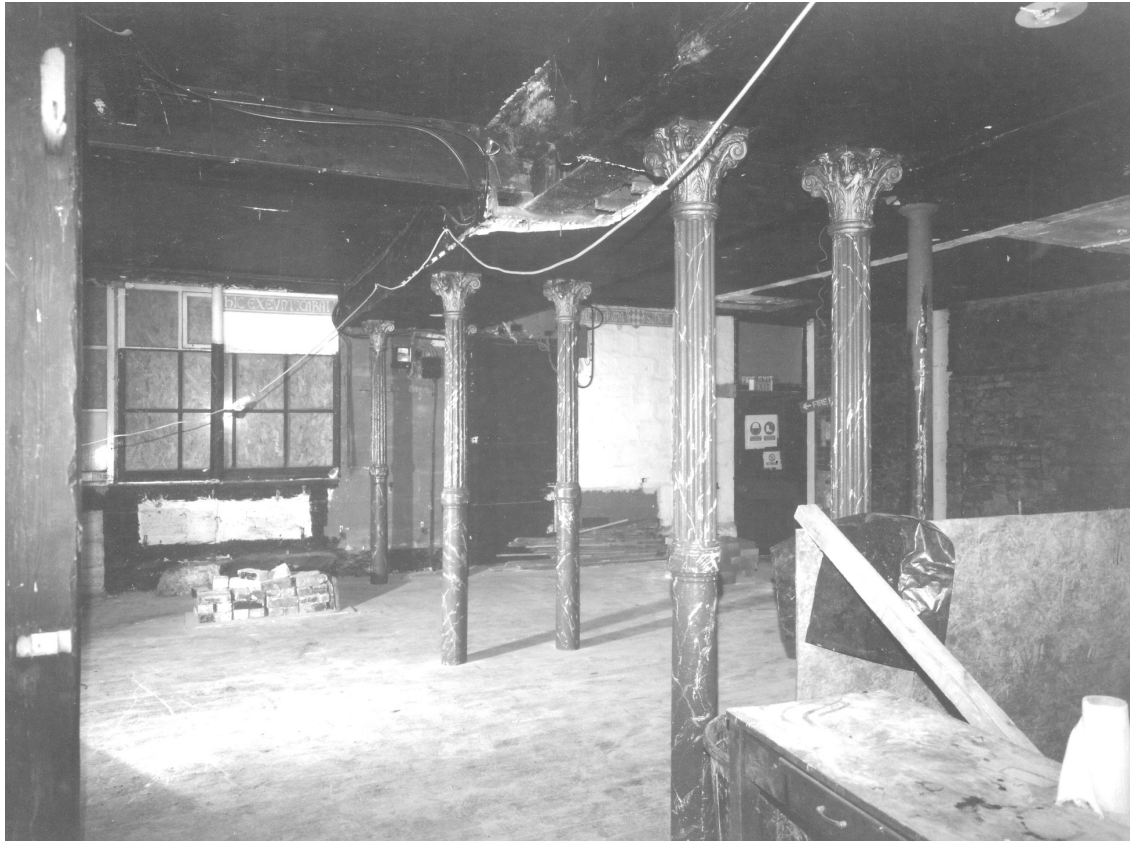
Fig 17 Cast-iron columns within the shop area, used to support the first floor

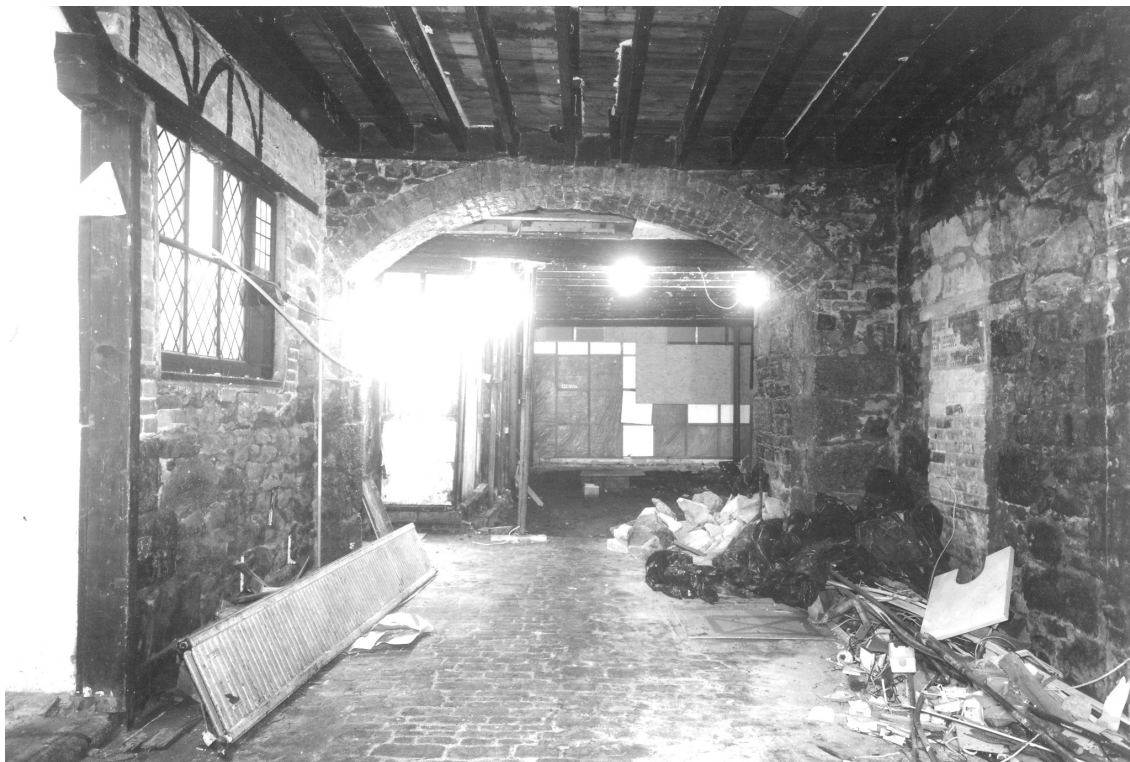
Fig 18 Rear cobbled yard and brick arch

The principal features of the rear passageway are its two brick arches and an area of granite cobblestones (see Fig 18). In the 19th century a tramway from the Harveys shipbuilding area and quayside ran through this area to connect with the foundry complex. This tramway is depicted on a plan of 1853 (Fig 6) and was still in existence in 1877 when the First Edition OS 25 Inch Map was surveyed. It would be expected that some trace of this tramway would be visible in the surviving cobblestones. Instead the cobbles are laid in continuous courses and do not have any indications of alterations, aside from minor patched disturbances associated with installation of services. It therefore appears that the cobbles were laid after the tramway had been removed.

The tramway foundations, and the contemporary 19th century ground surface, therefore lie at greater depth than was anticipated. The existing cobbled surface also post-dates the use of the tramway, and also appears to have been laid over a slightly raised ground surface.

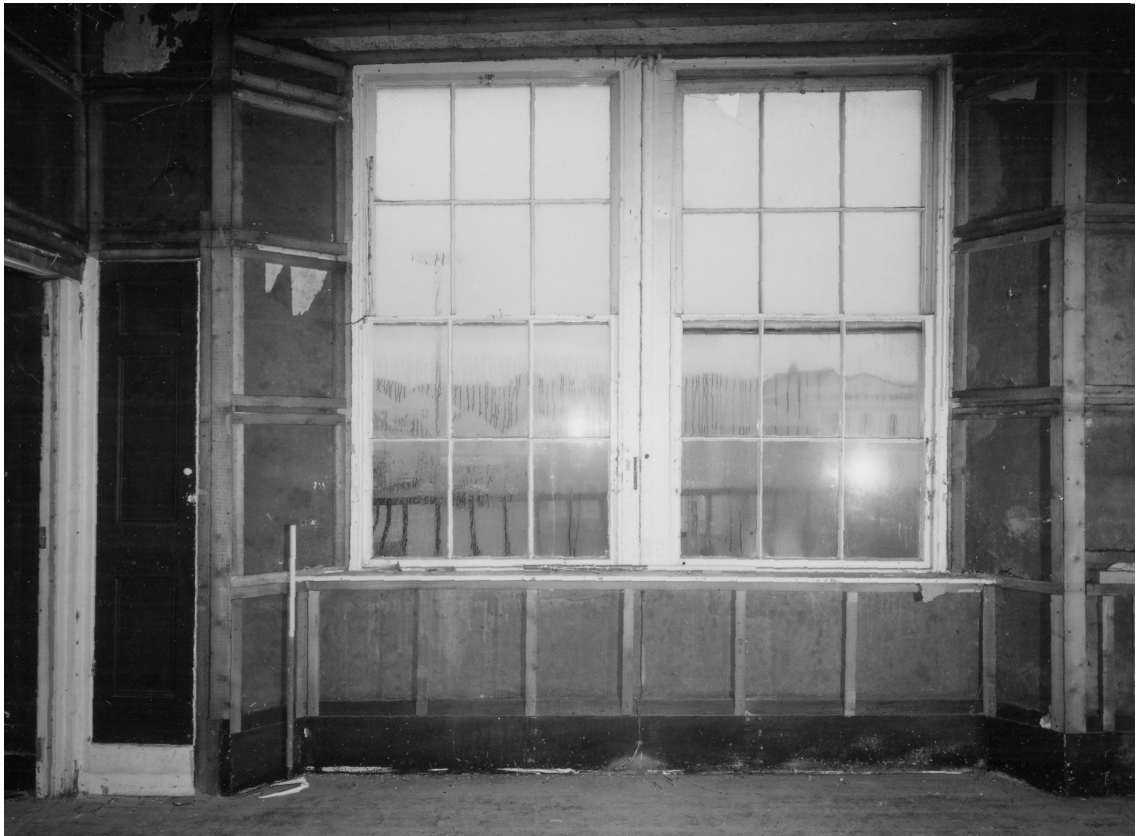
Either before or at the time of the 1980s re-use as a restaurant, the walls of the former offices were covered in softboard supported on battens. This probably provided a degree of insulation and also (fortunately) largely preserved earlier wall finishes. Beneath the battens in the inner office were areas of two different but heavily patterned faded red wallpapers, perhaps of late 19th century date but more likely to represent a decorative scheme of the early to mid 20th century (Fig 20). In the smaller front office traces were found of imitation pine planking. As the renovation scheme includes the creation of new plasterboard surfaces over the existing battens, elements of these former decorations will survive and again be hidden.

*Fig 19 Rear office showing battened walls and wallpaper behind
Walling to the left of the window is entirely constructed of timber framing and cladding.*

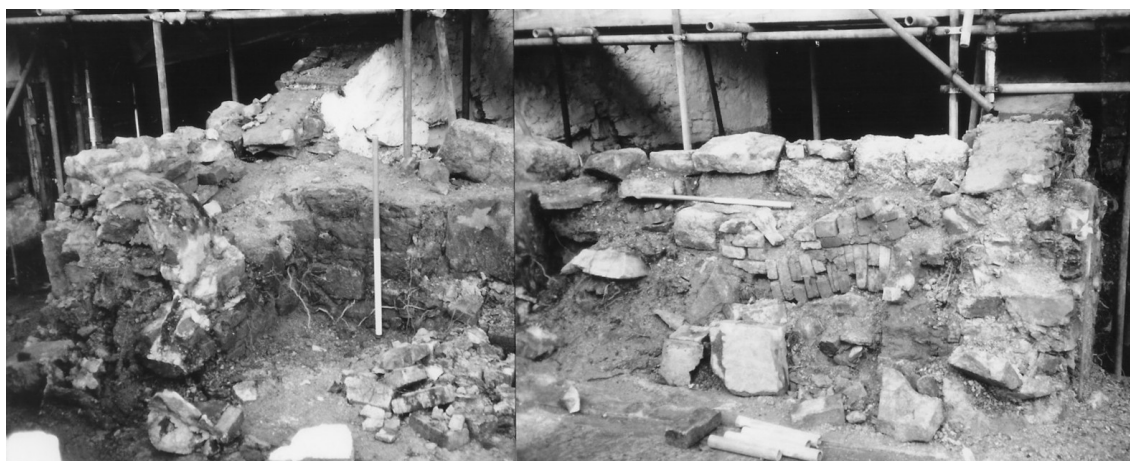
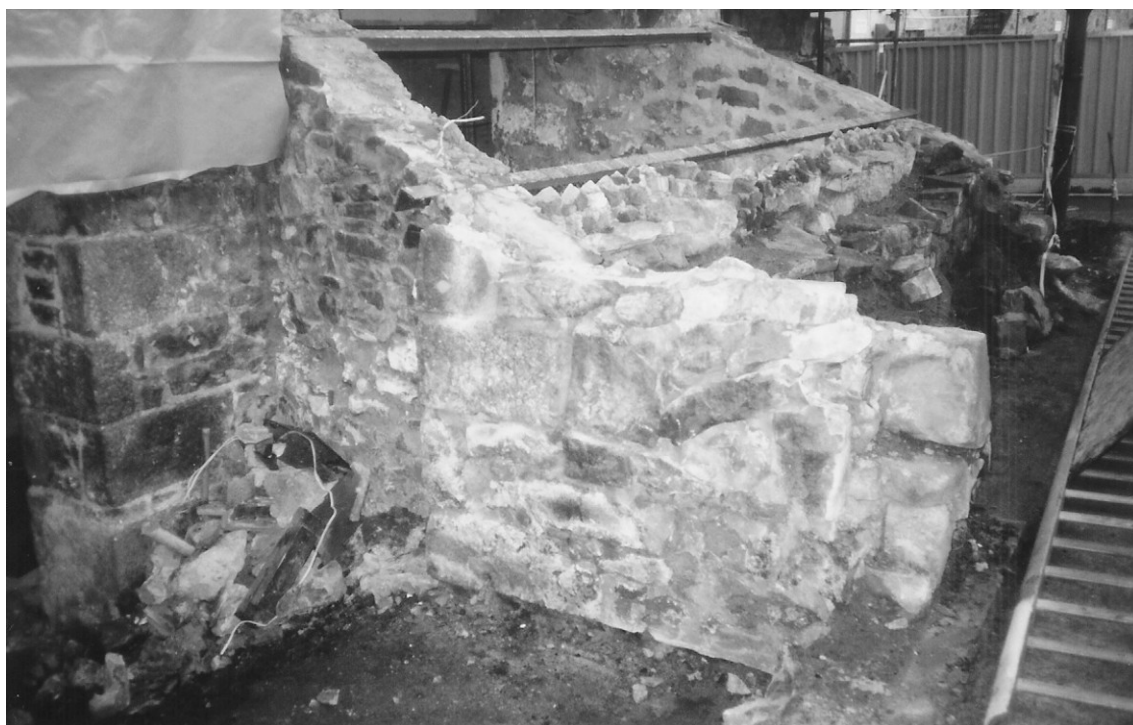
Fig 21 Photos of Building [1]

The interior wall face of the building has experienced intense heat, with many of the stones reddened and damaged. This suggests it is part of the casting shop.

Top: interior view, with arched recess towards the right.

Bottom: exterior view from the north-west. The quoin of Building [1] is visible at the centre of the photo; doorway [4] is to the left.

Refurbishment plans for this area included measures to keep the early walls intact. After the watching brief was undertaken it was recommended that the majority of the structure could be reburied both to protect the masonry and to prevent this area from becoming a void which could become a litter trap. Plans were made to install a new property boundary wall and a retaining wall so that this could be achieved. Exposed masonry of the wall top was to be cleared of 1980s masonry and cement-based repairs, the joints raked out and then repointed with lime-based mortar.

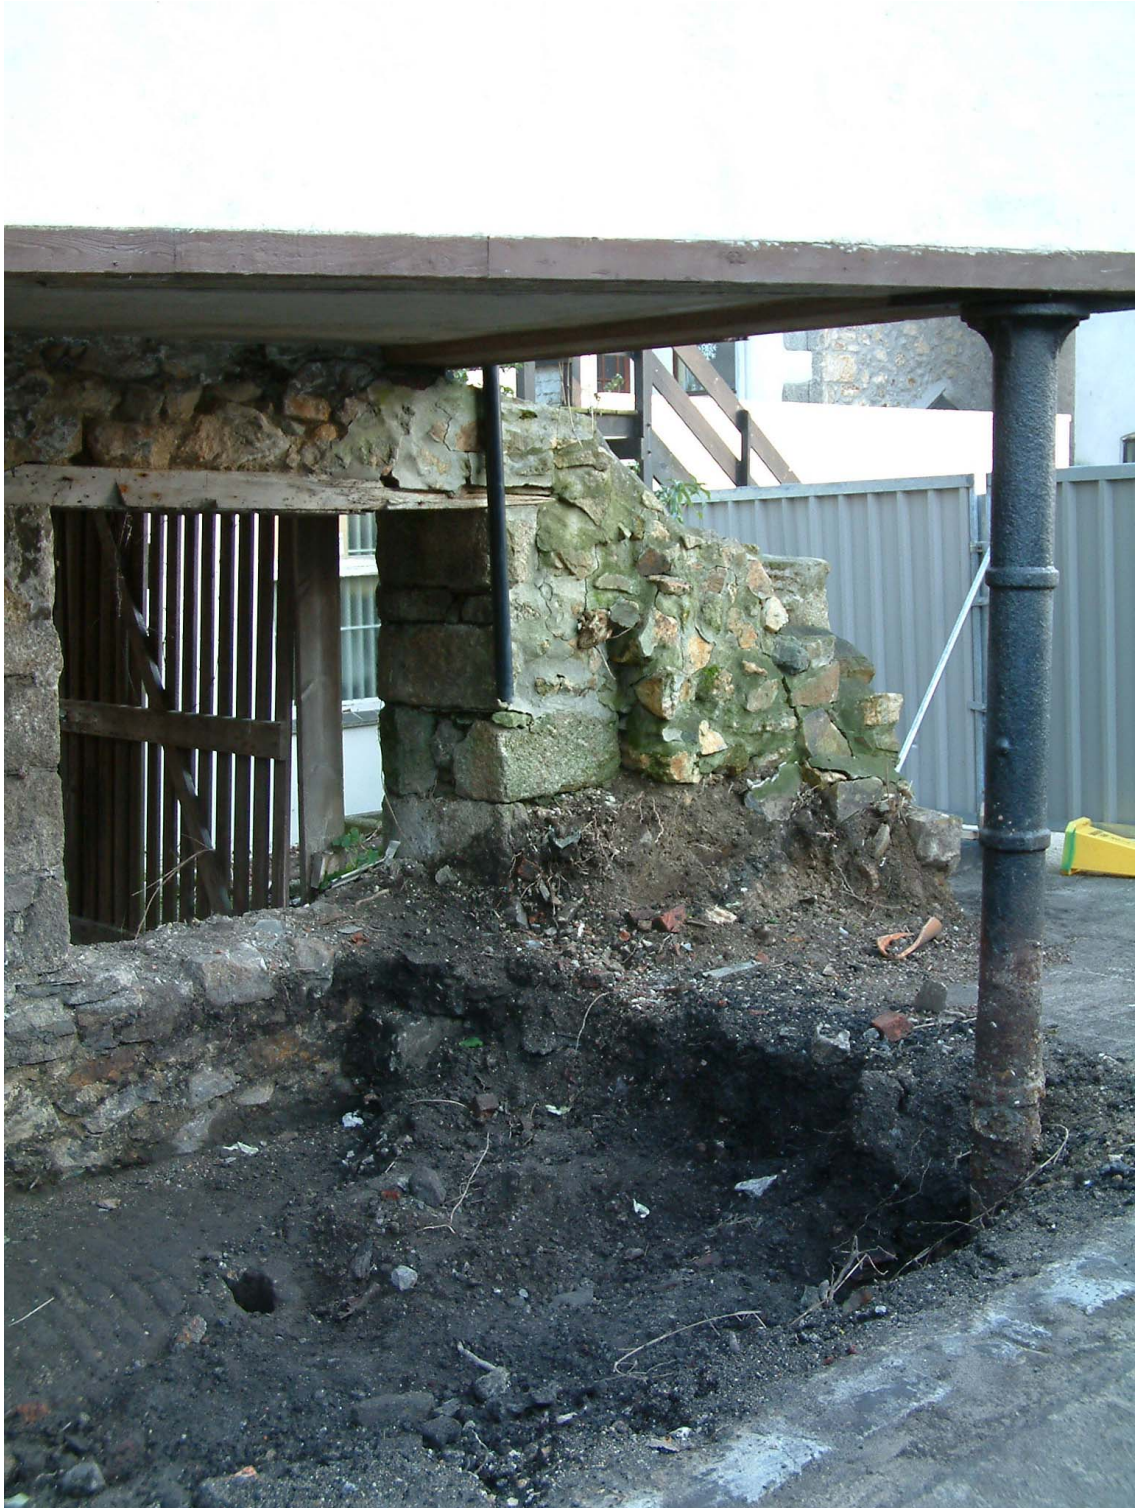
The major part of Building 2 comprises a wall 7.50m long containing two wooden lintelled window openings. The wide reveals of the windows, as well as quoin masonry and the wall returns, indicate that the building's interior was to the west. This building is well constructed of granite blocks to the quoins and predominantly granite semi-coursed masonry elsewhere. Wall faces are heavily limewashed, with indications of numerous coats. This wall was later used as a foundation for the wooden drawing office built above. There is a strong likelihood that this structure was originally two storey, but that all traces of any higher levels have disappeared.

*Fig 22 Interior of Building [2] and its cobbled floor, beneath the wooden drawing office
A cast-iron rising main has been used as a pillar to support the drawing office.*

Recommendations for treatment for the building under the refurbishment scheme included removal of 1980s cement-based repairs and renewing the pointing with lime-based mortar.

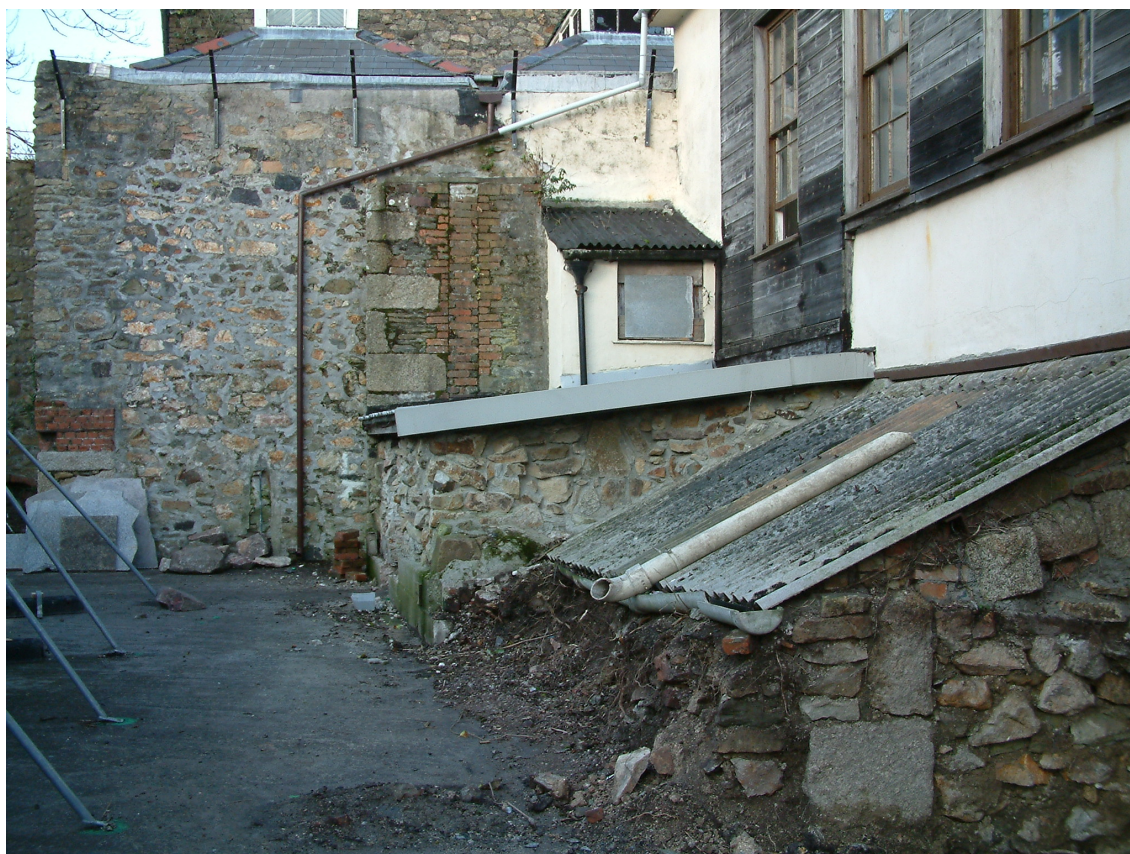
Fig 23 Rear of the property, viewed from the south

A brick-lined flue structure [6] is in the centre of the photo, overbuilt by the taller walls of the toilet block and stairwell. A granite quoin of Building [1] is in the foreground.
