Cornwall and Isles of Scilly Coastal Advisory Group

Cornwall Sand Dune and Beach Management
Strategy

Pilot Dune Management Plan Harvey's Towans
September 2009

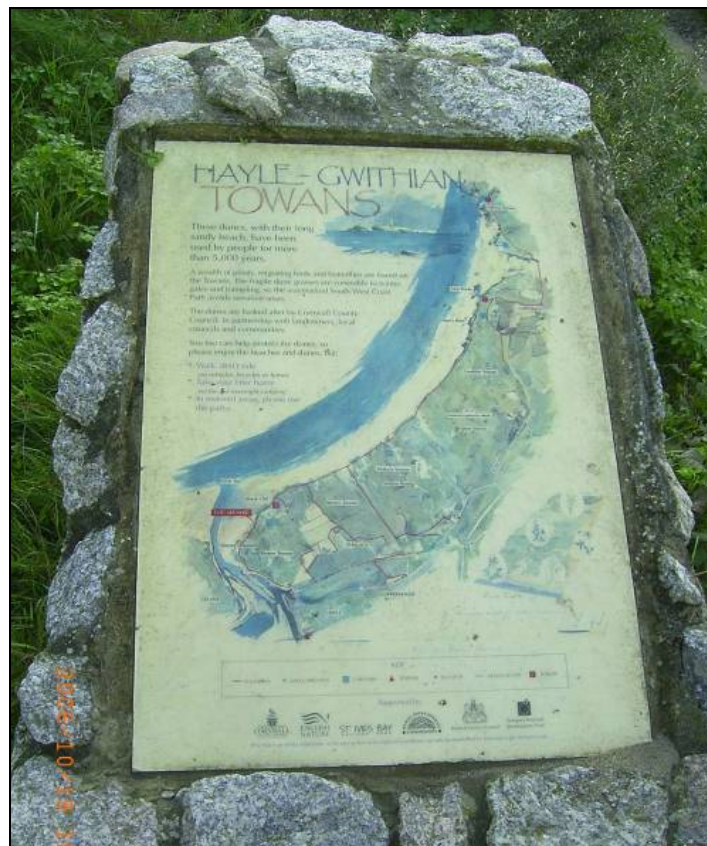
Figure 6 - Signage at access point to beach

- An information board is located at the main access point from the Holiday Park providing information on dune habit and asking people to help protect it (Figure 6);
- Fencing is present within the dunes, however, much of this has been damaged and is likely to be remaining from previous management schemes, which are no longer maintained;

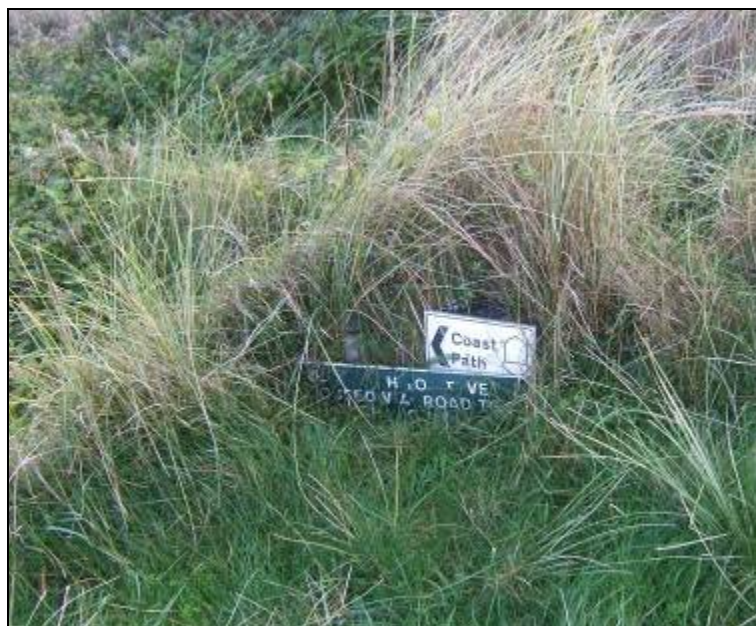
Figure 7 – Damaged signage to beach/ coast path

- Signage indicating access to the beach and the coast path route are present but damaged, with some signs lying on the ground/ propped up in the vegetation (Figure 7).

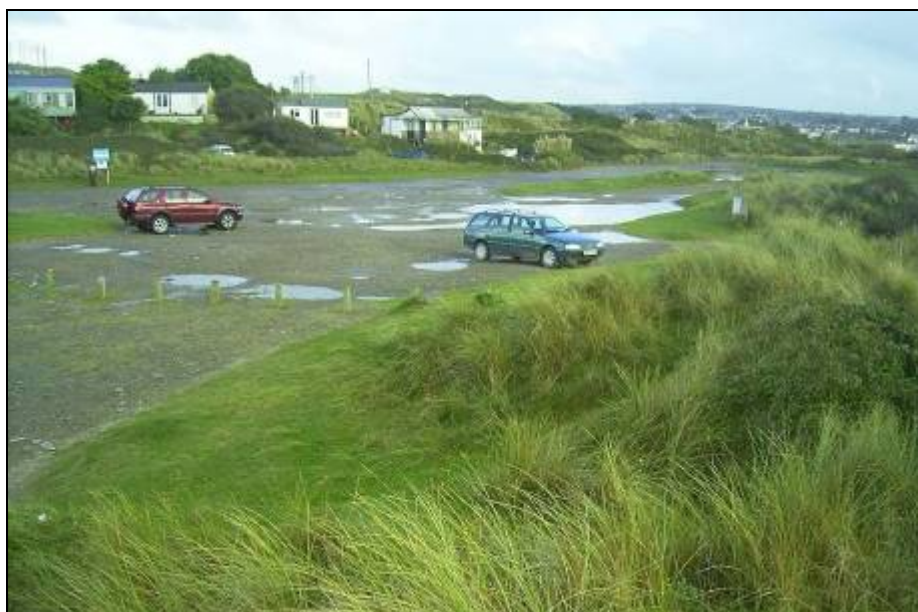
Figure 8 – Properties and car park within the dune system

- The industrial and tourism land development directly behind the dunes restrict the active dune area and the ability of the dune system to react to future pressures (Figure 8).

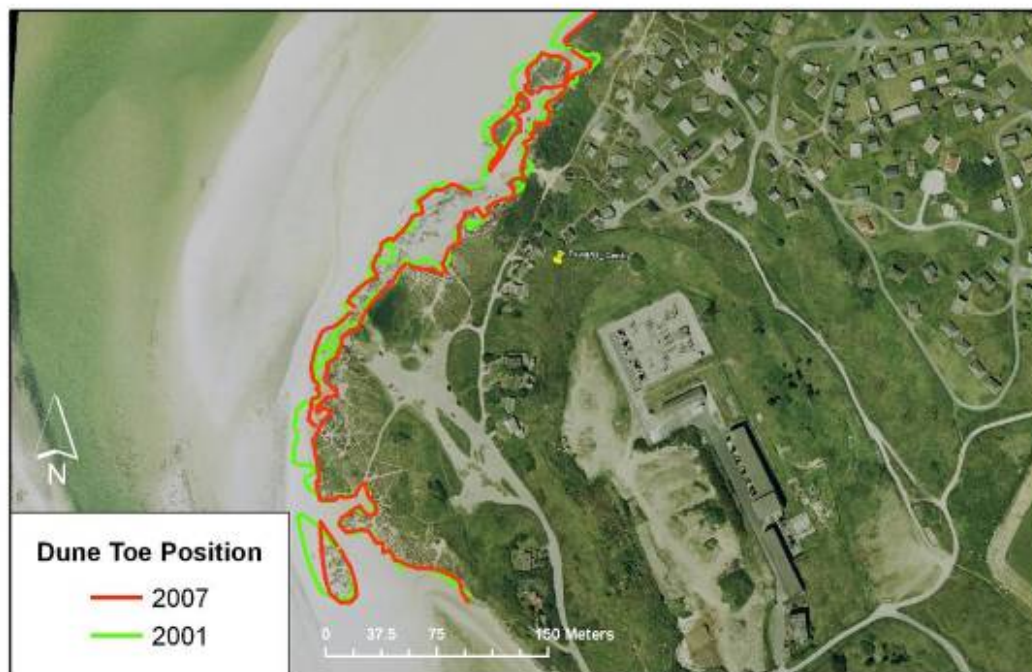
Figure 10 – Comparison of dune toe position digitised from 2001 and 2007 aerial photographs (courtesy of Environment Agency and Plymouth Coastal Observatory respectively)

The analysis of 2001 and 2007 aerial photography indicates little change in the position of the dune toe and foredunes for the majority of the site (Figure 10). There is, however, an area at the most westerly extreme where the foredunes have retreated by about 14m. Directly south of this, another area of foredune near to the river channel has also been eroded.

The photographs also appeared to show an area of considerable dune-toe recession at the northern extent of the dunes. Further analysis, however, showed that this is an erroneous feature caused by the two aerial photographs having been taken at different angles.

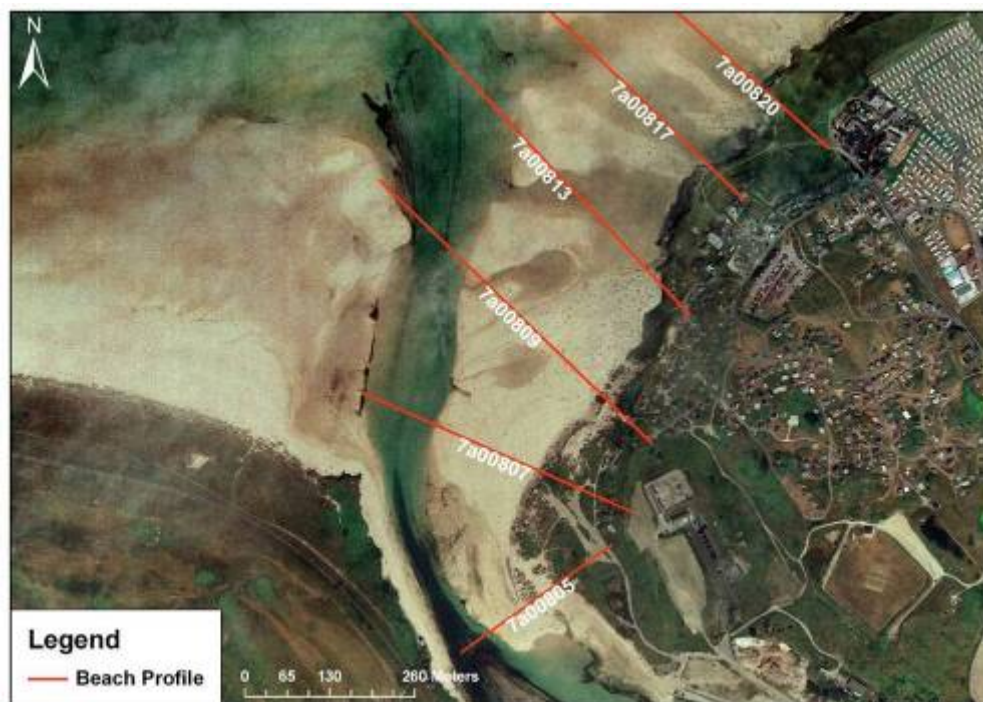
Figure 11 - Location of beach profiles currently measured by the South West Regional Monitoring Programme (Aerial photograph courtesy of Plymouth Coastal Observatory)

Six profiles have been surveyed at Harvey's Towans as part of the SWRCMP and three of these cover accessible areas of dune (Figure 11). The beach profile charts (Appendix C) show that the dunes in the estuary mouth (Profiles 7a00805 and 7a00807 Figure 11) have accreted over the monitoring period, with growth of the crest of a small foredune in front of the main dune system.

The beach in the estuary mouth has also accreted over the analysis period, up to February 2008. The recent profile, however, September 2008, shows a drop in beach levels along the majority of the profiles measured. This is associated with an increase in level immediately in front of the dune system. As this is only observed in one data set, further monitoring will be required to identify whether this is a short term response, which may be followed by a recovery period.

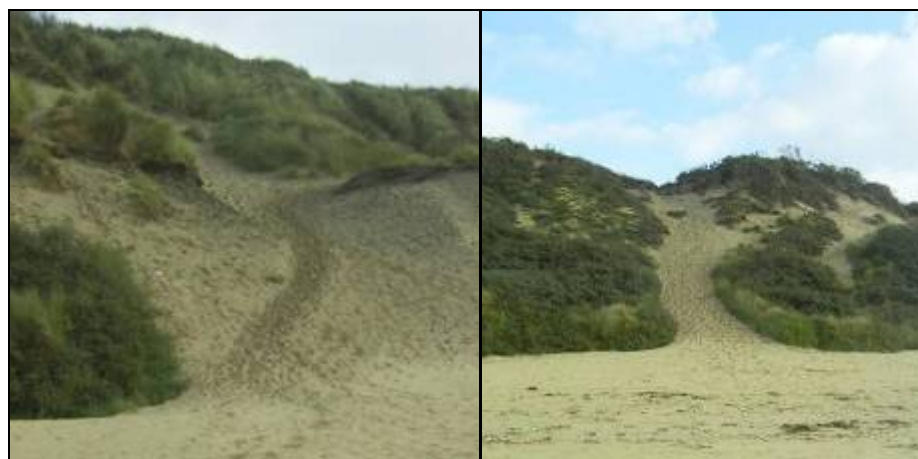
Figure 12- Erosion of steep dune face through trampling along many access routes

The climbing dunes at Harvey's Towans are high, steep dunes. Where access is gained to the beach from the car park and beach users travel down the steep dune face to the beach, there are wide steep sections of eroding bare sand where new vegetation is not establishing (Figure 12). As visitors trample the dune system, vegetation is destroyed and the sand becomes more mobile, with the dune then becoming more vulnerable to wind erosion. Continued trampling destroys any marram grass which attempts to re-establish on the bare dune face, thus preventing the dune from recovering. Although there may be conservational benefits to some bare sand areas, without management they can lead to issues of wind blown sand in developed areas behind the dunes and loss of dune habitat. Over stabilisation of the dunes however would not be desirable as the dunes would become undynamic and unable to react to pressures. Management through stabilisation therefore needs to be applied only to appropriate sections of the dune system and these sections should be identified by a dune manager with an understanding of the local dune system.

To manage the steep bare sand areas sand stabilisation measures are recommended. The eroding areas should be fenced off to enable vegetation to establish without the threat of trampling. If fencing is not successful, sand stabilisation measures such as planting, mulching, thatching or sand binding could also be implemented to stabilise the dune face and reduce wind erosion. Planting may be most appropriate, with native species such as marram grass and sea couch used where possible to avoid damaging the dune habitat. Matting, mulching or sand binding compounds could be used alongside planting to further stabilise the sand surface if this is required. Thatching may not be appropriate in amenity areas such as Harvey's Towans, as it can provide an attractive barbeque fuel to visitors. The dune manager should assess which areas of bare sand are vulnerable and require stabilising, as it can be beneficial to have some areas of bare sand exposed to encourage habitat diversity. For the stabilisation measures to be effective a supply of wind blown sand would be required.

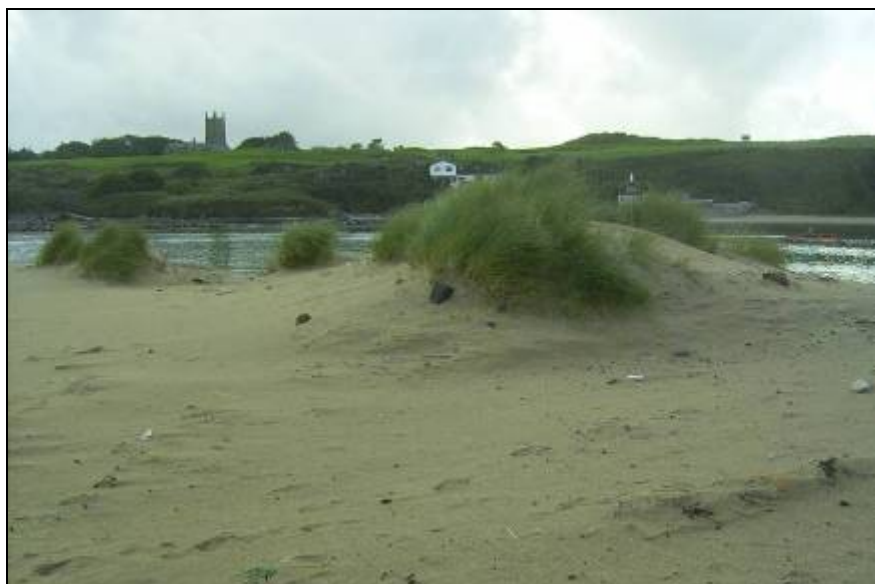
Figure 13– Embryo dunes forming on sand feature extending into estuary

The formation of embryo dunes on the sand feature extending into the estuary shows that embryo dune formation is possible at this site (Figure 13). At the dune toe embryo dune formation may not succeed as high trampling pressure means that vegetation and sand build up do not survive long enough to fully establish into dunes. To encourage embryo dune formation fencing could be constructed to prevent access to the dune toe where embryo dunes could form. The presence of a dune warden would help ensure restricted access zones are adhered to. Preventing access will give establishing sand trapping vegetation a greater chance of survival, encouraging sand build up and embryo dune formation. Sand trapping fencing could also be constructed to further encourage dune formation. These measures to encourage vegetation growth and embryo dune development along the dune front can also increase the dunes ability to respond to and recover from seasonal wave erosion. If the dune front is subject to regular wave action the embryo dunes will not be able to fully establish. Further investigation and monitoring is recommended before implementing these measures to ensure conditions are suitable for embryo dune formation at the proposed location on the dune site.

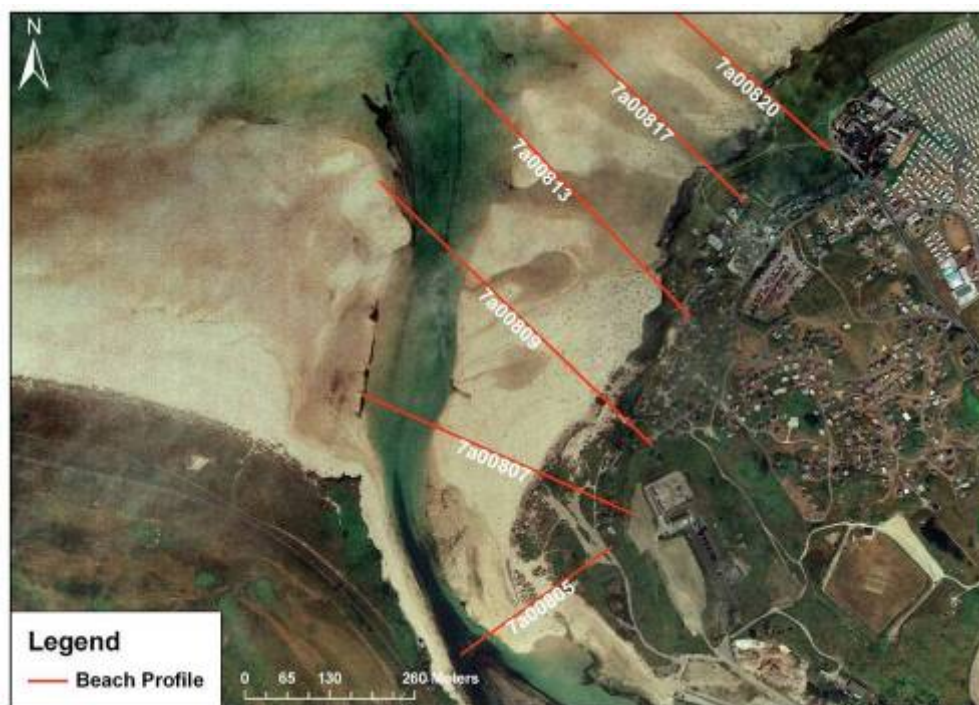
Figure 14 - Location of beach profiles currently measured by the South West Regional Coastal Monitoring Programme (Aerial photographs courtesy of the Plymouth Coastal Observatory)

Six profiles are currently surveyed at Harvey's Towans and are undertaken on a twice yearly basis with additional post storm surveys following major storm events. Figure 14 shows the location of the beach profiles measured. Beach profiles from 2006 to present are contained within Appendix C. No post storm surveys have been triggered at this site since the start of the programme in 2006.

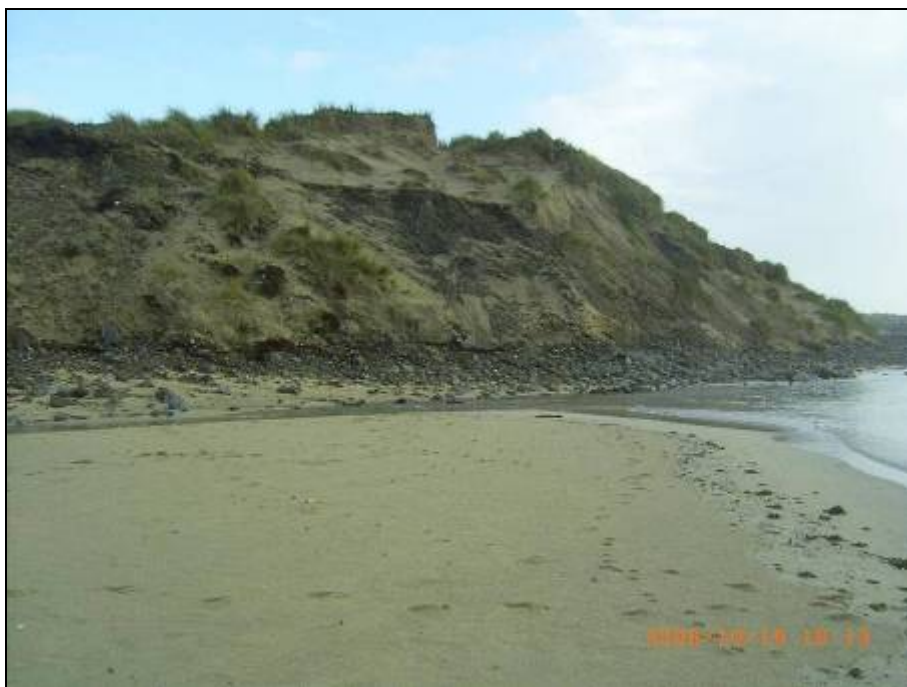
Plate 1: Small rocks had built up at the base of the sand dunes in October

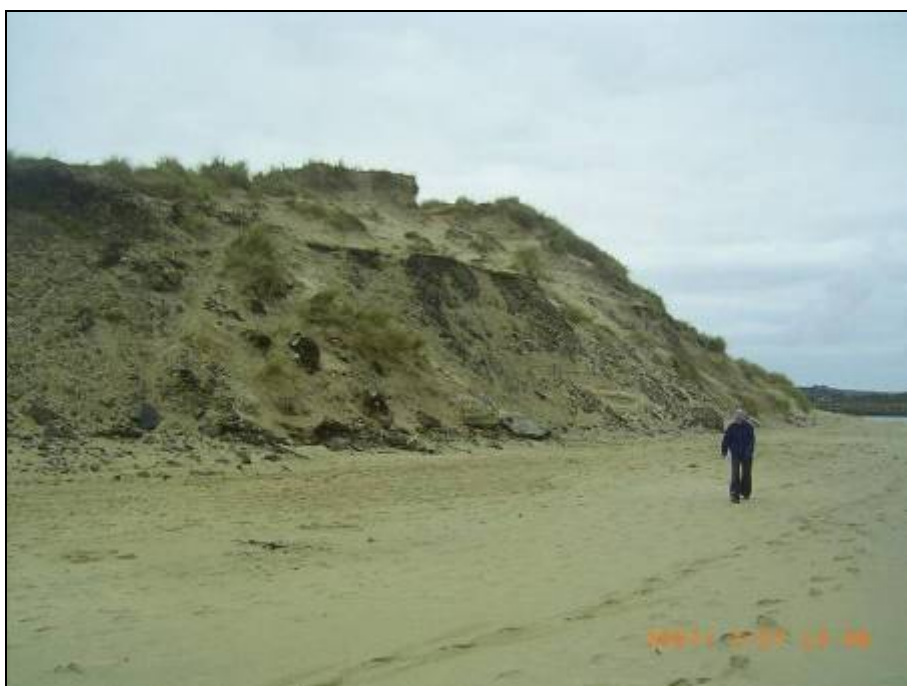
Plate 2: In January the rocks had been removed and the dune face eroded by wave action

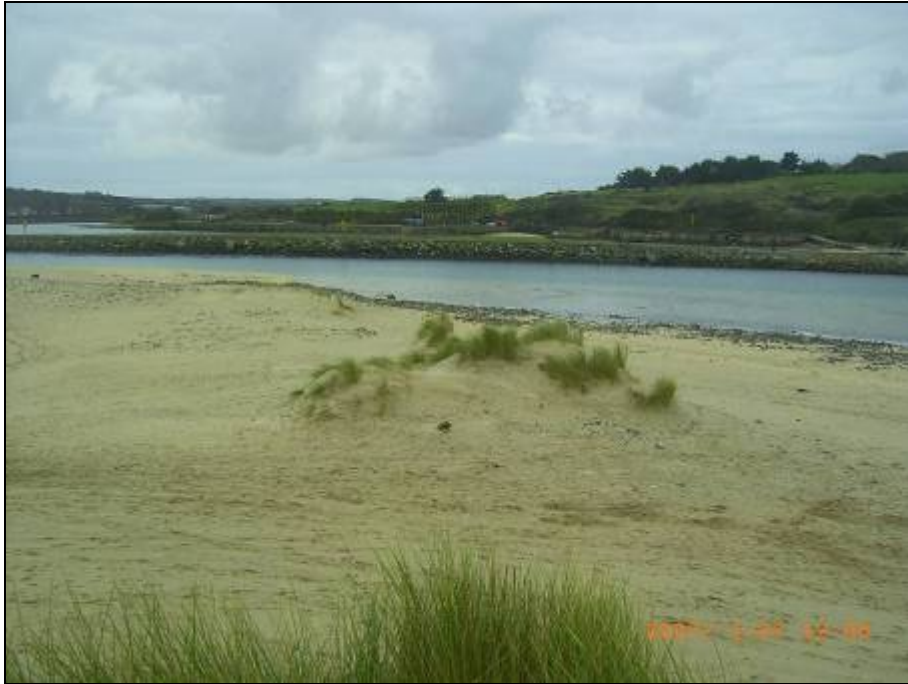
Plate 3: Embryo dunes on the spit feature survived the storm conditions

It was noted that the embryo dune present on the spit feature (Plate 3) had maintained much of the vegetation which had established in October 2006. The embryo dunes appeared slightly smaller in size as a result of the storm; however, a topographic survey would be needed to confirm this. The location of these embryo dunes a greater distance from the estuary mouth could result in the dunes being protected from wave action. Much of the wave energy would be dissipated by the flat sand at the estuary entrance before it reached the spit feature.
