# Hayle Harbour Building, Structures & Archaeological Remains: An Inventory

ING RED UK (Hayle Harbour) Limited

Edition 181107.

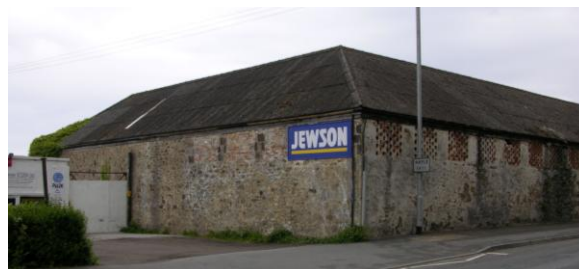
**Description:** The roadside wall and that to the south are irregular stone block walls, probably originally just retaining walls, standing to a height of just over 2 metres, this is topped with a brick ventilated brick wall which together with the timber roof structure were added in about 1900. There is a round glazed addition at the north end, probably as a shop front added in the late 20<sup>th</sup> century.

**Baseline Condition:** Good

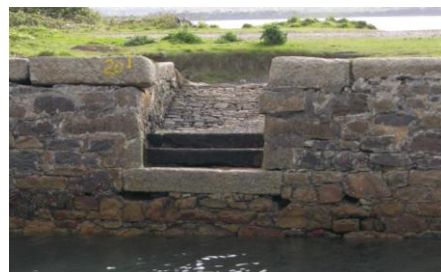
**Description:** Gap in the quay wall with a slop leading down to the sea wall, a drop of about 1.5 metres. The slope is surfaced with stone setts.

**Baseline Condition:** Good.

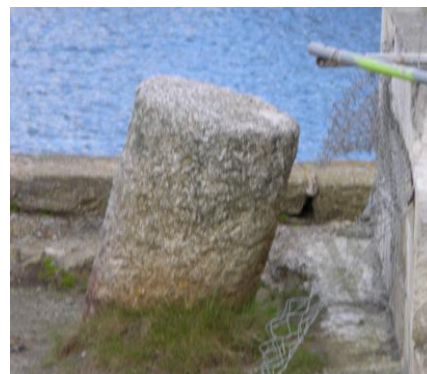
**Description:** Granite Bollard standing about a metre high set at the corner of the sluice projection. From its position and size the post was more likely to be used for warping boats rather than for mooring. (see especially DSCN 2182)

**Baseline Condition:** fair.

**Proposals:** To retain as found.

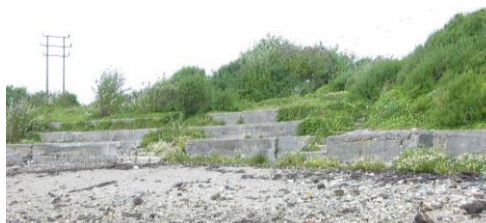
**Description:** Large concrete steps on the extreme north-east corner of the pool.

**Baseline Condition:** Poor.

**Proposals:** To be left as found.

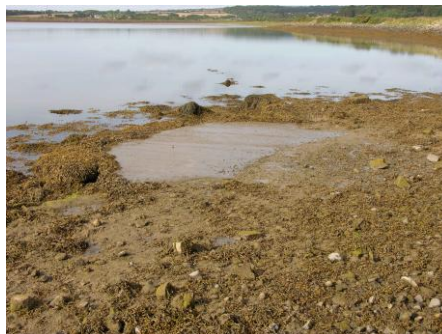
**Description:** Concrete Plug that seals the inlet to the seawater supply to the Power Station.

**Baseline Condition:** Fair.

**Proposals:** To be left as found.

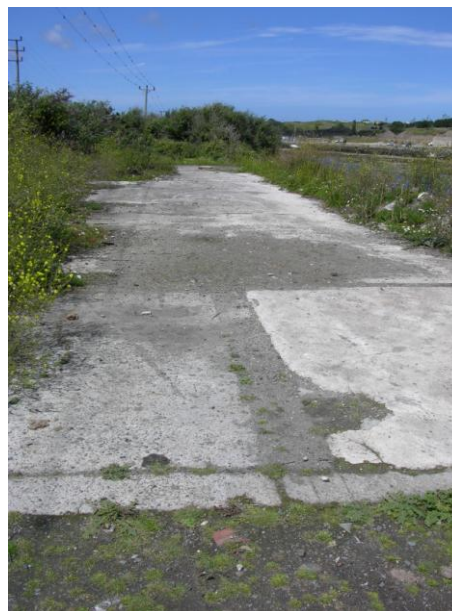
**Description:** Concrete pad 34 metres long by at least 5 metres.

**Baseline Condition:** Poor.

**Proposals:** To be left as found.

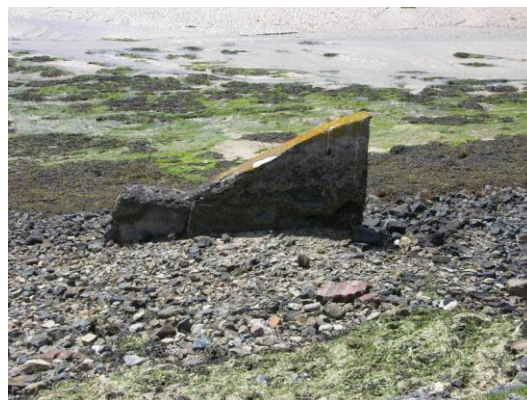
**Description:** Fragment of a wall on the tidal area of the River Hayle.

**Baseline Condition:** Poor.

**Proposals:** To be left as found.

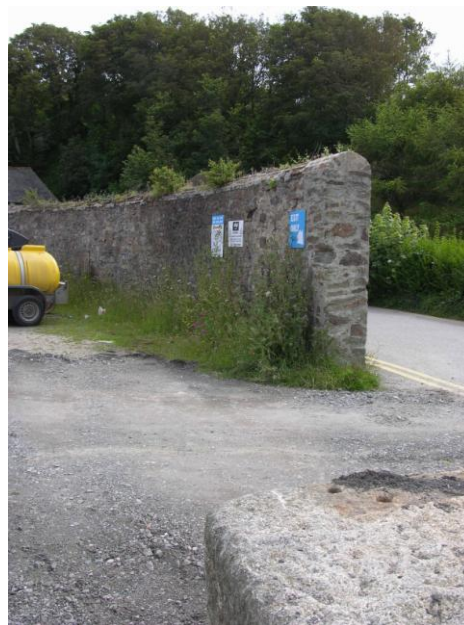
**Description:** Wall 56 metres long serving as a boundary to the north of Foundry Lane. The wall is of stone mainly made up of a local sedimentary and stratified stone. The first 17 metres, to the west, has a segmental top. The wall is 2.7 metres high.

**Baseline Condition:** Fair.

**Proposals:** To be left as found.

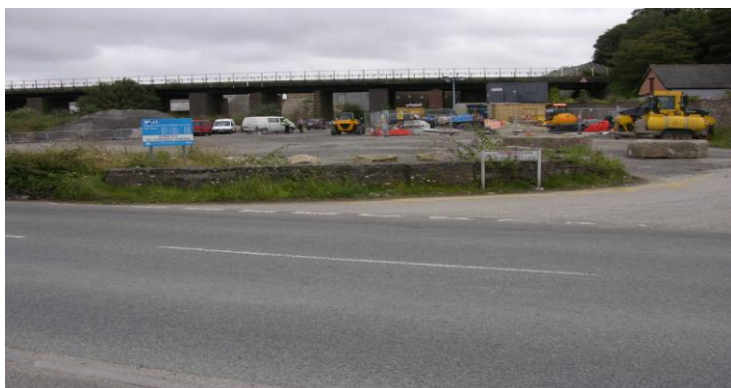
**Description:** Low retaining wall of stone only 60 cm high on the Carnsew Road There is a granite gatepost of 3 metres with metal band attached the opening adjacent to the post is bricked up. The area is now a car park and there is another gatepost in the middle of the park just over 2 metres tall.

**Baseline Condition:** poor.

**Necessity of change:** To provide a safe access to Foundry site from the South Quay.

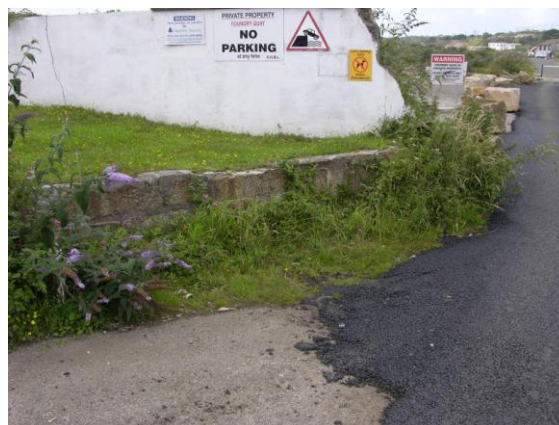
**Description:** Small fragment of wall

**Baseline Condition:** Good.

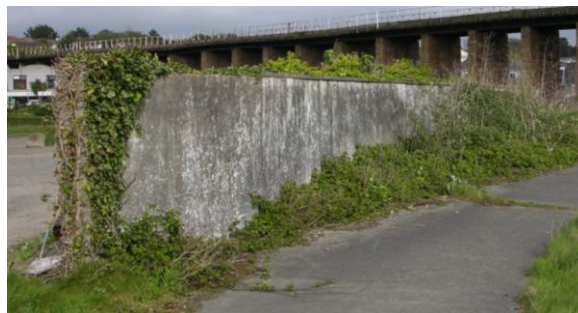
**Description:** The remains of a concrete boundary wall approximately 2 metres high built across an older building the remains of the south east corner of the building now act as a low retaining wall (see entry SQ 1.3.) The northern end curves away to the north.

**Baseline Condition:** Fair.

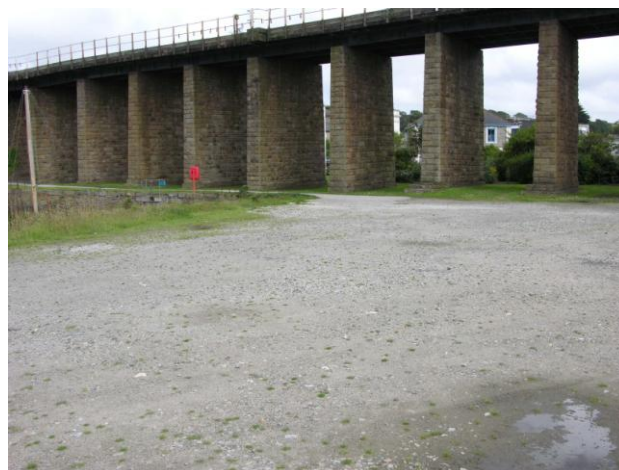
**Description:** Small area of stone paving also possible remains of the rail track that lay on the South Quay, part of the hidden archaeology of the area.

**Baseline Condition:** Unknown as much of it is covered by present surface.

**Necessity of change:** The current surface is in poor condition and resurfacing will require to excavation to a depth beyond the depth of the original surface.

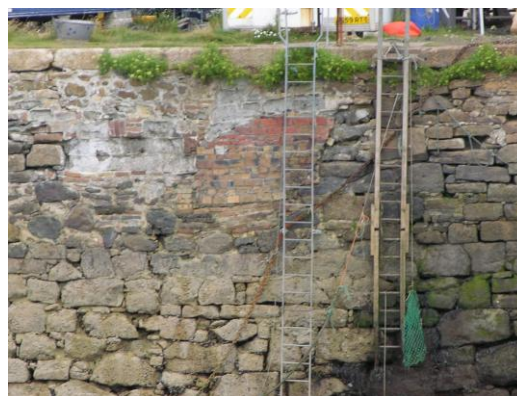
**Description:** The external evidence is scant the possible north end is covered by an area of metal piling, the south end by an area of apparent in-filled masonry. The metal piling on the east side is possibly there because of the danger of collapse of the quay wall because of the tunnel. There is a portion of an 1828 map in the PPG 15 Statement that accompanies the Outline Planning Application which shows the position of the tunnel.

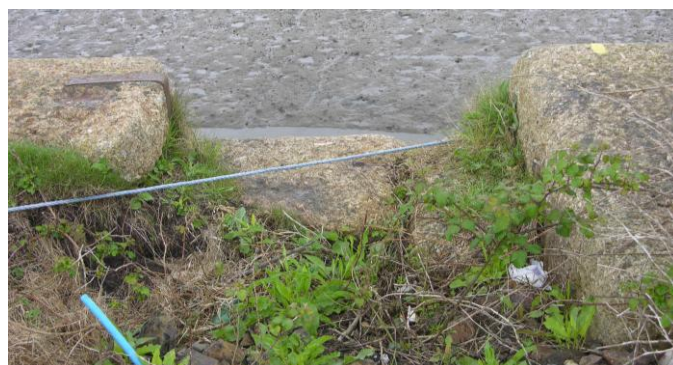
**Description:** There are a series of lowered sections of the parapet of the quay wall to take loading shoots. These 'slots' are about 25cm deep and 1.5 metres wide. There are 4 possibly six or more to the south of the collapsed area and other 6 between the collapse and the new piling. The majority of these can only be detected from Penpol Terrace as most have been filled in.

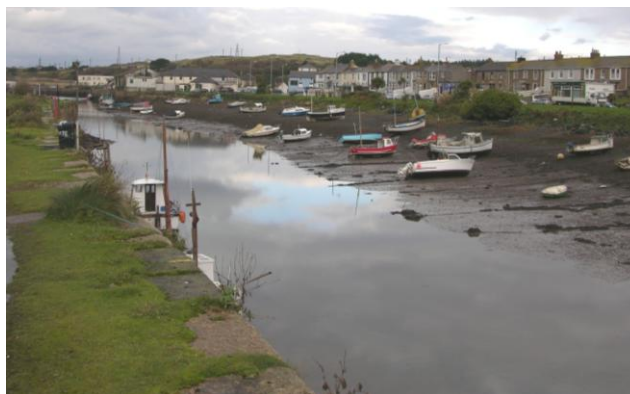
**Description:** Tidal dock basin created between Penpol and South Quay in the late 18<sup>th</sup> century. The Penpol Creek is culverted to this point and is today controlled by a sluice at the south end of the Pool.

**Baseline Condition:** Good.

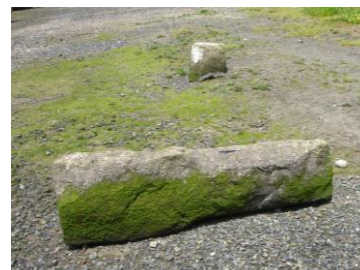
**Description:** Granite post detached from base – which is probably the granite stump, close by – approximately 1.5 meters tall. The remains of the post have been moved up the bank since the original report and the stump appears to have disappeared.

**Baseline Condition:** Fair.

**Proposals:** To be left as found.

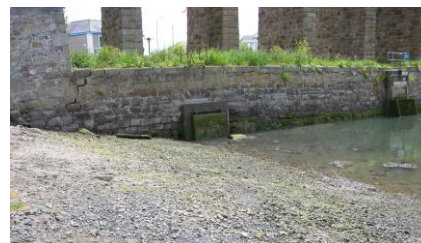
**Description:** Two sluices controlling the water of the Penpol Creek. The northern of the sluices covers what appears to be the entrance to the original culvert of the creek. The southern sluice is the active one and was probably put in the 20<sup>th</sup> century.

**Baseline Condition:** Southern Good, northern one fair.

**Proposals:** To be left as found.

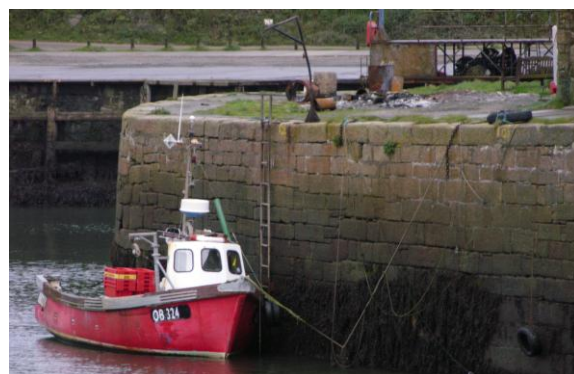
**Description:** The Wall forms three sides of the ‘peninsular style’ quay. South side rubble laid stone blocks topped with dressed granite copings. The north wall is laid in three distinct styles, the first section at the east end granite ashlar, then a section in rubble, a collapsed area, a wall of scoria and then a repeat of the other end. The significant collapse of the quay wall is said to be the result of the recent irregular opening of the sluices. There are steps to the water at the furthest point (northwest) of the Quay. The Quay has a sharp turn to the east-northeast at the Penpol end (southwest) and the quay was probably terminated at this point to keep the access to the right of way across the sands free.

**Baseline Condition:** Good to very poor.

**Proposals:** To repair and retain.

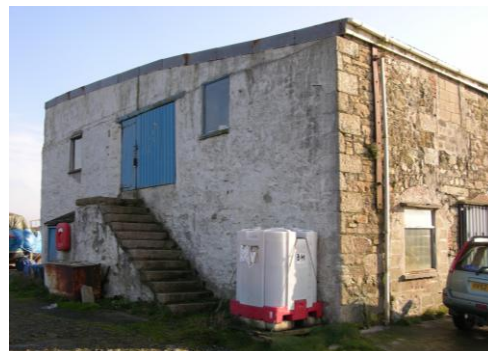
**Description:** 2 storey building, rubble walls with stone quoins modern mono-pitched roof. Has stone-steps to first floor taking-in door on the north face also the remains of an arched entrance to the west but with a modern intervention, adjacent is a window and another bricked window at first floor level. The east face is partially a modern intervention see especially DSCN 2464

**Baseline Condition:** Good to fair.

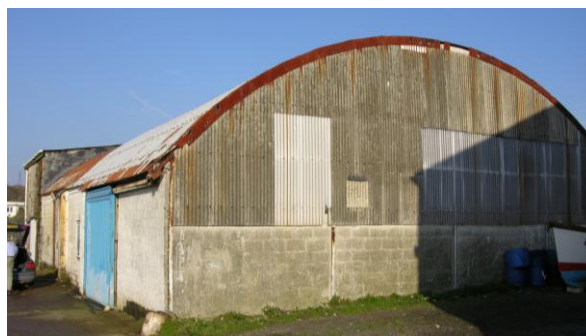
**Description:** Industrial building attached to EQ10, single storey with corrugated iron curved roof – Gable end also made of corrugated iron sheets with plastic roof sheets inserted for light above a masonry wall. Masonry wall on west side with sliding door. The east side is a masonry wall with door opening and window.

**Baseline Condition:** Fair to poor.

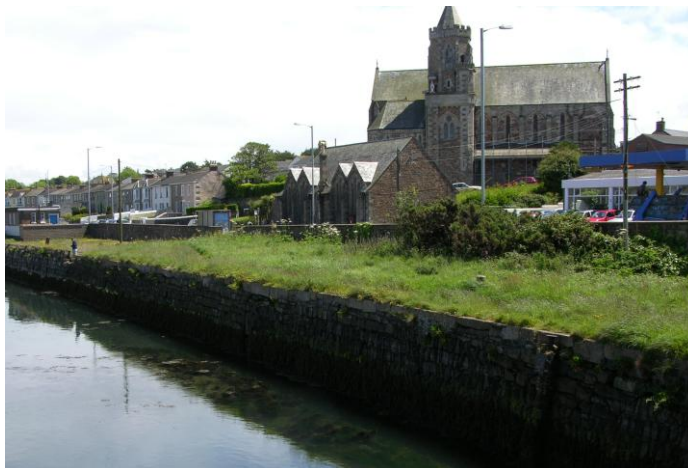
**Description:** Quay to the west of Swing Bridge of granite blocks extended with scoria Blocks. There are several mooring posts on the quay. A recent need to repair a gas main (18/07/07) close to the swing bridge indicated that the surface was non-mortared inter-locking stone over a stone underlay and then earth.

**Baseline Condition:** The walls of the quay are in a fair condition but the surface condition is unknown as it is covered mainly by grass. (Recent excavation on site [September 2007] because of a gas leak suggest that the surface may be a mixture of granite slabs and setts over a rubble core.)

**Proposals:** The scheme is to repair and retain all the remains of the quay. The proposed bridge that will span the Copperhouse Pool between Hayle Terrace and North Quay will not touch the quay as the anchor point lies to the road side of the historic structure.

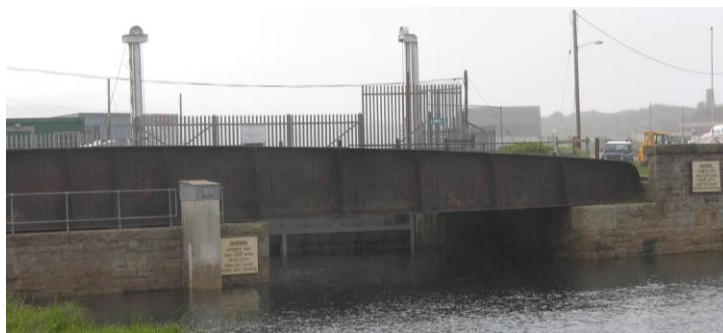
**Description:** The cantilevered iron riveted swing bridge was once lifted and turned by a hydraulic engine, the engine has gone and the swinging of the bridge is no longer operational. The bridge is 26.6 metres long and 9 metres wide, divided into two equal sections – the west section took the railway and the east the road.

The parapets and the dividing wall are built in sections riveted together forming a segmental top to the bridge. The bridge is supported on granite abutments. The northern one is in rubble with granite dressed coping in which the rebate for the drawbridge can be clearly seen. The southern end was probably put in at the time of the replacement of the old drawbridge by the swing bridge. It is battered granite ashlar with a dressed curved edged coping, beyond which is the original abutment at the base of this is the opening to the sluice (see especially DSCN 2471). The gearing house for moving the bridge stands close by and still contains the gears and the chains that run to the centre of the bridge.

**Baseline Condition:** Fair to good.

**Proposals:** To be left as found.

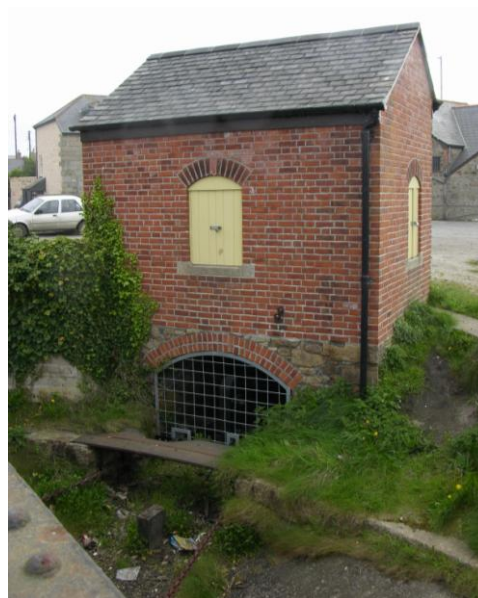
**Description:** The Shed, winding mechanism, chains and track of the railway swing bridge.

**Baseline Condition:** Fair to good.

**Proposals:** To be left as found.

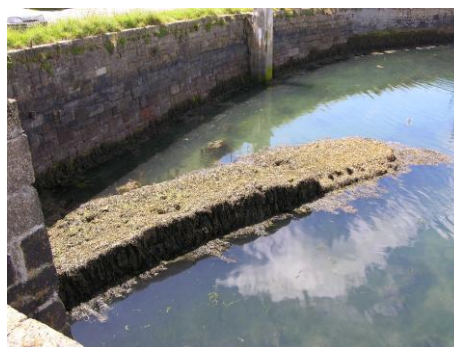
**Description:** All that can be seen of the sluice is the tunnel entrance in the Quay wall (see especially DSCN 0190) the remains of the masonry training wall is now reduced to a few courses above the Creek bed to the north east of the sluice opening.

**Baseline Condition:** Fair to good.

**Proposals:** To retain, repair where necessary.

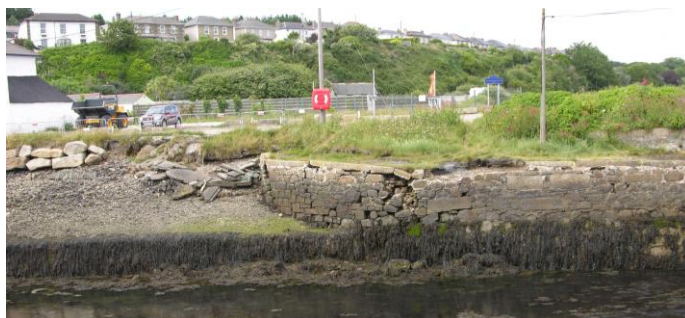
**Description:** The quay wall in front of the Harbour Managers Office (sometimes known as Custom House Quay). Cinder Bank and wall – might date from the early 18<sup>th</sup> century<sup>1</sup> but was certainly part of the 1780s development. Today most of the wall has gone and is mainly cinder bank; the remains of the old wall lie to the south west close to the Swing Bridge. The old slipway is at the north end of this part of the Quay – the new and temporary slipway lies just to the south of the old.

**Baseline Condition:** Poor.

**Proposals:** Repair and rebuild where necessary.

**Necessity:** The bad state of repair makes repairing necessary.

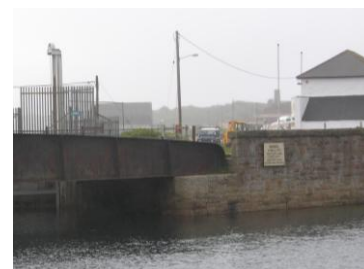
**Description:** Retaining Dock wall on the east side of the North Quay – on the Copperhouse Pool side just before the Swing Bridge originally made in scoria and cinder by the Copperhouse Company. It was once part of the lock and sluices system.

**Baseline Condition:** Good.

**Proposals:** Retain and repair where necessary – part of the parapet will be lost because of the building of North Quay Bridge.

**Necessity:** The harbour wall requires repair to ensure its safety and survival, the loss of the parapet wall needed for passage of new bridge.

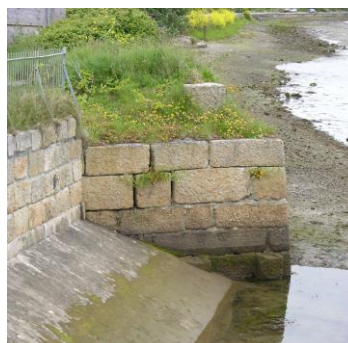
**Description:** Stone abutments of Hayle Railway Bridge

**Baseline Condition:** Good.

**Proposals:** Retain, repair if necessary.

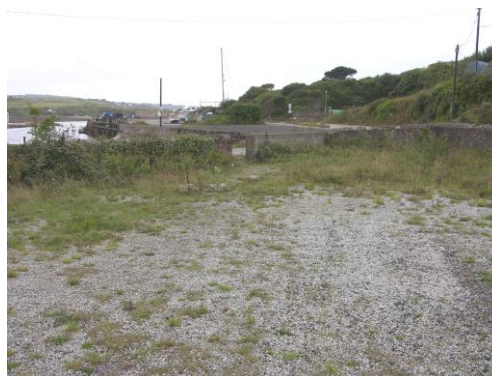
**Description:** Set of lock gates buried in the yard (north east corner) of the Harbour Manager's Office (see NQ 4) when the present sluice gate was erected at the Swing Bridge (see SB 2)

Photo No	Object and orientation	Note
DSCN 2590	Site of burial looking NW	
DSCN 2591	Ditto

**Baseline Condition:** Unknown – they are part of the hidden archaeology of the area.

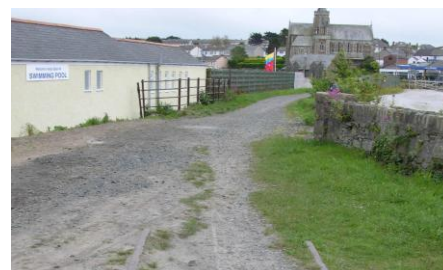
**Description:** “Bridge over stream dating from 1830s constructed from granite rubble with scoria. It is a single span bridge widened at the south west side dating late 19<sup>th</sup> century. Original southwest parapet has a curtailed end. “(CAU 2000) The site today is part of the walkway that bends behind (north east) of the old Customs House (NQ4), some old railings are part of the bridge.

Photo No	Object and orientation	Note
DSCN 2204	Track and site of bridge looking SW	The bridge is where the railings to the left begin
DSCN 2365	Ditto closer	
DSCN 2366	Edge of bridge looking SSW

**Baseline Condition:** Partially unknown as the foundations of the bridge have not been surveyed

**Proposals:** To retain possibly with the exposure of more of the structure and to add some interpretative material; repair as necessary.

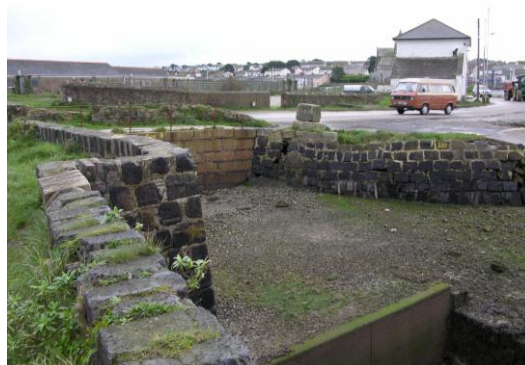
**Description:** Scoria block inset into the quay where the sluice empties into the estuary. The sluice today is blocked by a wall of granite the culvert of the sluice running under the Hayle swimming pool. (See NQ8.2 below)

Photo No	Object and orientation	Note
DSCN 0194	Scoria block training wall looking W	
DSCN 0195	Looking into the inset ENE	
DSCN 0197	Western wall looking WSW	
DSCN 0198	Ditto end of looking SW	
DSCN 0199	Training wall and end of modern culvert looking NNW	
DSCN 2203	Training wall looking W	
DSCN 2360	Looking into inset looking ENE	High water
DSCN 2361	Western wall looking WSW	Ditto
DSCN 2362	Training wall looking W	Ditto
DSCN 2363	East wall with modern repair looking NW	
DSCN 2364	Training wall looking W	
DSCN 3638	Grid 3 metres from wall of sluice area looking SSE	water activity about 3 metres from ground level indicates use.

**Baseline Condition:** Good.

**Proposals:** To retain and repair where necessary.

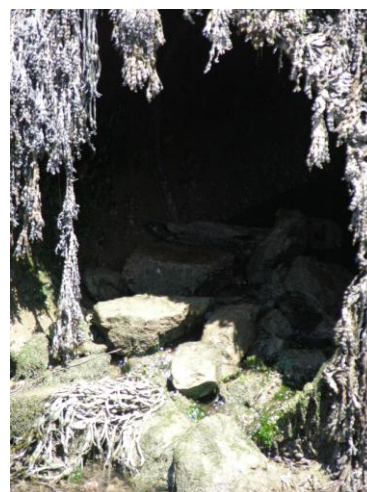
**Description:** The concrete wall that blocks the line of the stream that was part of the sluicing system associated with the Copperhouse Pool has several outlets in it. One at least may be for surface drainage but at least one is assumed to drain the culvert that possibly still joins the Pool to the estuary at this point.

Photo No	Object and orientation	Note
DSCN 3636	Parapet of old bridge across stream looking NW	
DSCN 3637	Line of stream looking SW	
DSCN 3667	Water outlets on site of sluice looking NE	
DSCN 3668	Ditto	
DSCN 3669	Ditto close up of main channel.

**Baseline Condition:** Unknown.

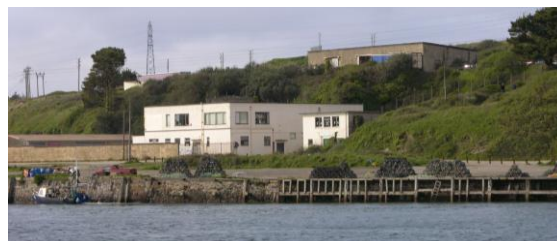
**Description:** Quay from the Sluice at the Customs House running east. It is built in an irregular stone (rubble) form with a granite coping. There are granite posts and a set of granite steps from the waterline at a knuckle about half way along the length of the quay. The west end of the quay was a protective wooden frame – this may have been constructed because ships moored here were subject to the violent stream coming from the adjacent sluice. This protective screen was removed as part of the harbour improvements in 2006). The quay has a ‘scalloped’ plan this made the berthing of ships more economical as they could overlap the bowsprits of the sailing ships.

Photo No	Object and orientation	Note
DSCN 0149	East end of quay looking NW	
DSCN 0151	Ditto showing scallop WNW	
DSCN 0155	North wall looking SE	
DSCN 0159	East end looking toward the knuckle SW	
DSCN 0142	Quay protection from quay looking WSW	
DSCN 2175	Ditto from East Quay looking NNW	
DSCN 2399	Ditto looking N	
DSCN 2400	Ditto looking N	
DSCN 2402	Ditto	
DSCN 2403	Ditto NNW	
DSCN 0163	Steps at Knuckle looking SE	Note scoria wall behind steps
DSCN 2236	Steps at Knuckle looking SE	
DSCN 2237	Steps close up looking SE	
DSCN 2338	Ditto looking SSW	
DSCN 2339	Mooring post at knuckle SSW	
DSCN 2534	Edge of protection looking NW	
DSCN 2535	Ditto looking SE

**Baseline Condition:** poor to good.

**Necessity:** The condition of parts of the harbour wall require repair to ensure safety and survival.

**Proposals:** Repair and retain.

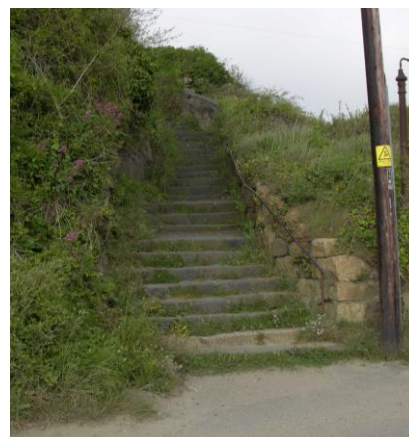
**Description:** Steps from North Quay to Clifton Terrace created with Scoria blocks.

Photo No	Object and orientation	Note
DSCN 2206	Steps looking NE

**Baseline Condition:** Fair to Good.

**Proposals:** To be left as found.

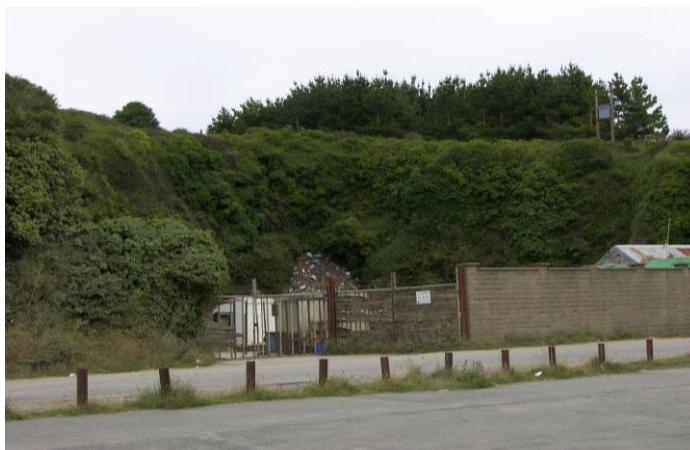
**Description:** The site is a former quarry, which today is fenced and is used by the fishermen as a lock-up area. The surface of the area has been concreted. There is nothing on the site to indicate the existence of a lifeboat station today.

Photo No	Object and orientation	Note
DSCN 2315	Railway and Fence to Quarry	
DSCN 2540	Quarry looking E	
DSCN 2543	Ditto looking NE	
	There are a number of photos of track entering the Quarry area	See section on Wharf Railways – see NQ16.

**Baseline Condition:** Not totally determined at this point.

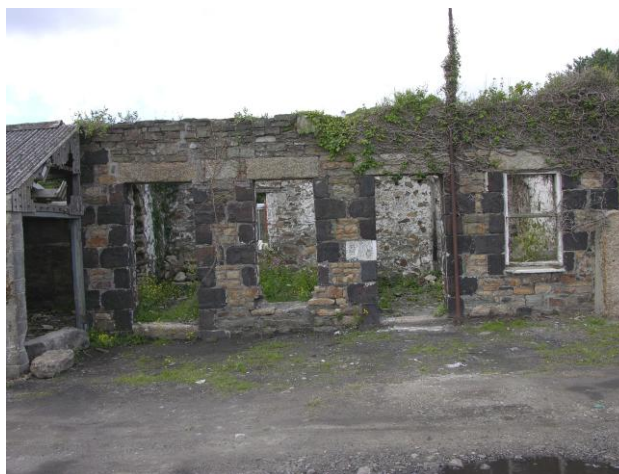
**Description:** Four walls of Killas irregular blocks and scoria with dressed granite lintels to windows. There are two windows and a door opening on the south side – it was two roomed and had a pitched roof but this and any interior details have gone – the building is derelict. There is a 20<sup>th</sup> century shed attached which, is also derelict. The newer block has a stone rubble wall to a height of 1.2 metres the rest is constructed in concrete blocks and asbestos sheeting.

Photo No	Object and orientation	Note
DSCN 0139	Stables looking NE	
DSCN 2207	Ditto	The building have buried
DSCN 2544	Join between Stables and 20 <sup>th</sup> century shed looking E	Join shows that the 20 <sup>th</sup> century had an older history
DSCN 3619	View 2007 looking N	Has been cleared of organic matter
DSCN 3620	Ditto looking NE	
DSCN 3621	Northern exterior wall from newer portion	
DSCN 3622	Interior of newer portion looking N	
DSCN 3623	Exterior of newer portion looking SE	
DSCN 3639	Interior looking NNW	
DSCN 3640	Ditto looking NE	
DSCN 3641	Ditto looking NW

**Baseline Condition:** Poor.

**Proposals:** Retain as found – to look at future integration into the next phase of the proposed development.

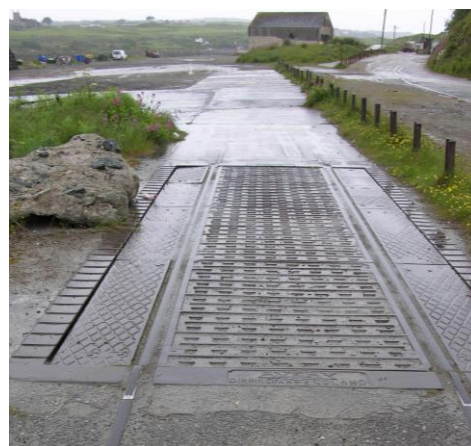
**Description:** Weighbridge made by Avery at Birmingham – the footplate of the weighbridge office can be seen close by.

Photo No	Object and orientation	Note
DSCN 0140	Looking ENE	
DSCN 2404	Ditto	
DSCN 2541	Mechanism holes in office looking ENE	
DSCN 2542	Footplate of Office looking NW

**Baseline Condition:** The weighbridge is in a good condition, the condition of the mechanism below the bridge is unknown. The remains of the adjacent weighbridge office is in very poor condition.

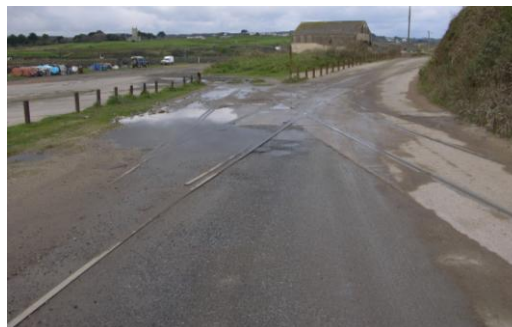
**Description:** There are extensive remains of the track of the Wharf railway on the North Quay

Photo No	Object and orientation	Note
DSCN 0141	Main track and branches looking W	
DSCN 0146	Track looking E	
DSCN 0150	Track at east end of Quay looking NW	
DSCN 2204	Main track toward Swing Bridge looking SE	The track to the left may have been for the dock cranes
DSCN 2205	Main track onto quay looking WNW	
DSCN 2216	Branch onto quay looking W	
DSCN 2217	Track entering Octel site looking W	
DSCN 2213	Track at Quay edge looking WNW	This track may have been for the dock cranes
DSCN 2214/5	Track entering Quarry looking E	2 photos different distance
DSCN 2220	Track within the Octel site looking NW	
DSCN 2313/4	Track entering Quarry	2 photos different distance
DSCN 2315	Ditto looking WSW	
DSCN 3642	Railway sleepers	These were found in a pile on the quay – there was no indication where they came from

**Baseline Condition:** Not yet totally determined.

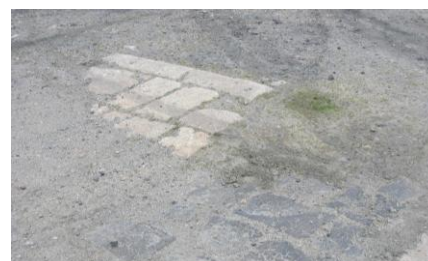
**Description:** A small area of granite and scoria blocks.

Photo No	Object and orientation	Note
DSCN 2358	Surface looking NNE	
DSCN 2359	Ditto looking N

**Baseline Condition:** Unknown.

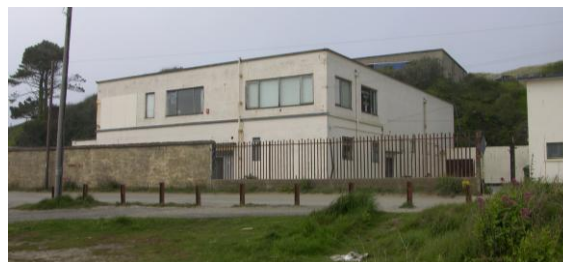
**Description:** The larger of the two remaining buildings – it is two storeys some 22 metres wide and 28 metres deep. It is of reinforced concrete – strengthened against the threat of bomb action by the enemy – and flat roofed.

Photo No	Object and orientation	Note
DSCN 2222	Offices looking NNW	
DSCN 2223	Offices looking NE	
DSCN 2316	SE corner of office	
DSCN 2320	SW corner of office

**Baseline Condition:** Good.

**Proposals:** To retain, repair where necessary – in subsequent stages of the scheme the building will be altered.

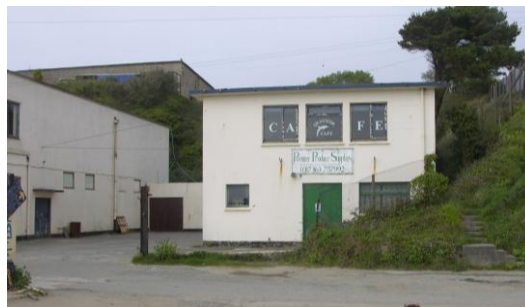
**Description:** The smaller of the two remaining buildings.

Photo No	Object and orientation	Note
DSCN 2218	Office looking NNW	
DSCN 2219	Ditto	
DSCN 2318	Office looking NE	
DSCN 2539	Close up of steps to the east looking NE

**Baseline Condition:** Good.

**Proposals:** To retain, repair where necessary – in subsequent stages of the scheme the building will be altered.

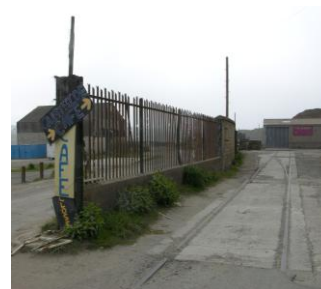
**Description:** Original railings to the west of the Octel Site – the concrete block wall runs to the end of the site to the chimney NQ25.2 with opening created for the works which are currently on site.

Photo No	Object and orientation	Note
DSCN 2220	Railings looking west	
DSCN 2221	Railings where they meet later wall looking west	
DSCN

**Baseline Condition:** Good to fair.

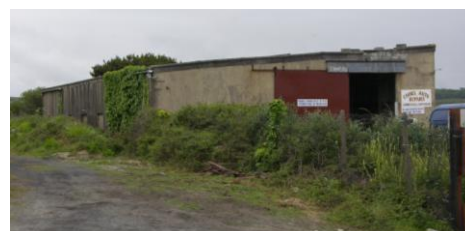
**Description:** Single storey, mono-pitched roof concrete walled possible warehouse. The west face of the building has a large sliding door, the north has five blocked/blind windows and has a fan embedded in the wall.

Photo No	Object and orientation	Note
DSCN 2339	West face looking SE	
DSCN 2340	Ditto	
DSCN 2341	East and north face looking SW	
DSCN 2344	Building from the quay looking NNW	
DSCN 2345	Ditto

**Baseline Condition:** Fair.

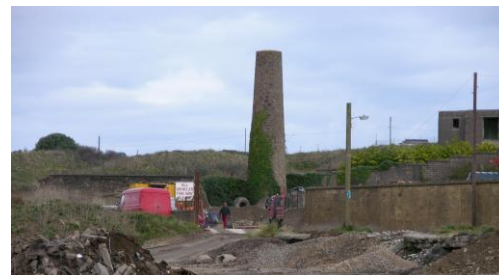
**Description:** The site today is the depot of an extraction firm that deals in sand and topsoil. The only remains visible on the site is a chimney at the eastern corner. The stack is circular and constructed in stone blocks (See NQ26)

Photo No	Object and orientation	Note
DSCN 0148	Stack looking NNW	
DSCN 0153	Ditto looking NE	
DSCN 2225	Stack looking NW	Inside compound
DSCN 2322	Base of stack looking NW	
DSCN 2323	Stack looking WNW	Inside the compound

**Baseline Condition:** Unknown.

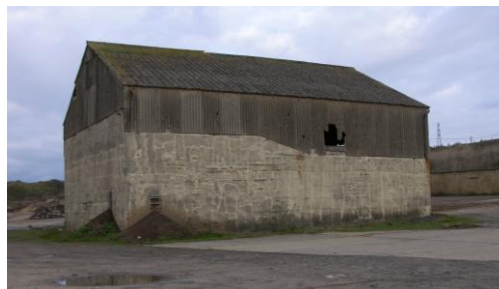
**Description:** Former sulphur store, breeze block walls, topped with metal sheeting with asbestos sheet roof supported by light steel structure. The Latter part of the structure was removed in 2006 and only the base now remains.

Photo No	Object and orientation	Note
DSCN 0145	Shed looking NW	
DSCN 0147	Shed looking E	
DSCN 0165	Shed looking SW of entrance on north	
DSCN 2211	Shed looking NW	
DSCN 2212	Ditto	
DSCN 2230	Shed looking SE	
DSCN 3624	Shed with roof removed looking W	Photo taken July 2007

**Baseline Condition:** Poor.

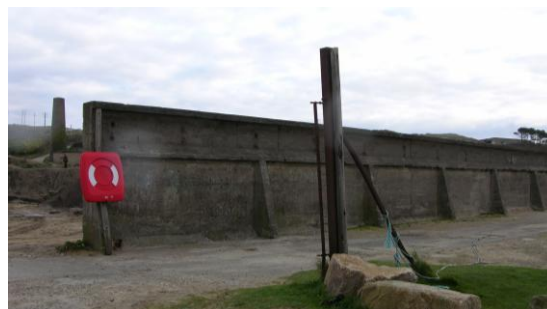
**Description:** Concrete wall east to west, parallel to quay edge, approximately 3 metres high and just over 100 metres long – it has heavy buttresses on the south side. Railway tracks can be detected on the seaward side of the wall.

Photo No	Object and orientation	Note
DSCN 0150	Wall looking NW	
DSCN 0160	Ditto looking NE	
DSCN 2231	Ditto looking NW	
DSCN 2232	Ditto Looking E	
DSCN 2234	Ditto with railway looking E

**Baseline Condition:** Fair.

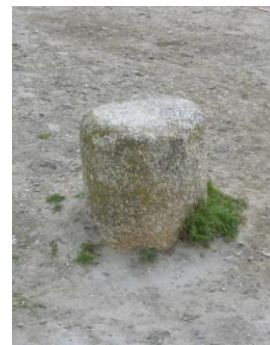
**Description:** Granite post slightly under a metre tall.

Photo No	Object and orientation	Note
DSCN 2348	Post looking NE	
DSCN 2349	Ditto

**Baseline Condition:** Good.

**Proposals:** To be left as found.

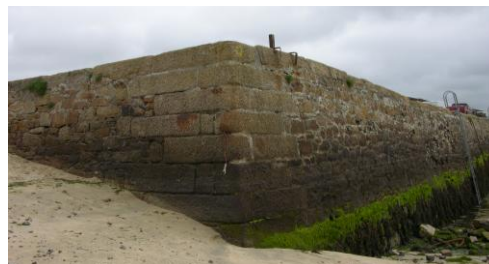
**Description:** The quay wall at the extreme west end of North Quay – beyond are the sand dunes of the estuary. Rubble wall with dressed granite coping and large dressed blocks at the corner. The portion of the wall as it turns and runs north has been extended – the stones here are a couple of metres long and fairly regular.

Photo No	Object and orientation	Note
DSCN 2347	Quay Wall looking NE	
DSCN 2350	Top of Quay with remains of ladder	
DSCN 2351	Top of quay looking SW	
DSCN 2536	Stones to north of edge looking SE	There is evidence of working on these stones.

**Baseline Condition:** Fair.

**Proposals:** To repair and retain.

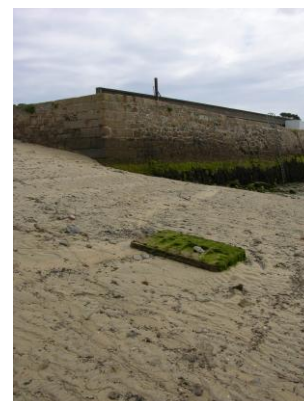
**Description:** Cast manhole cover about 10 metres from the edge of the North Quay.

Photo No	Object and orientation	Note
DSCN 2537	Manhole cover looking SE	
DSCN 2538	Ditto looking NE

**Baseline Condition:** Fair to good.

**Proposals:** To be left as found.

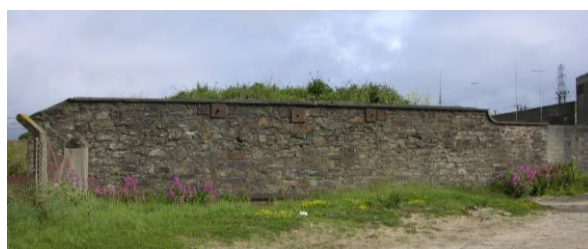
**Description:** Apart from the two standing ancillary buildings and the adjacent electricity distribution station there are no standing elements of the power station. Most of the site is the rubble of the demolished building which is heavily overgrown with vegetation. There is part of the outer boundary wall standing to the south east of the site (DSCN 2324 and 2325) and at the southern end the remains of an ancillary building.

Photo No	Object and orientation	Note
DSCN 2324	Boundary Wall looking NW	
DSCN 2354	Ditto Looking NW	
DSCN 2334	Remains looking NE	
DSCN 2335	Ditto looking SE

**Baseline Condition:** Unknown.

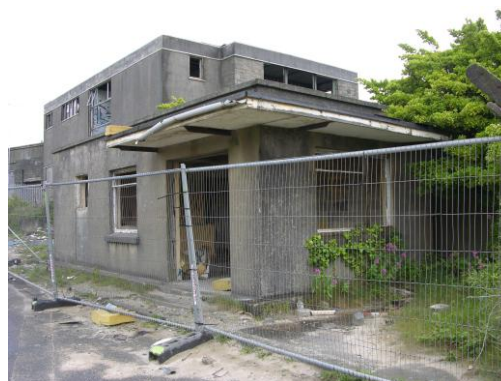
**Description:** Two storey three roomed with flat roof concrete structure with single storey extension – very heavily vandalised.

Photo No	Object and orientation	Note
DSCN 2326	Gatehouse looking NE	
DSCN 2327	Gatehouse looking SE

**Baseline Condition:** Very poor.

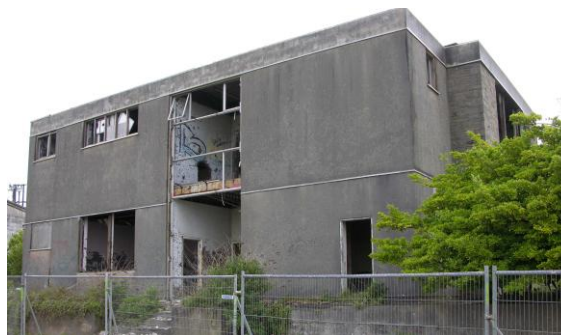
**Description:** Two storey building and if built before the 1914-18 War then its design could be regarded as quite avant-garde.

Photo No	Object and orientation	Note
DSCN 2328	Building looking ESE	
DSCN 2329	Building looking NE	
DSCN 2330	Canteen detail of ramp looking NE	
DSCN 2331	Building of front looking ENE

**Baseline Condition:** Unknown

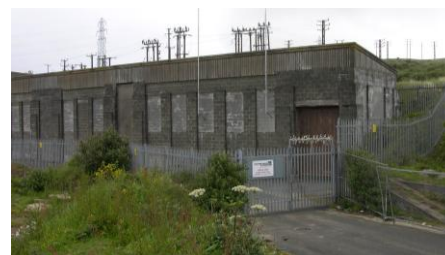
**Description:** Substantial buildings a major point of electricity distribution.

Photo No	Object and orientation	Note
DSCN 0154	Distribution Station looking NW	
DSCN 2226	Distribution Station looking SW	
DSCN 2332	Ditto looking E	
DSCN 2333	Ditto looking NNE	
DSCN 2337	View from Towans looking WSW	
DSCN 2338	Ditto

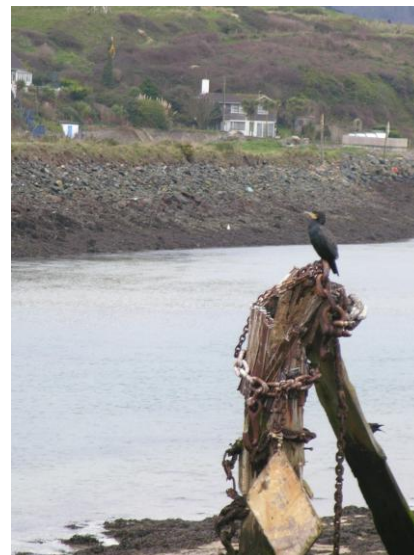
**Description:** Posts with support topped with a chain and hook – there are two one at each end of the bank. Both posts are in very bad condition.

Photo No	Object and orientation	Note
DSCN 0180	Warping Post looking NW	At SE end of bank
DSCN 0232 - 4	Warping Post looking NNE	
DSCN 2425	Warping Post looking NW	Taken at High Water

**Baseline Condition:** Very poor.

**Proposals:** To leave as found (There is a possible need to ensure a protection of its position once the Cockle bank is removed.

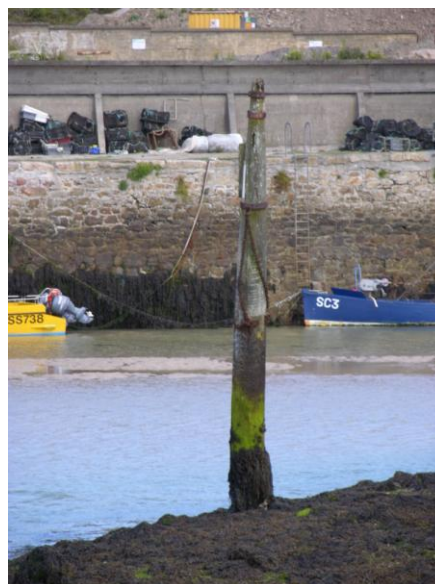
**Description:** Channel marker possibly an old ship's mast, it is in very poor condition.

Photo No	Object and orientation	Note
DSCN 3626	Marker/Warping post	At NW end of bank
DSCN 3651	Ditto	
DSCN 3652	Ditto

**Baseline Condition:** Very poor.

**Necessity:** The removal of the Cockle bank will make the position of this feature untenable and its condition precludes it being moved.
