hayle harbour :: regeneration South Quay

Harbour Wall Condition Survey

Extract from Harbour Wall Condition Survey

Job no 027802 December 2010

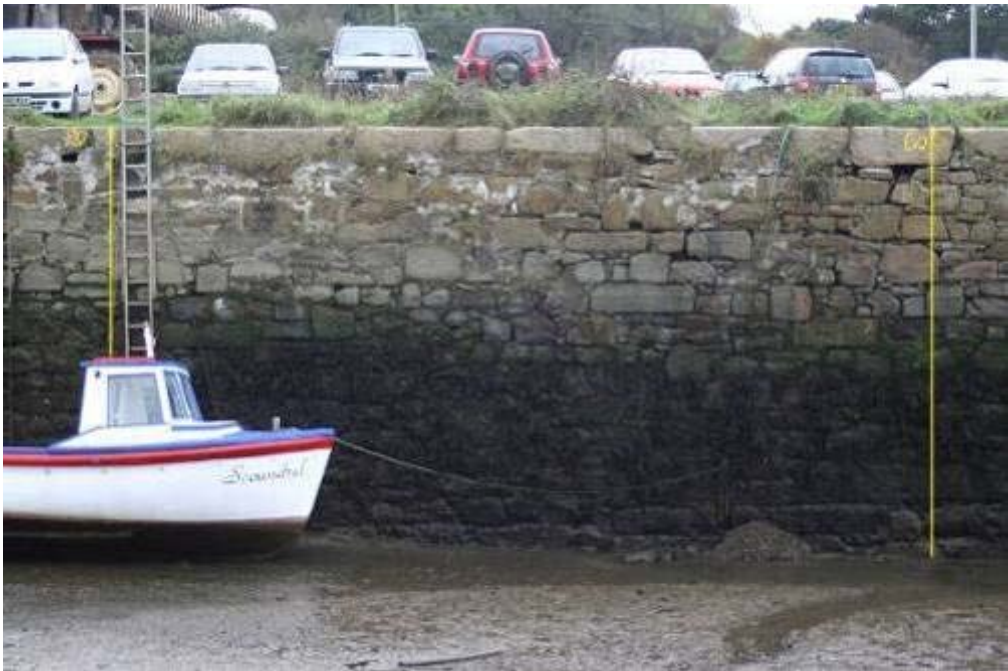
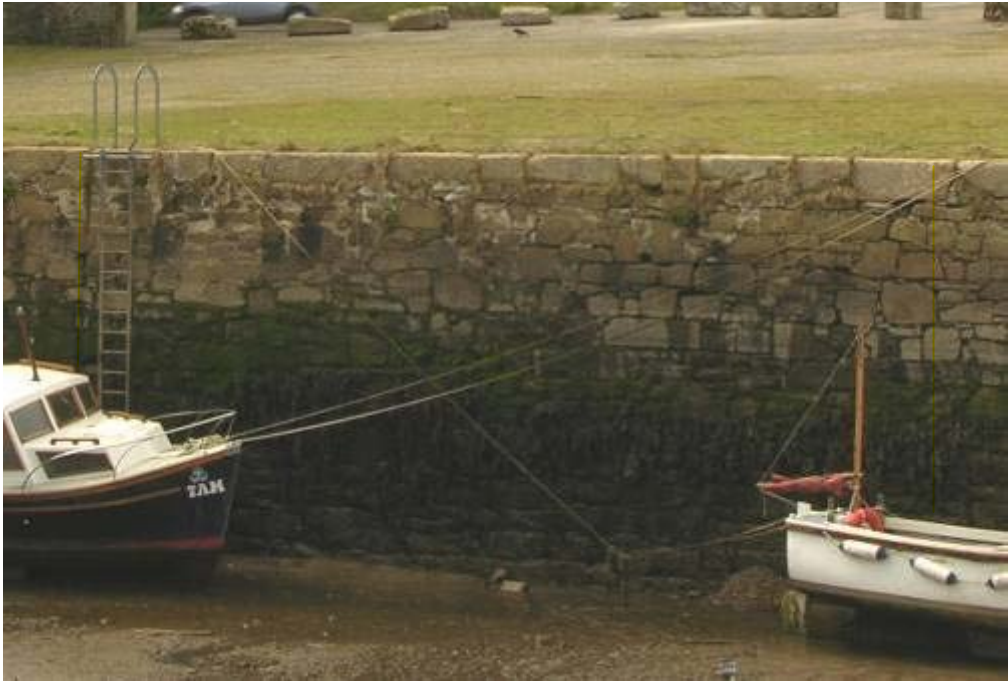
Location: SOUTH QUAY – Chainage 50 – 60m

| Condition Defects: | | | |
|---|---|---|---|
| 56.5 | | 0.3,1.2,1.6 | Missing blocks immediately below coping & open joints No change |
| 56 – 60 | | 0 – 2.30 | Generally open joints and missing blocks Boats in view |

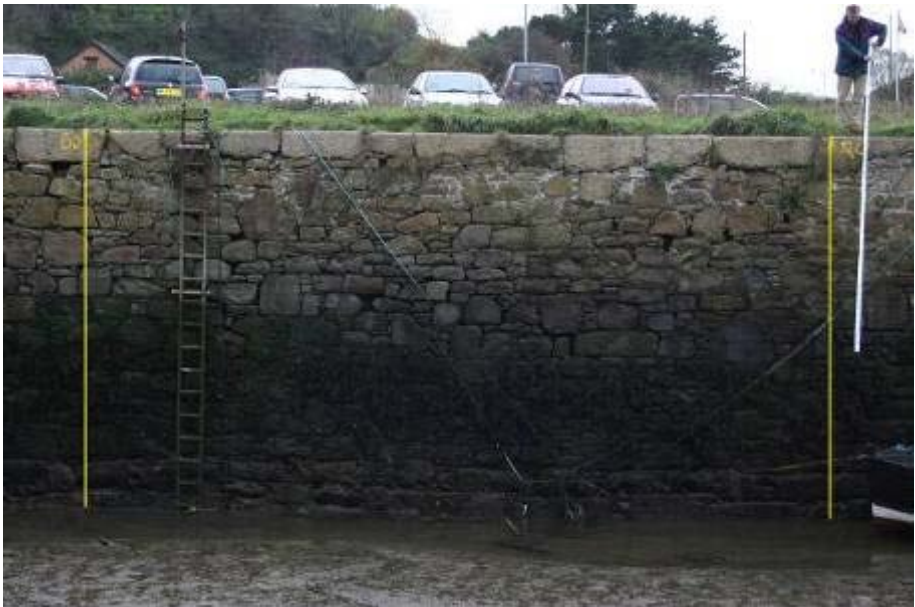
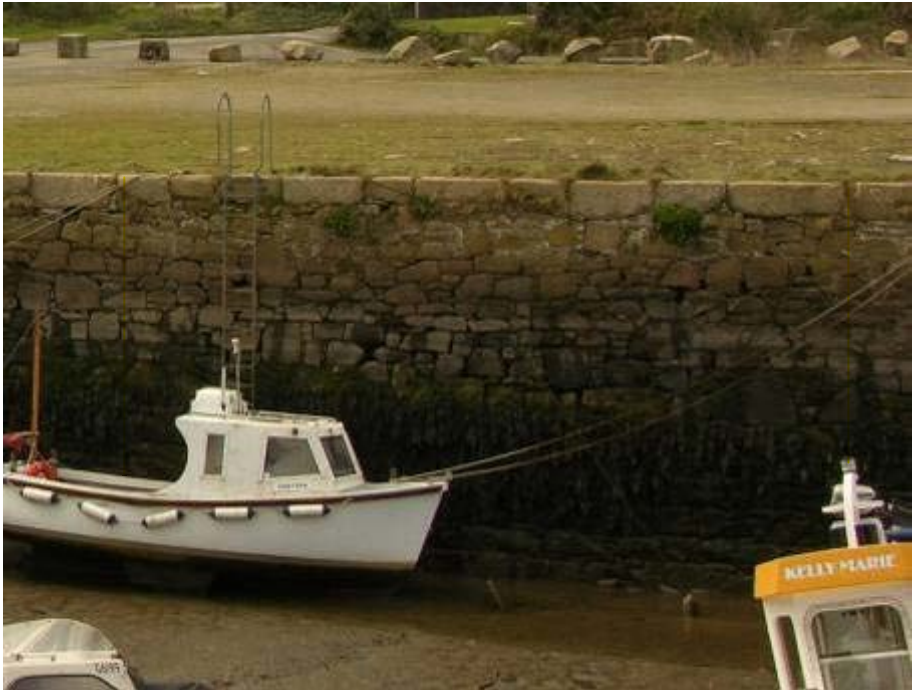
Location: SOUTH QUAY – Chainage 60 – 70m

| Chainage | Item | Depth | Description |
|---|---|---|--|
| 63 | | 2.30 | Missing block No change |
| 60 - 70 | | 1.30 & below | Generally open joints No change |

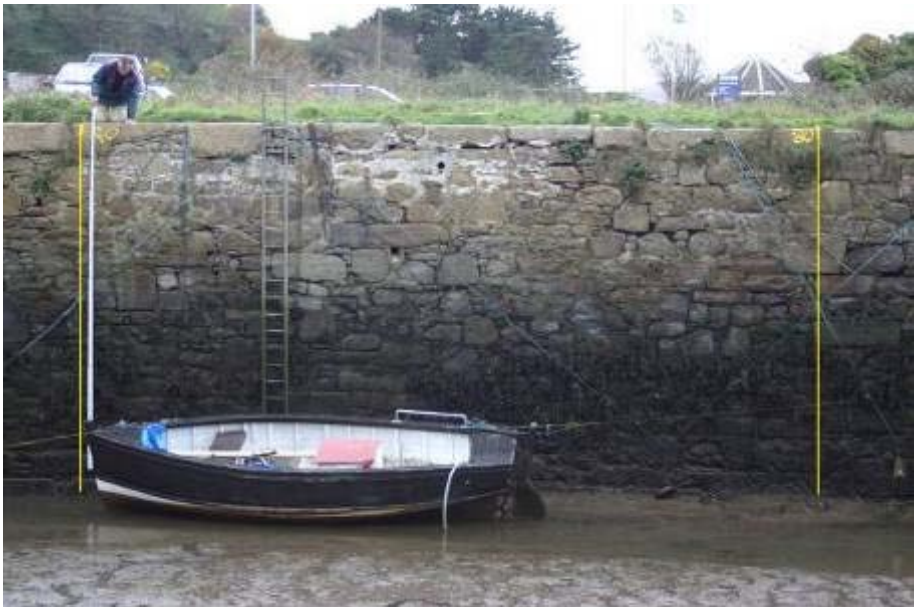
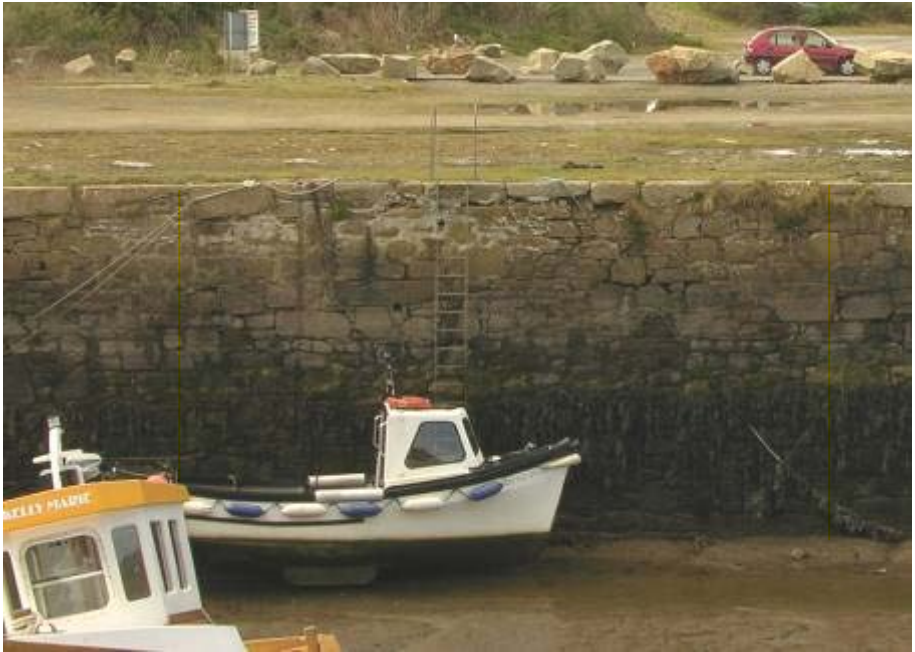
Location: SOUTH QUAY – Chainage 70 – 80m

| Chainage | Item | Depth | Description |
|---|---|---|--|
| 73 | | 1.90 | Rectangular block missing possibly old drainage hole No change |

| Chainage | Item | Depth | Description |
|---|---|---|--|
| 71 - 76 | | top - 1.0 | More recent repairs in this area No change |

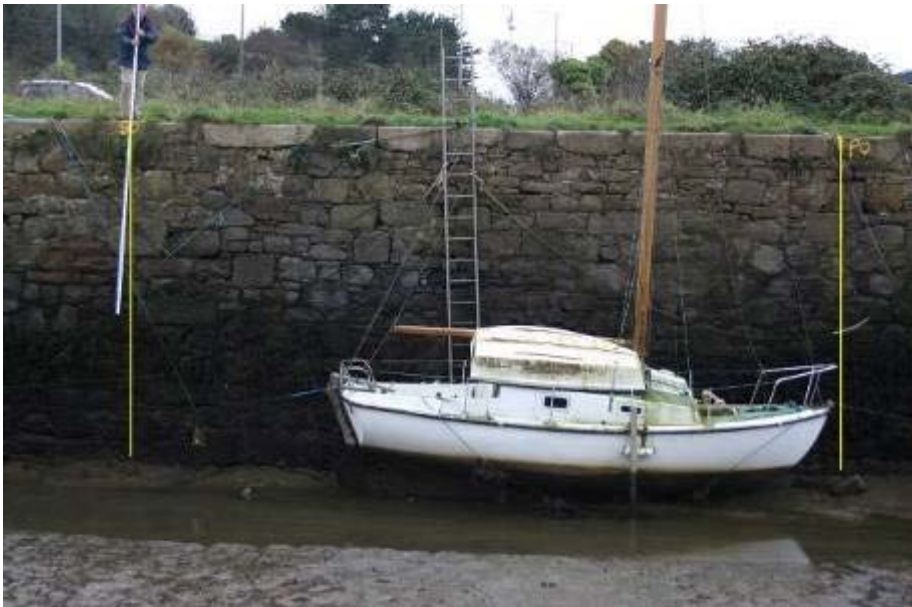
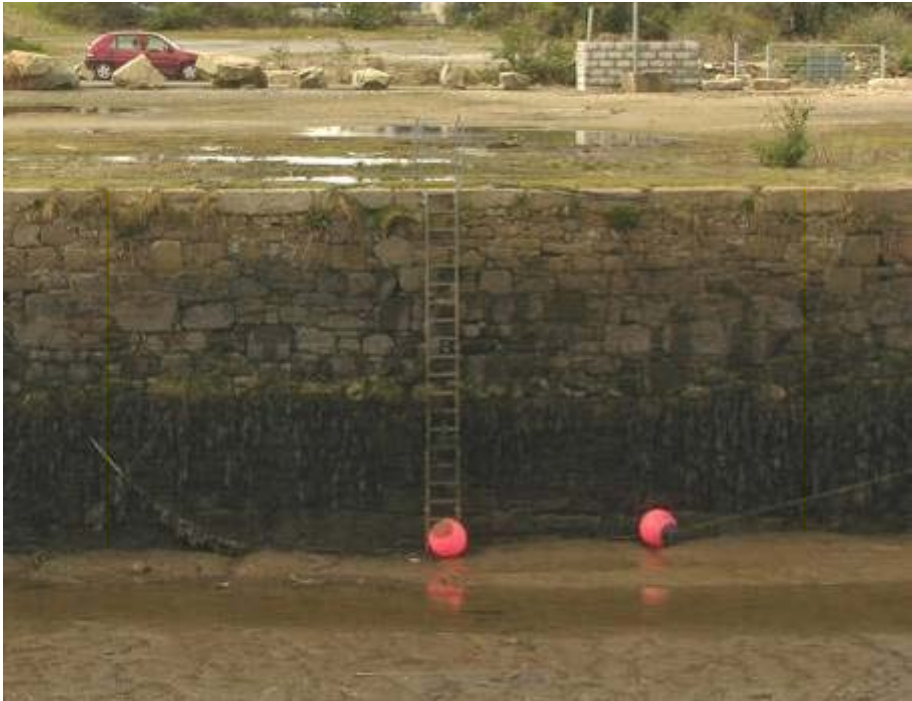
Location: SOUTH QUAY – Chainage 80 – 90m

| Condition Defects: | | | |
|---|---|---|--|
| | | | Generally good section with randomly spaced open joints No change Boat in way Sea weed line |

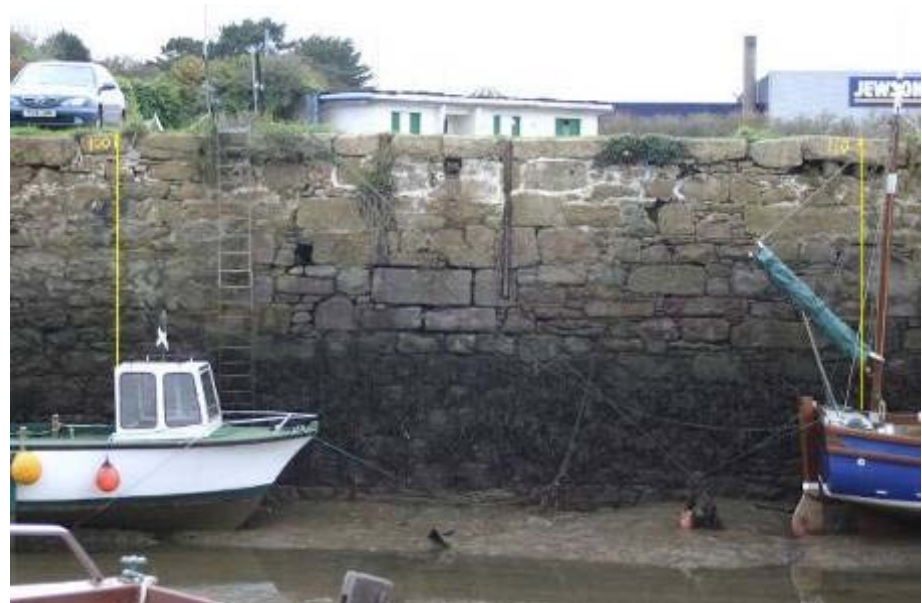
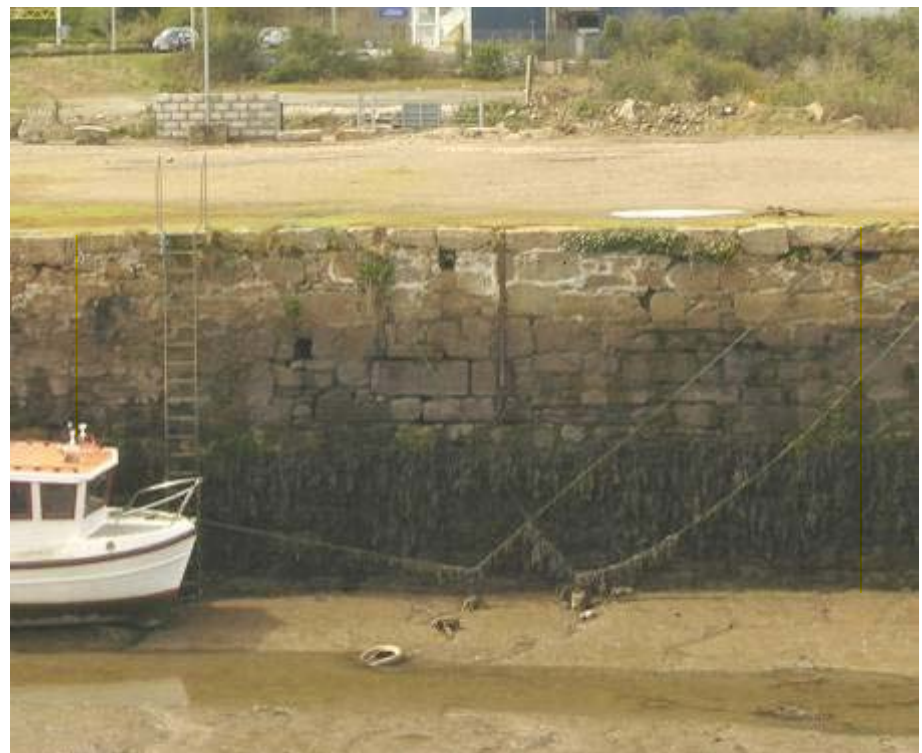
Location: SOUTH QUAY – Chainage 100 – 110m

| Condition Defects: | | | |
|---|---|---|---|
| 102 | | 1.6 | Block missing No change |
| 108 | | 1.0 | Missing block No change |
| 105 | | 0.3 | Missing block No change |
| 109.5 - 110 | | 0.4 | Missing blocks below coping No change |
| 100-110 | | 0-1.0 | Vegetation growth in joints (present in 2004) |

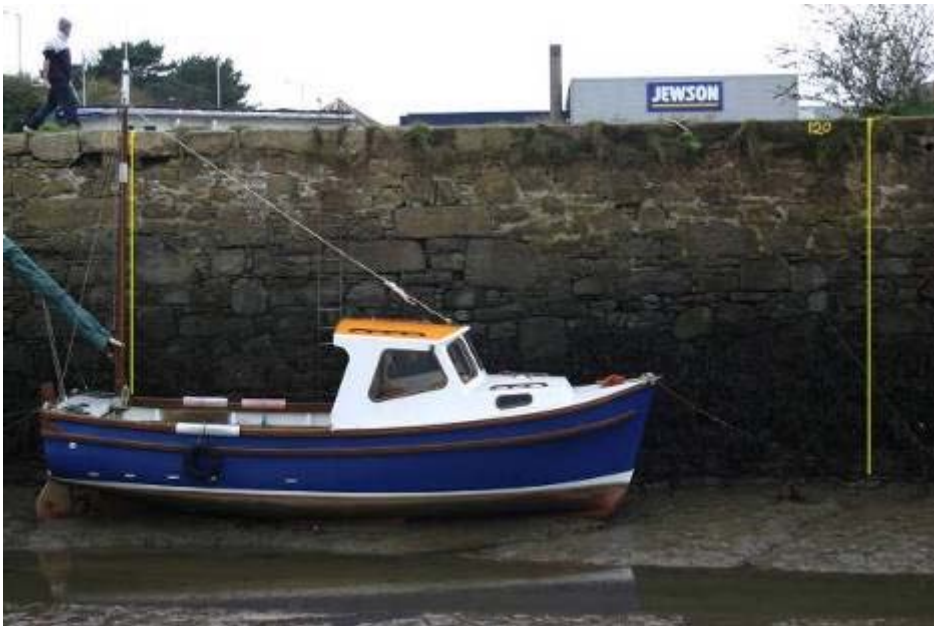
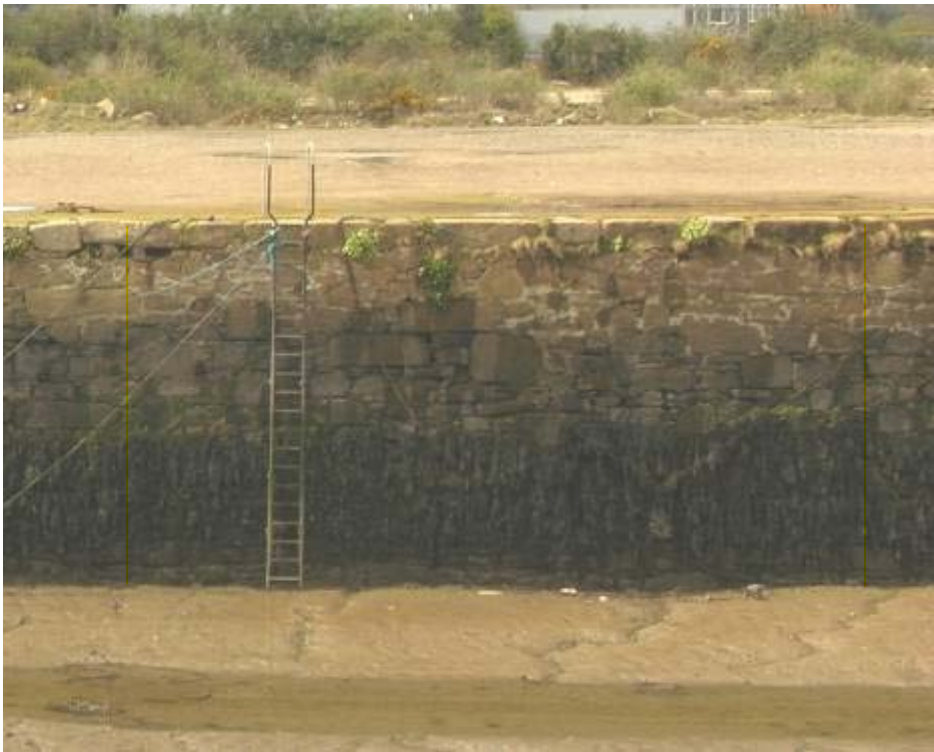
Location: SOUTH QUAY – Chainage 110 – 120m

| Chainage | Item | Depth | Description |
|---|---|---|---|
| 110-110.5 | | 0.4 | Missing blocks below coping No change |
| 112-120 | | 0-0.5 | Vegetation below coping (present in 2004) A few random open joints on this section No change |

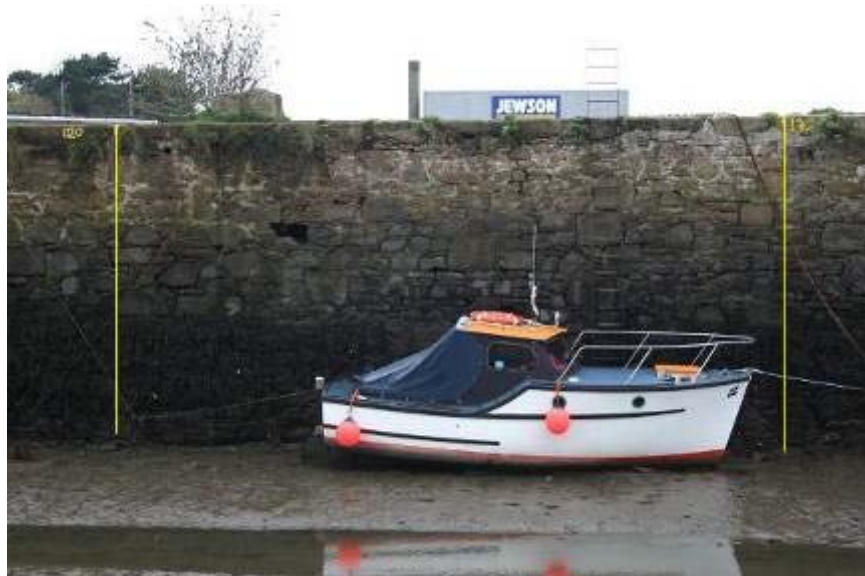
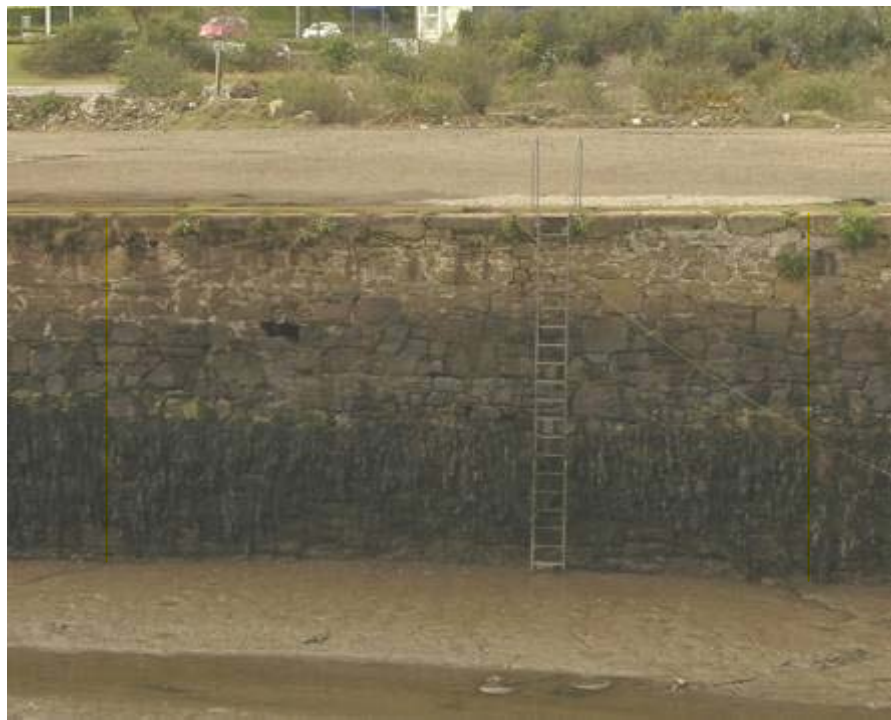
Location: SOUTH QUAY – Chainage 120 – 130m

| Chainage | Item | Depth | Description |
|---|---|---|--|
| 126 | | | Rusted mild steel ladder New ladder with hand supports at top. |

| Chainage | Item | Depth | Description |
|---|---|---|--|
| 120 - 130 | | 0 – 1.4 | Top section of wall more recent repairs, but still some open joints No change |
| 124 & 125 | | | Particular vertical cracks No obvious vertical cracks. Both vertical and horizontal visible. |
| 123 | | 1.60 | Large block missing No change |

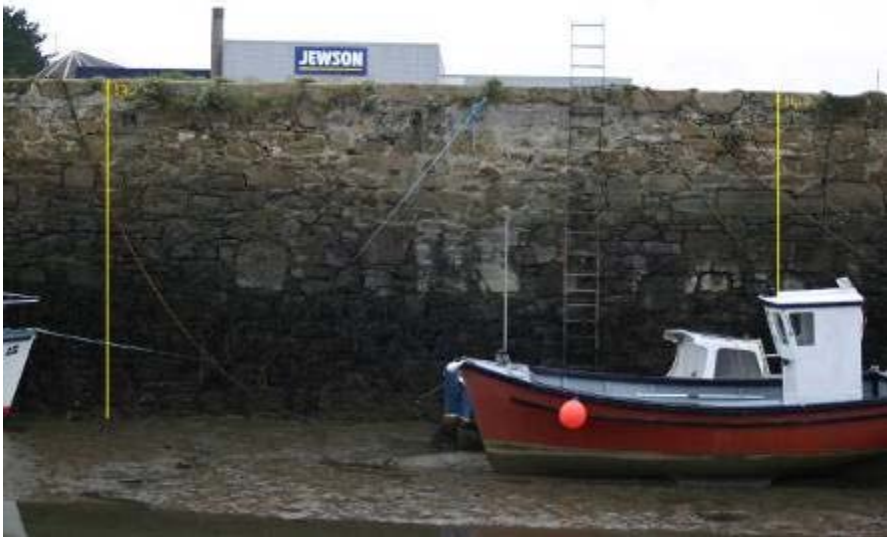
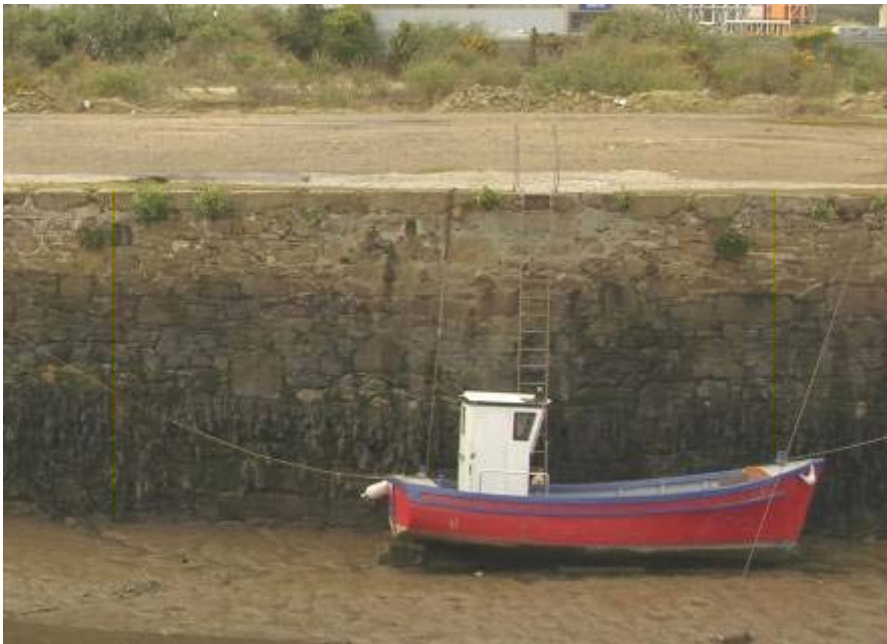
Location: SOUTH QUAY – Chainage 130 – 140m

| Chainage | Item | Depth | Description |
|---|---|---|--|
| 136.5 | | | Mild steel ladder very wobbly, unsafe. New ladder with handrails at top. |

| Chainage | Item | Depth | Description |
|---|---|---|---|
| 135 - 138 | | 1.3 | Rendered repaired section No change |
| 130.5, 131.5 & 135 | | 0.4 | Missing block with vegetation No change |
| 130 - 140 | | | Random open joints throughout whole section No change |

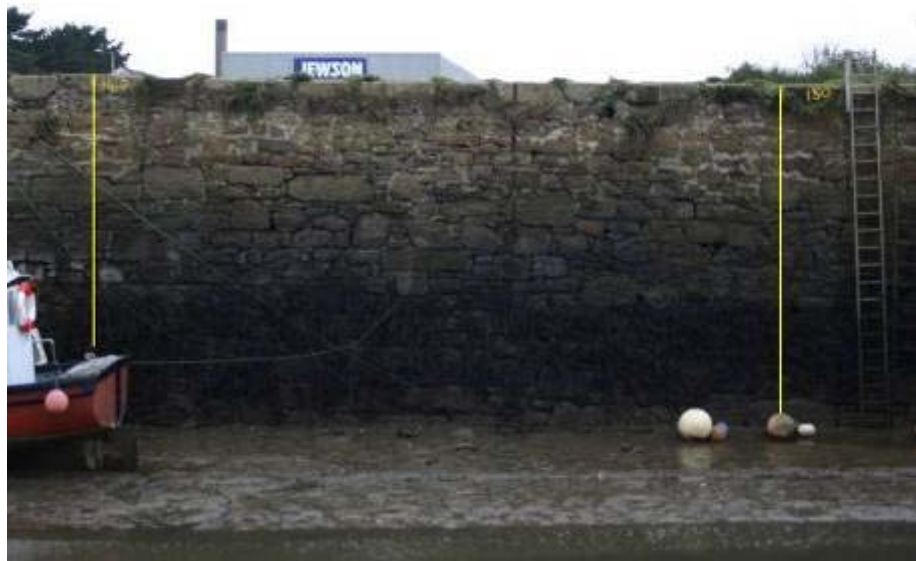
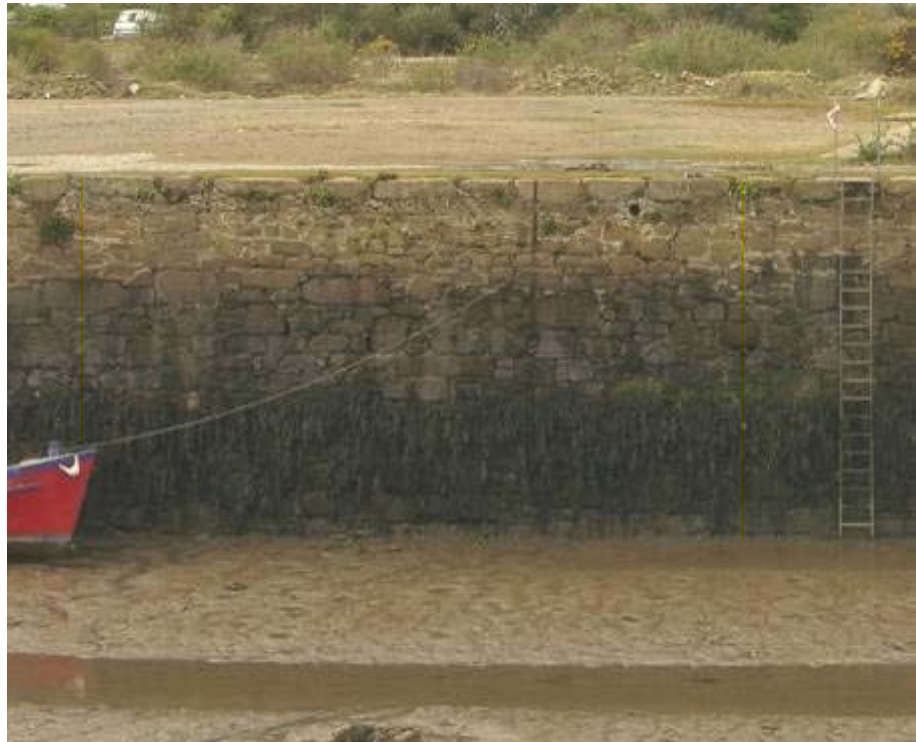
Location: SOUTH QUAY – Chainage 140 – 150m

| Condition Defects: | | | |
|---|---|---|---|
| | | | Vegetation just below top of wall No change |

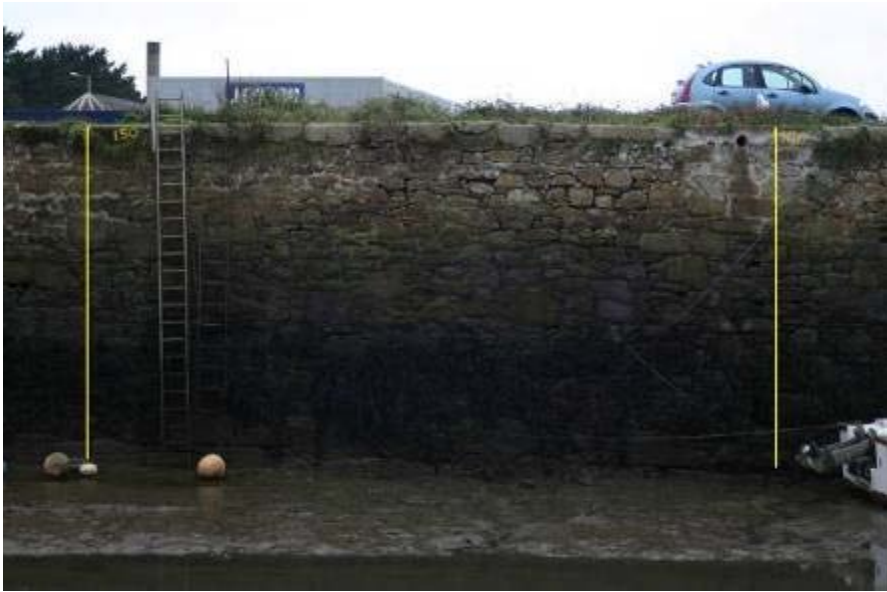
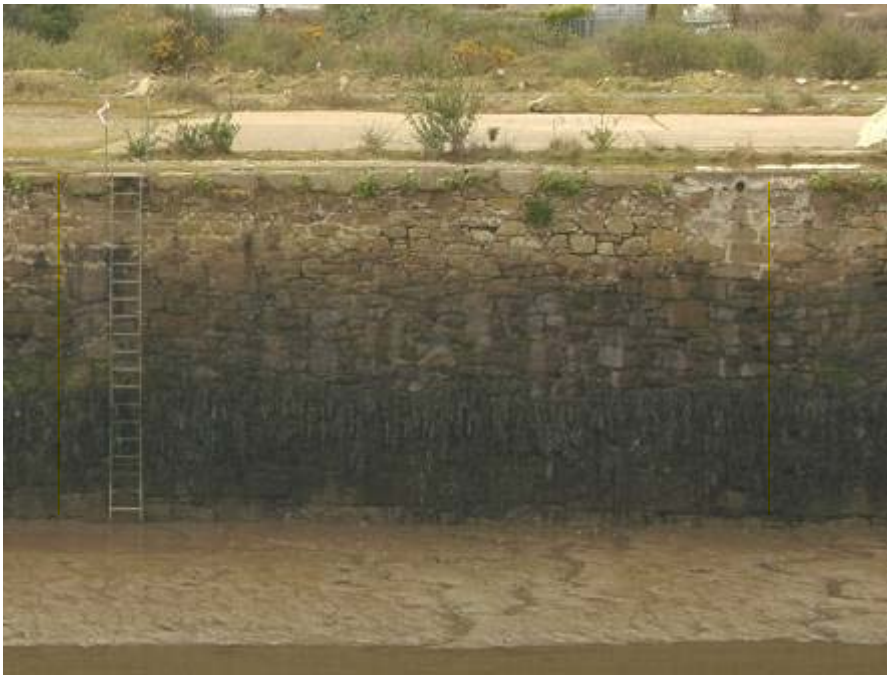
Location: SOUTH QUAY – Chainage 150 – 160m

| Chainage | Item | Depth | Description |
|---|---|---|---|
| 151.7 | | | Rusted galvanised mild steel ladder, very movable, in poor state New ladder, handrails at top |

| Chainage | Item | Depth | Description |
|---|---|---|---|
| 156 - 158 | | 1.3 | Deeper open joints. |
| 152-158 | | 0-0.5 | Vegetation from joints below coping |

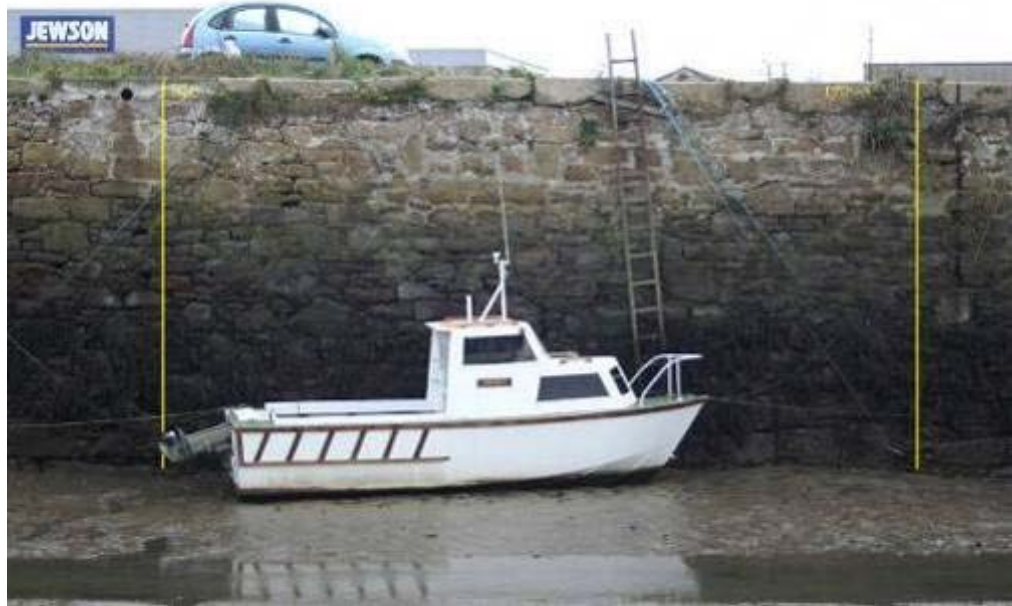
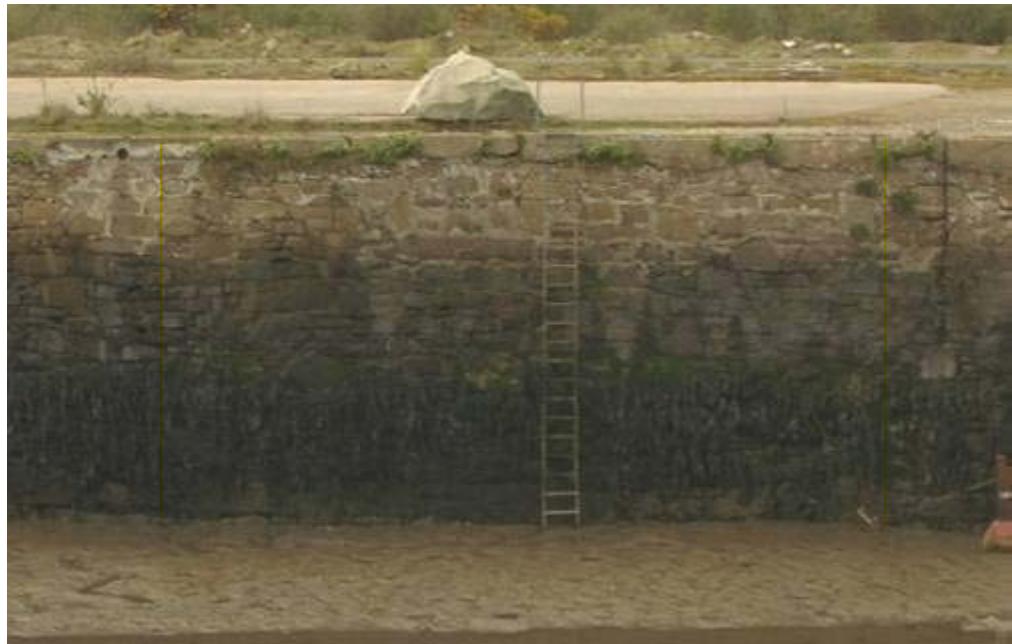
Location: SOUTH QUAY – Chainage 160 – 170m

| Chainage | Item | Depth | Description |
|---|---|---|--|
| 161 - 162 | | 0 – 1.70 | Vertical open joint No change |

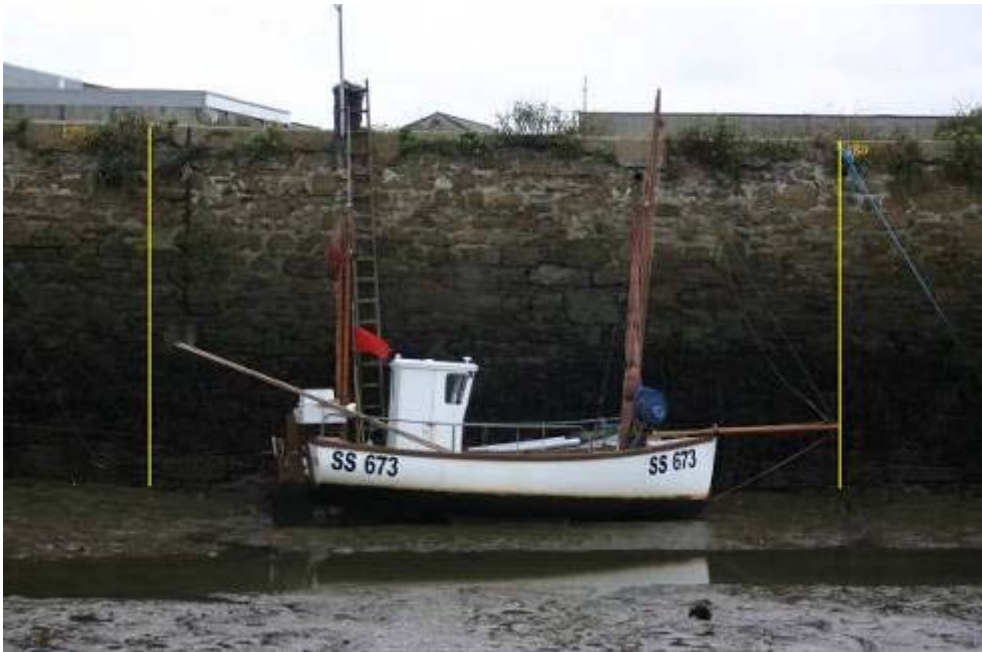
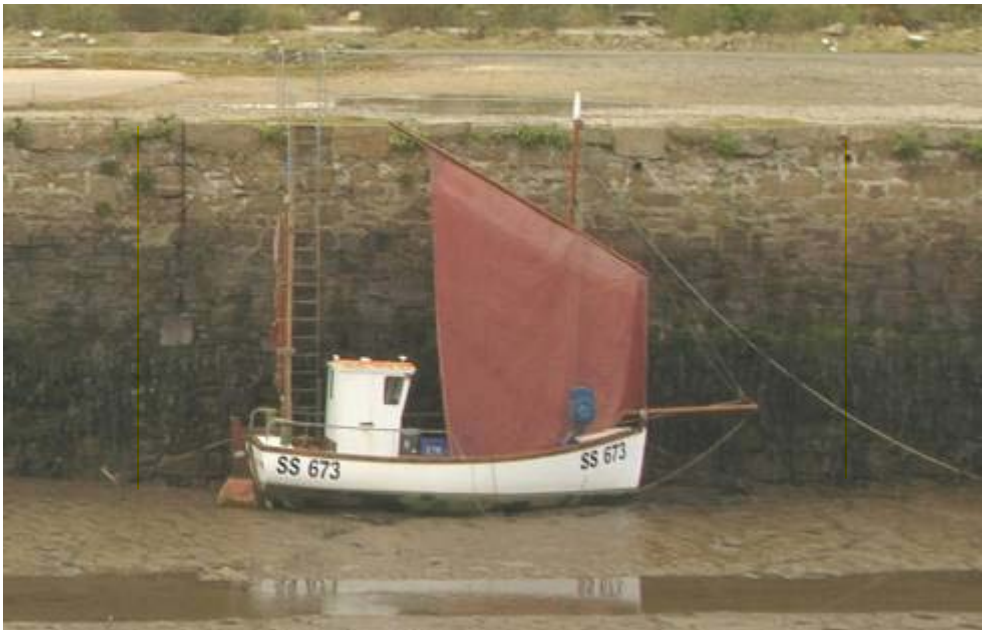
Location: SOUTH QUAY – Chainage 170 – 180m

| Chainage | Item | Depth | Description |
|---|---|---|--|
| 173 | | | Scaffold type ladder, wobbly, with lifting davit alongside made up of scaffold tube - poor condition New ladder with handrails at top. No davit. |

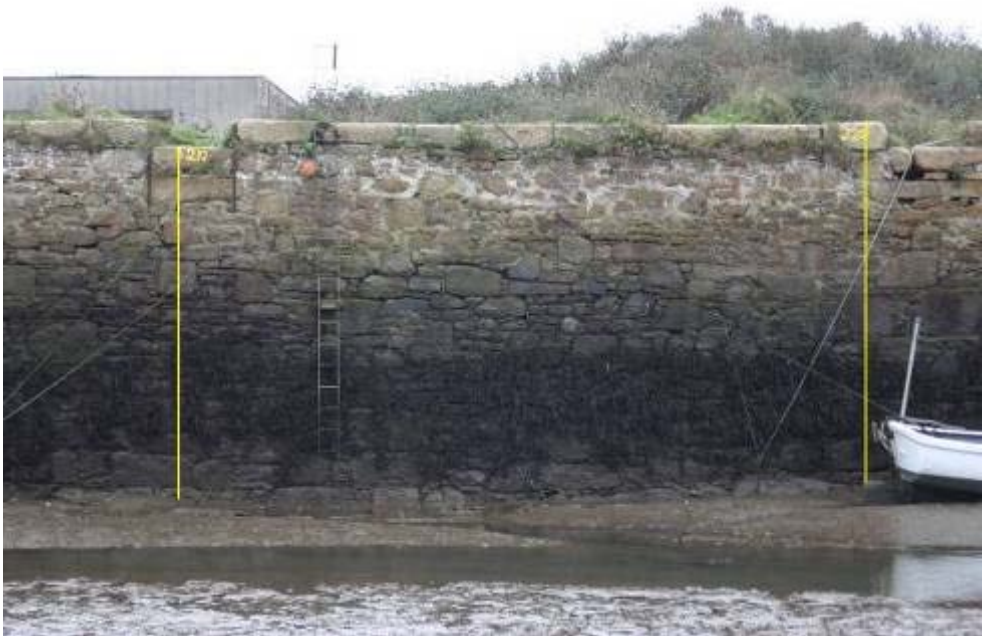
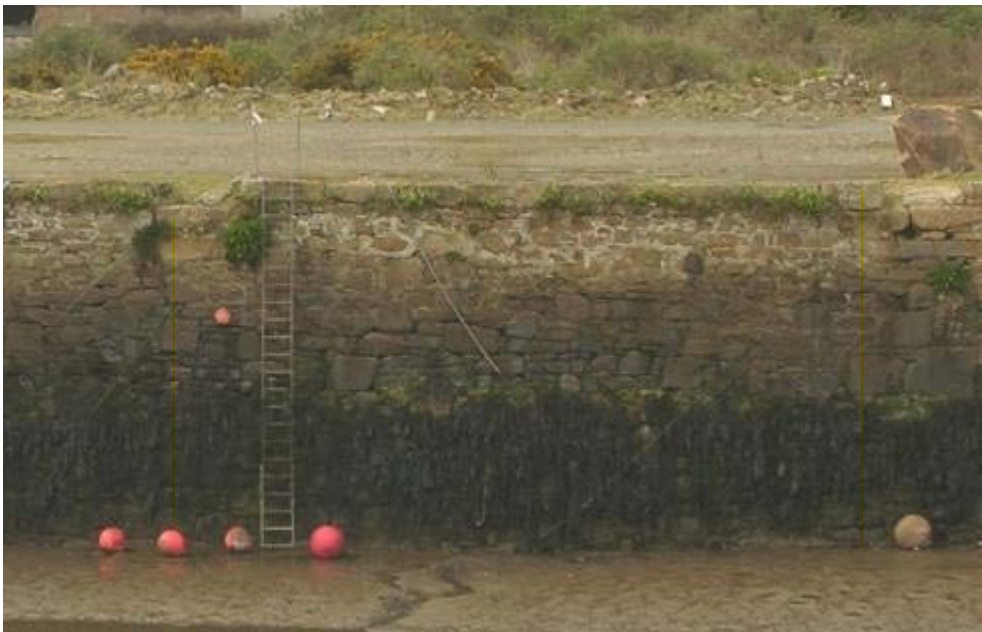
Location: SOUTH QUAY – Chainage 210 – 220m

| Overall Grading: | | | | | | | | | | | | | | | | | | | | | | | | | |
|---|---|---|--|---|---|--|---|--|---|---|---|---|---|---|--|--|--|---|--|--|--|---|--|--|--|
| 210 - 211 | | | Missing coping stones (width 1.4m) No change | | | | | | | | | | | | | | | | | | | | | | |
| 212 | | | Rusty mild steel ladder New steel Ladder with handrails at top | | | | | | | | | | | | | | | | | | | | | | |
| 210 – 210.8 | | | Top coping stone missing as above | | | | | | | | | | | | | | | | | | | | | | |

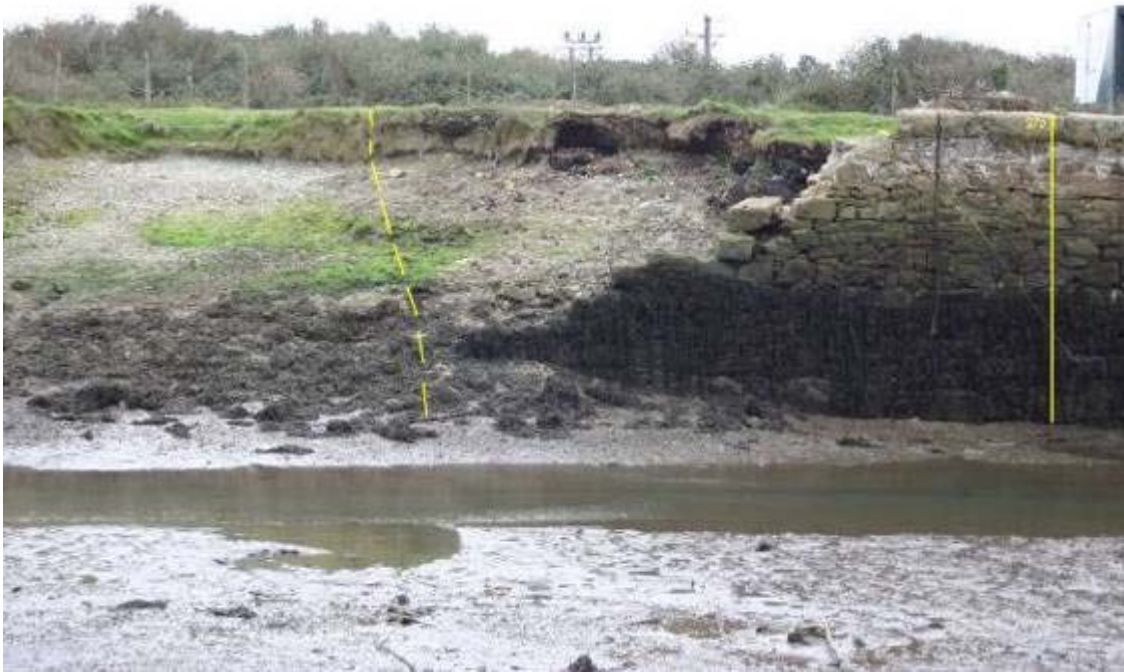
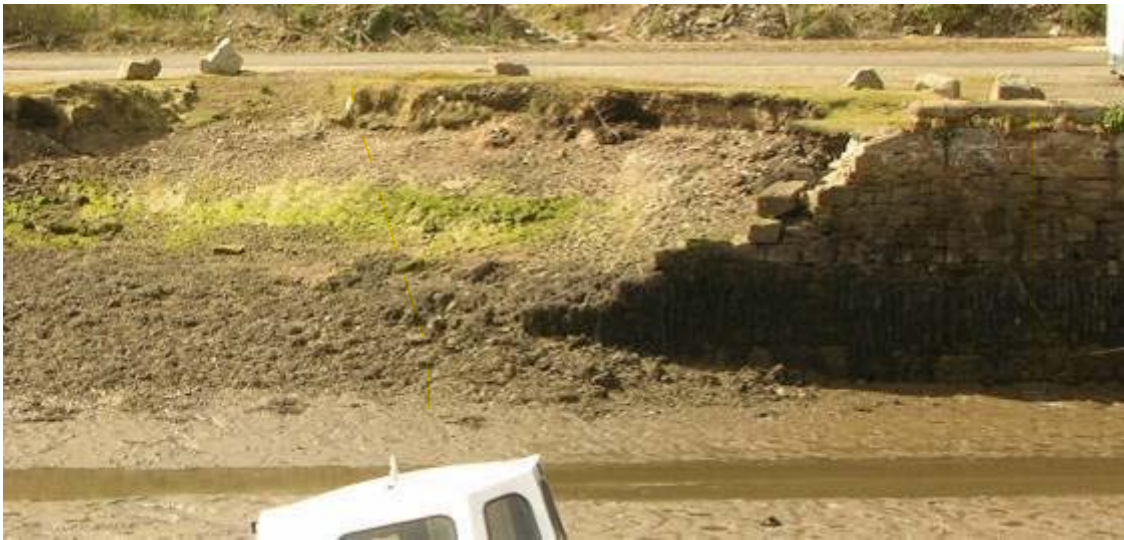
| 250 - 260 | | | Breach in wall (see images) No change |

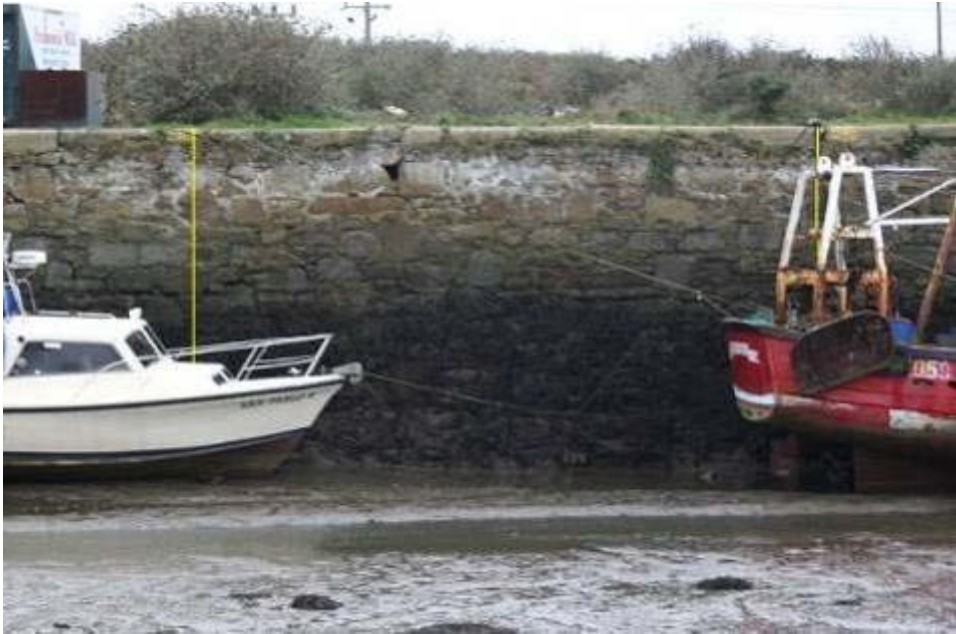
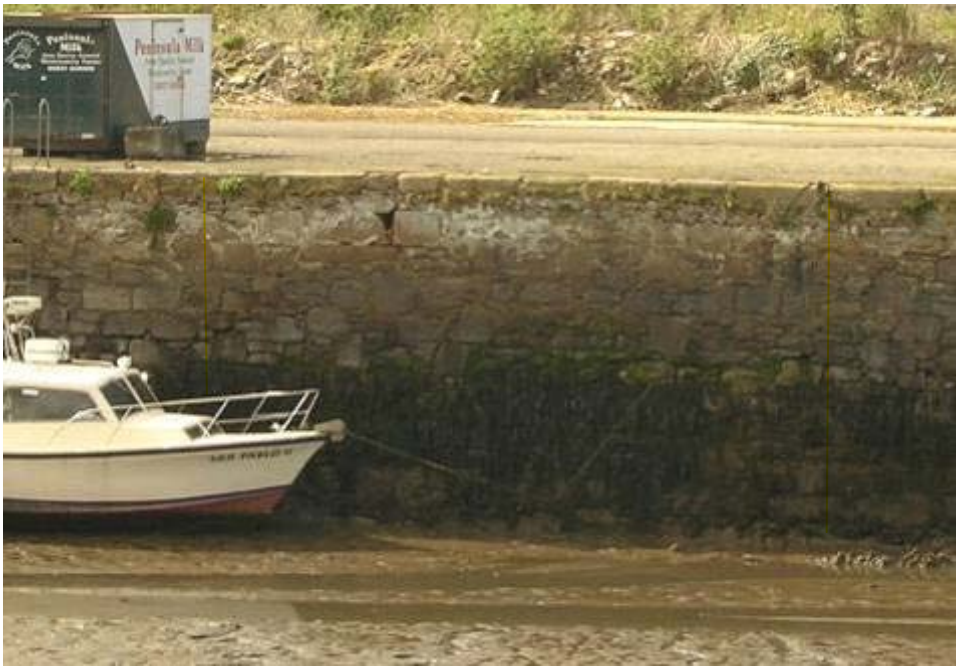
| Chainage | Item | Depth | Description |
|---|---|---|--|
| 270 - 277 | | 1.30 – 1.70 | Vegetation between and under open joints around coping All copings have metal pins in this area Horizontal crack, some recent repairs on top 1m approx of wall No change |
| 277 | | 1.00 | Block missing No change Randomly spaced open joints throughout No change Boat in way – lower sections not surveyed No change |

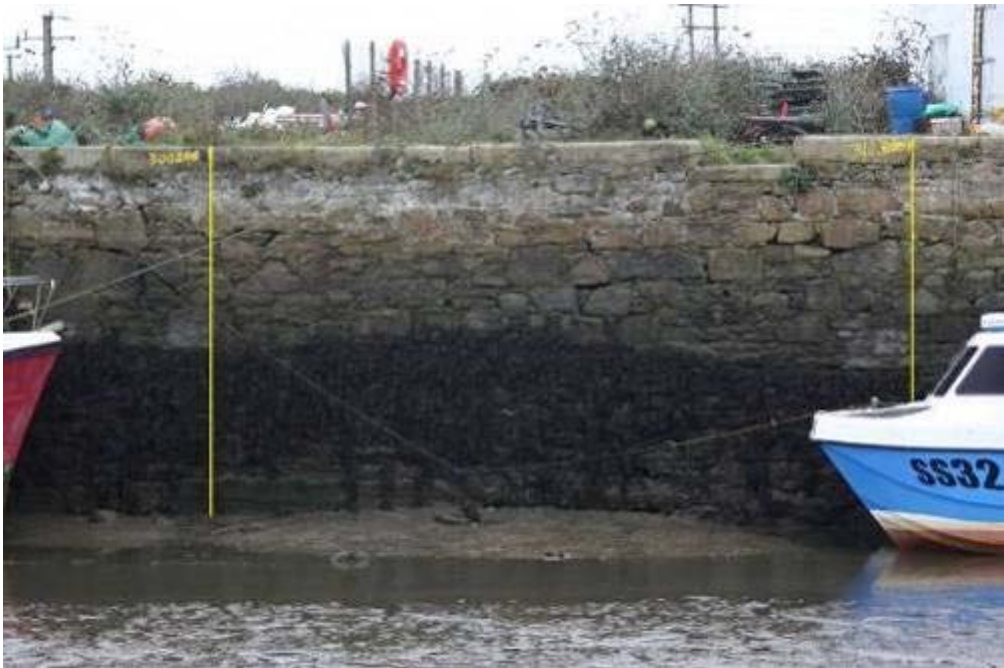
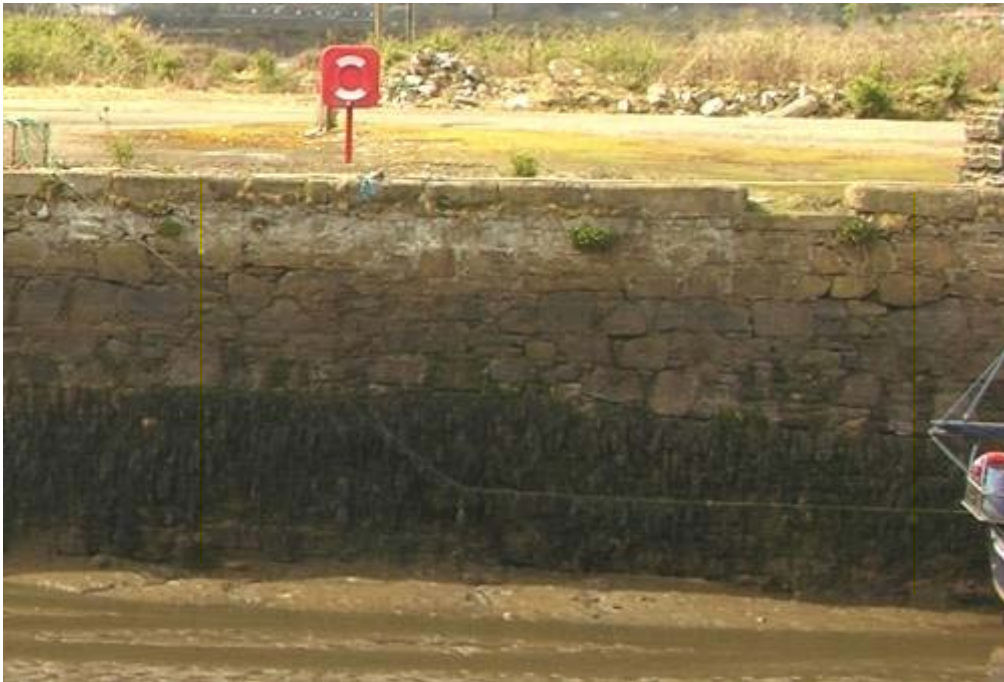
| Chainage | Item | Depth | Description |
|---|---|---|--|
| 290 - 300 | | | Vegetation below coping stone Only at 291.5 and 298 |
| 290 - 300 | | | Some randomly spaced open joints No change Re-pointing required below seaweed line. |

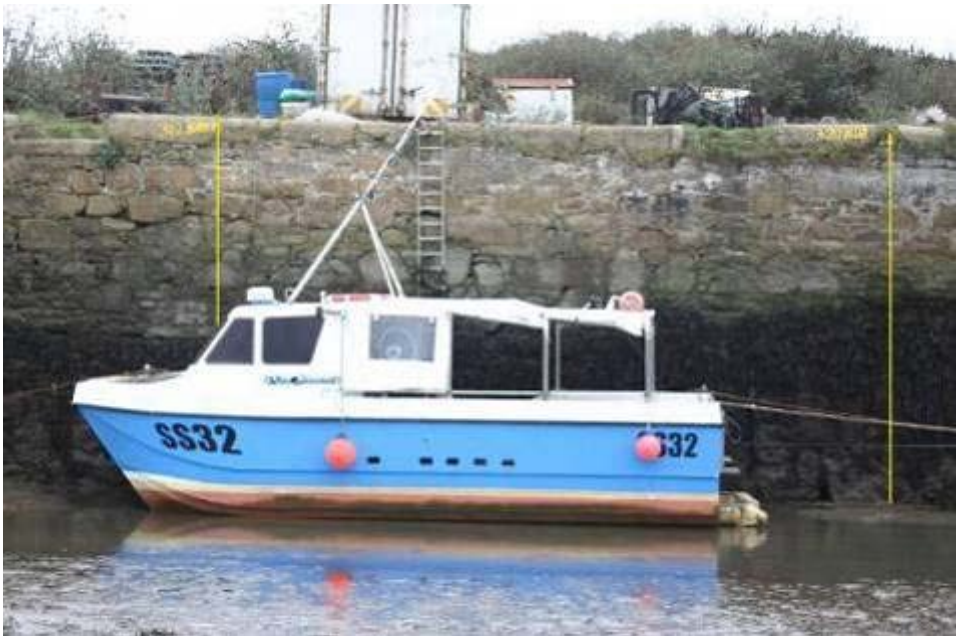
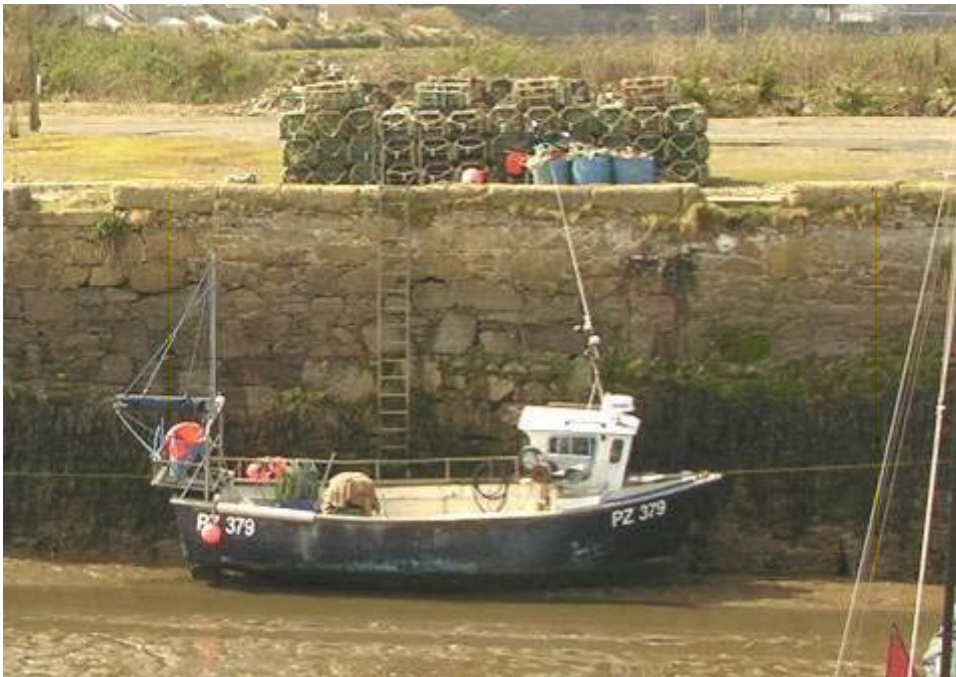
| Chainage | Item | Depth | Description |
|---|---|---|--|
| 308 | | | Missing coping stone, 1.35m No change |
| | | | Randomly spaced occasional open joints No change |
