hayle harbour :: regeneration South Quay

Harbour Wall Condition Survey

Extract from Harbour Wall Condition Survey

Job no 027802 December 2010

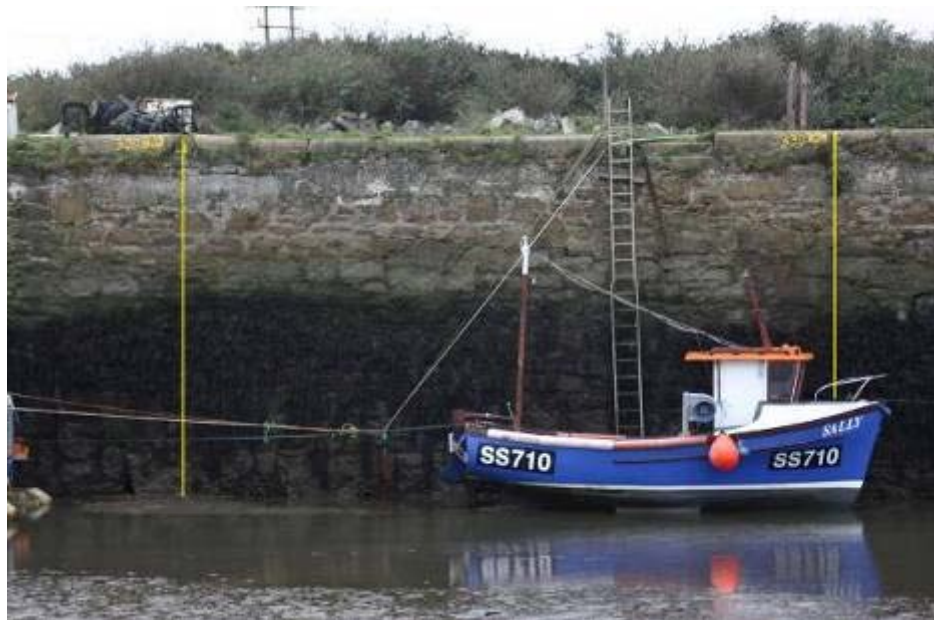
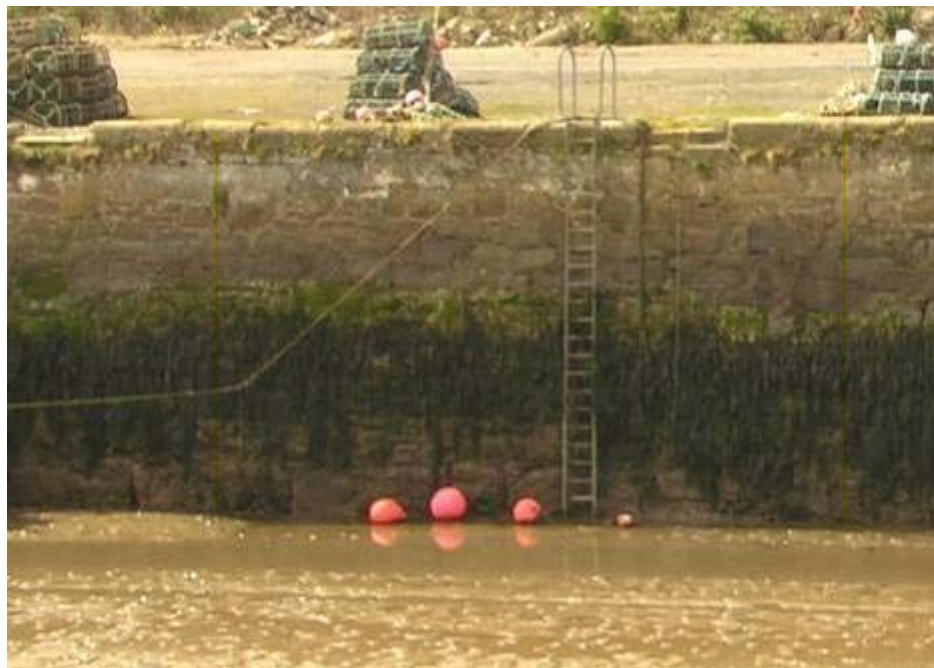
| Chainage | Item | Depth | Description |
|---|---|---|--|
| 317.7 | | | Missing coping stone 1.30 wide No change |
| | | | Boat in way no change |

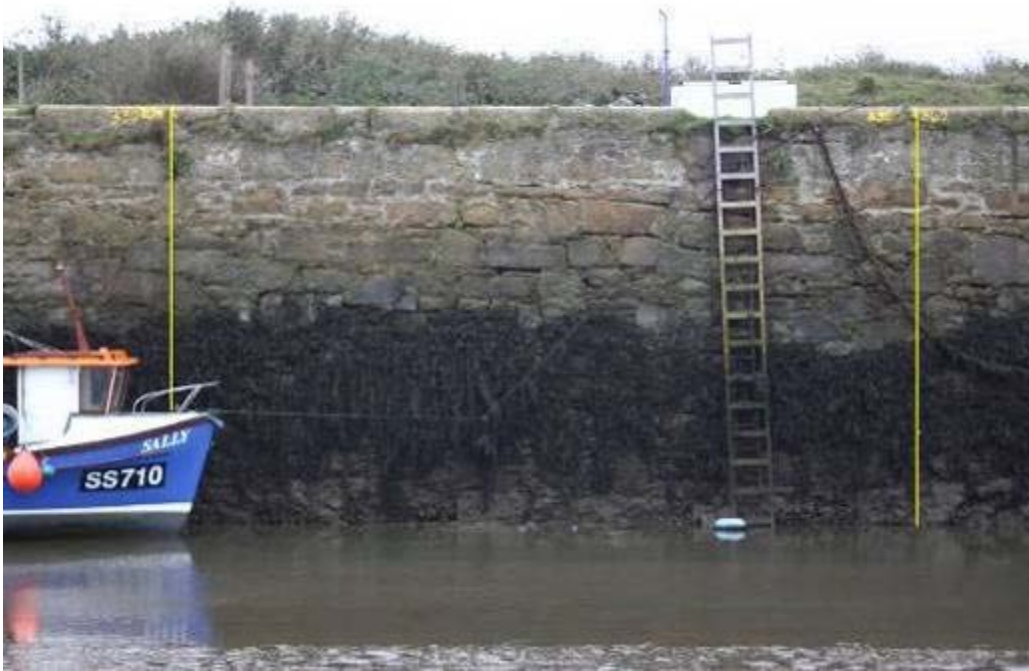
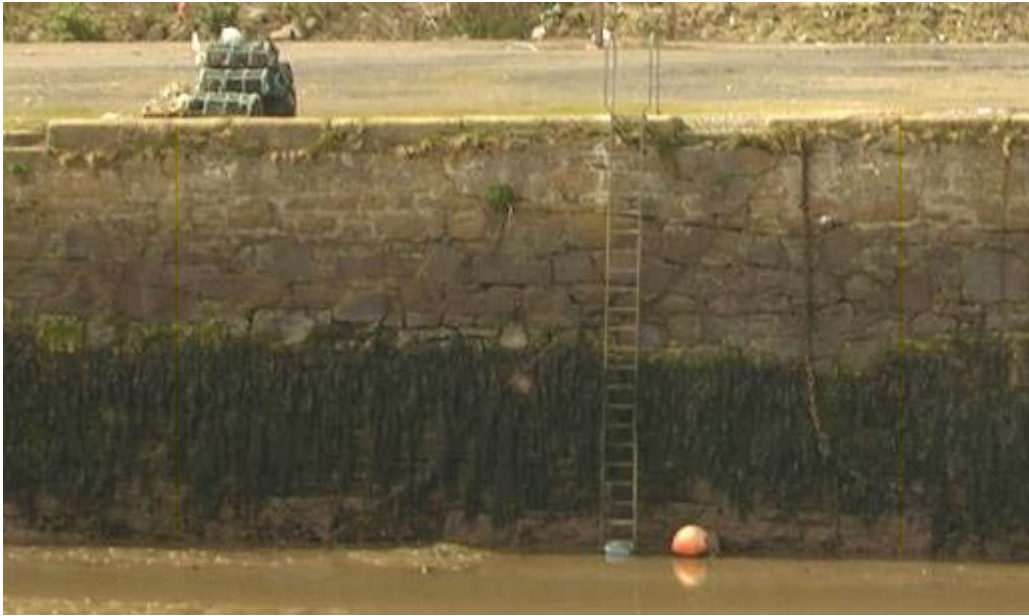
| Chainage | Item | Depth | Description |
|---|---|---|---|
| 327.50 | | | Vegetation below coping, open joints No change 1.40m wide gap in coping, may have been drainage outlet No change |
| 320-330 | | Around 2.5m | Few minor open joints on this section No change Seaweed growth line |

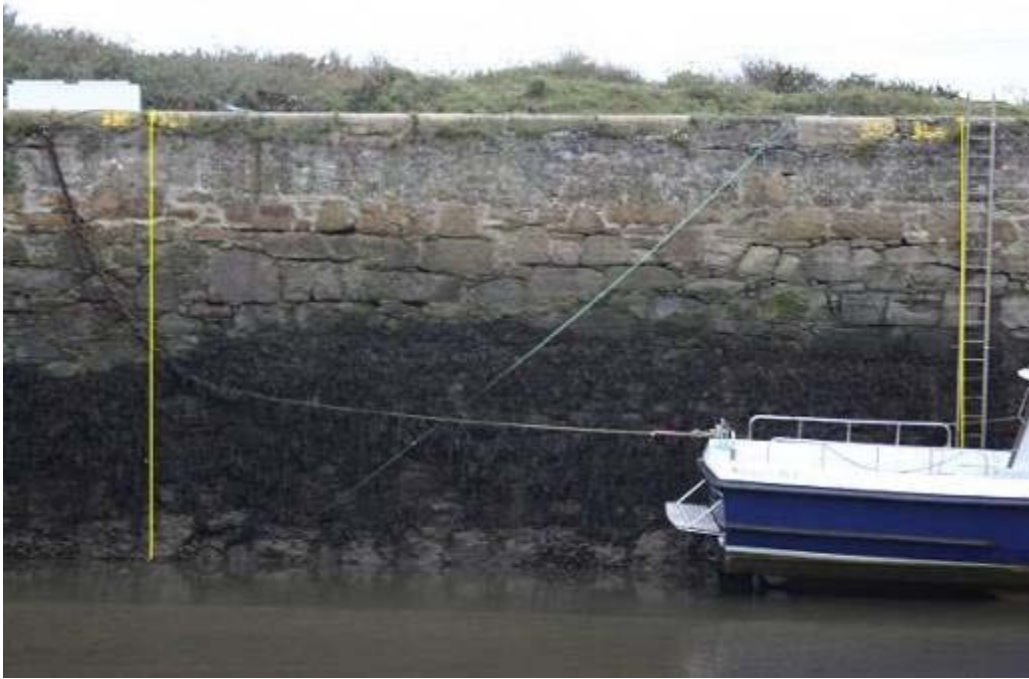
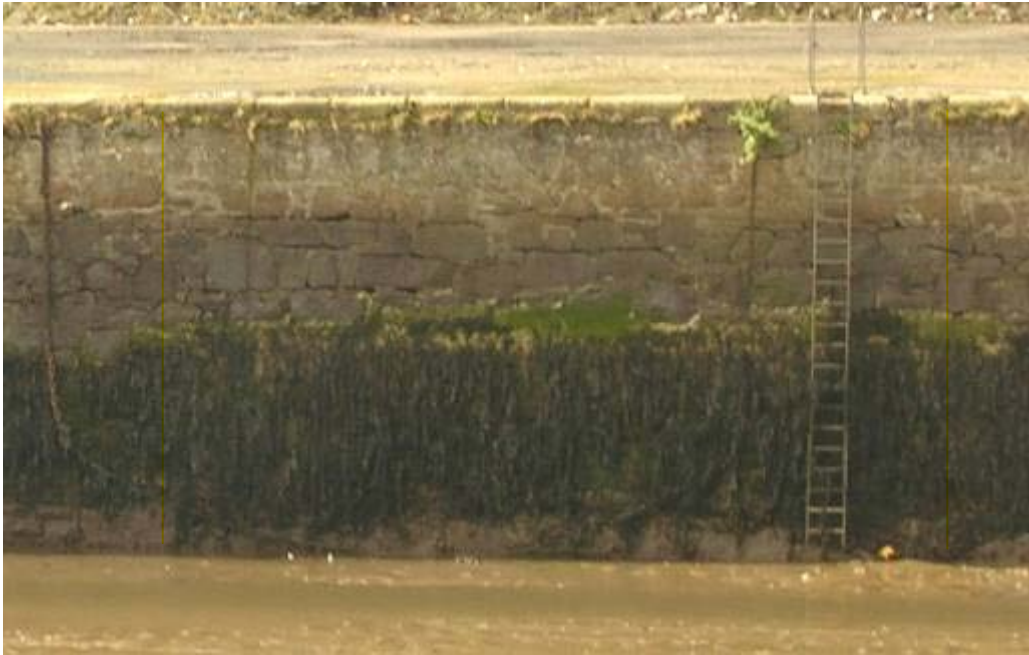
| Chainage | Item | Depth | Description |
|---|---|---|--|
| | | | Missing coping 1.20 (removed for ladder) Still missing, ladder now moved from this spot. |
| | | | Some open joints throughout No change |
| 330-340 | | Around 3.5m onwards | Seaweed growth line (present in 2004) |

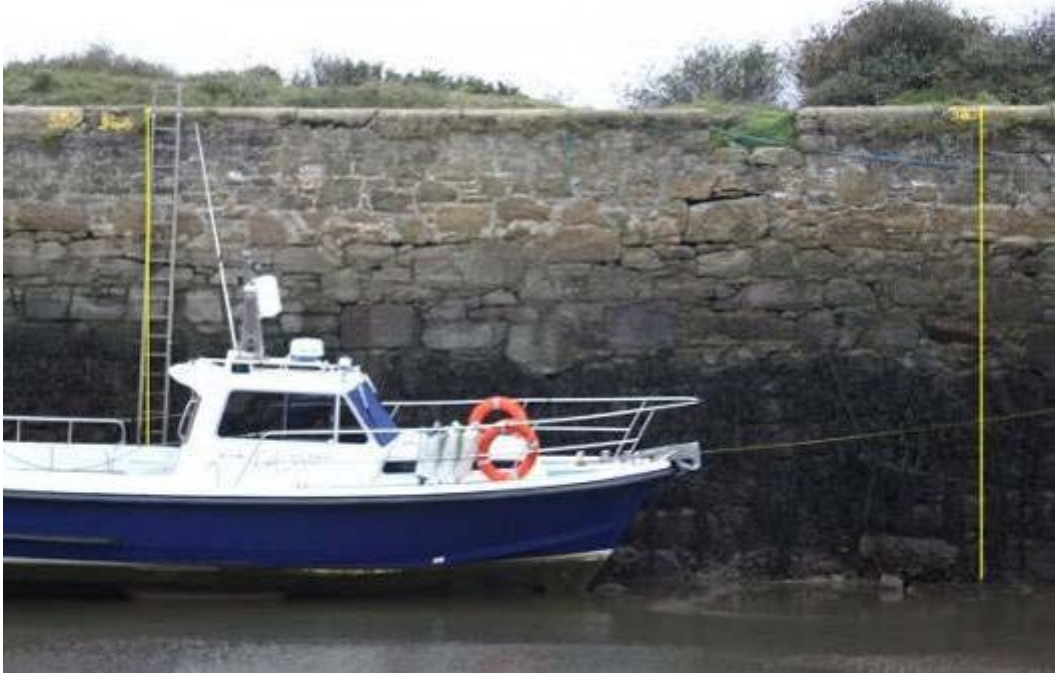
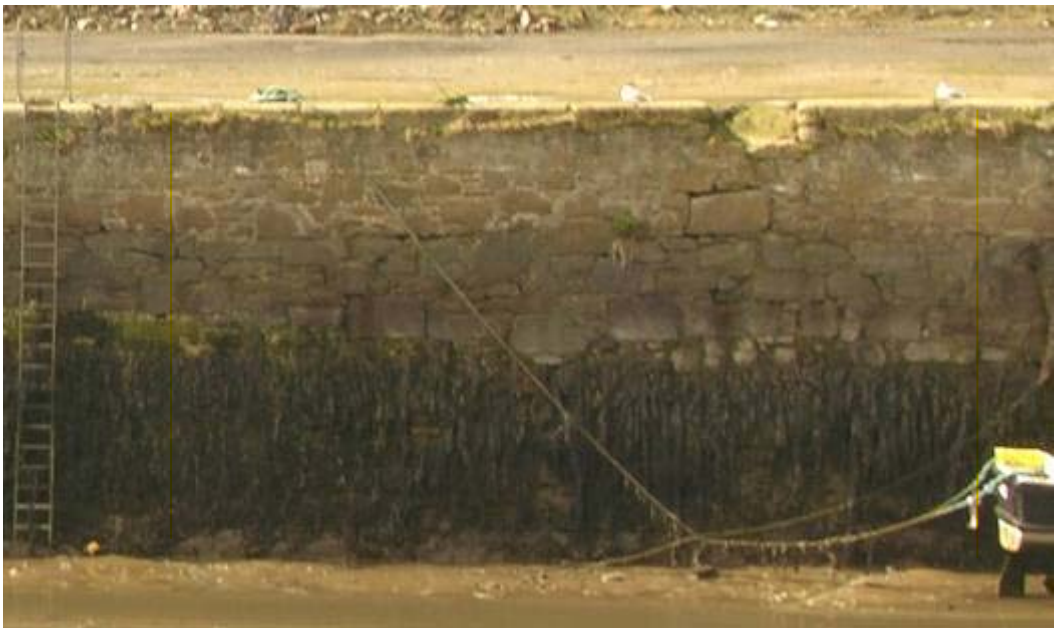
| Chainage | Item | Depth | Description |
|---|---|---|--|
| | | Recent repairs for full length | No change |
| | | below 1.30 | Some open joints, mainly horizontal No change |
| | | Around 3.0m | Seaweed growth line. Condition difficult to confirm. |

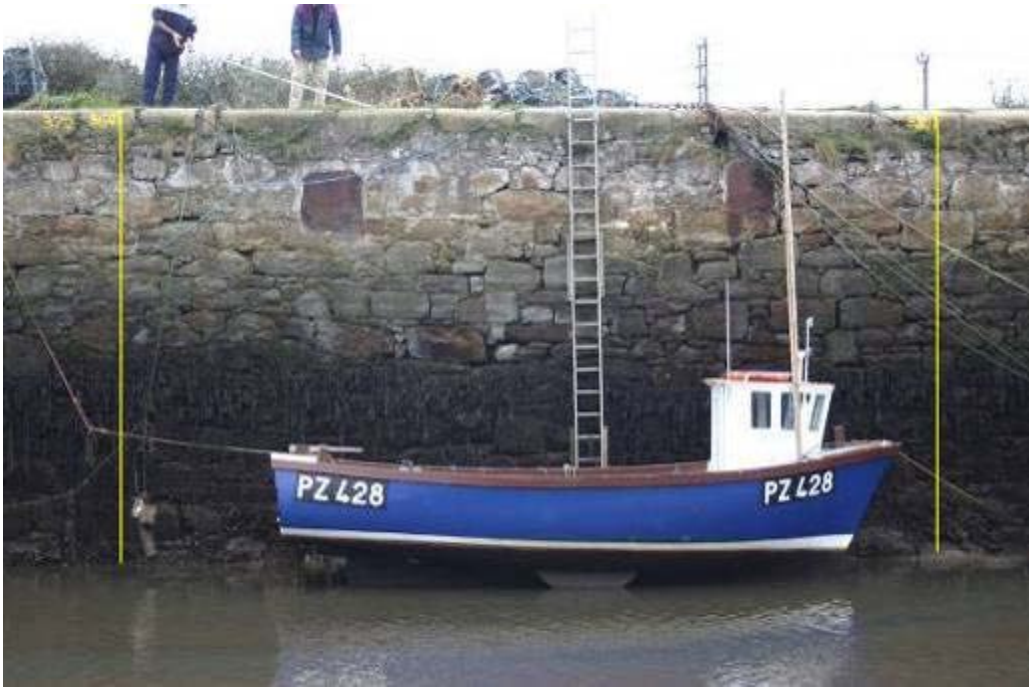
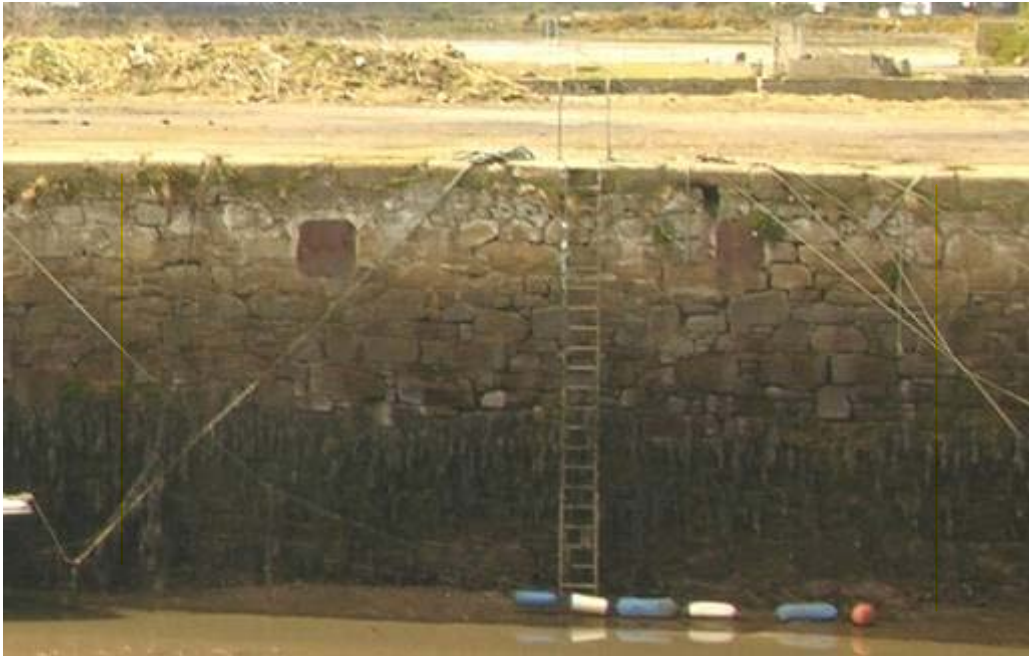
| Chainage | Item | Depth | Description |
|---|---|---|---|
| 365 – 367 | | | Vegetation / open joints below coping No change Small bulge in wall, i.e. looking on plan Unclear. Occasional open joints No change |
| 360-370 | | Around 3.0m | Seaweed growth line |

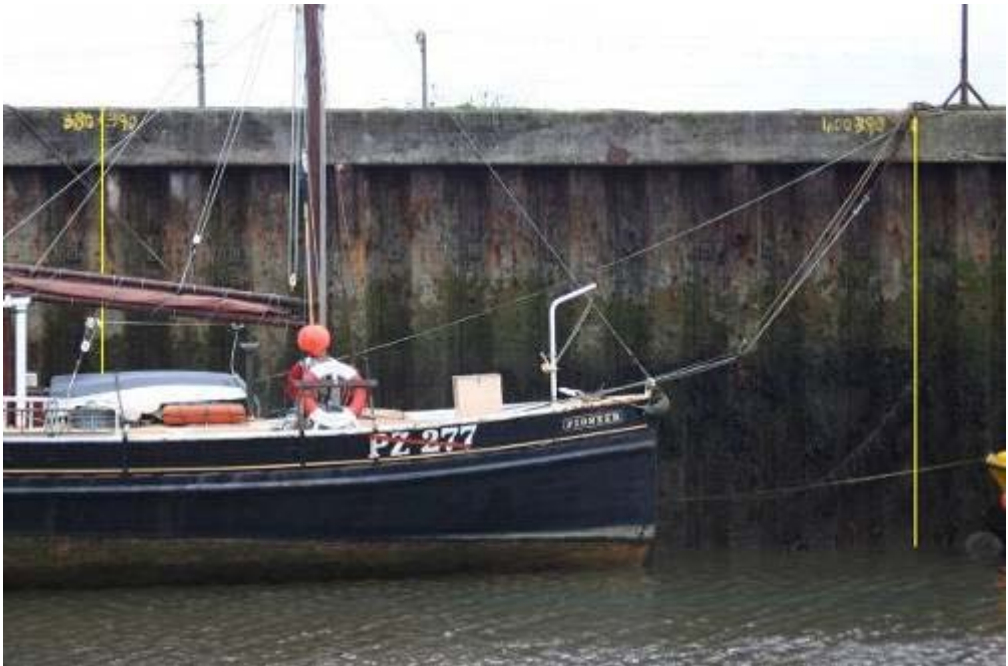
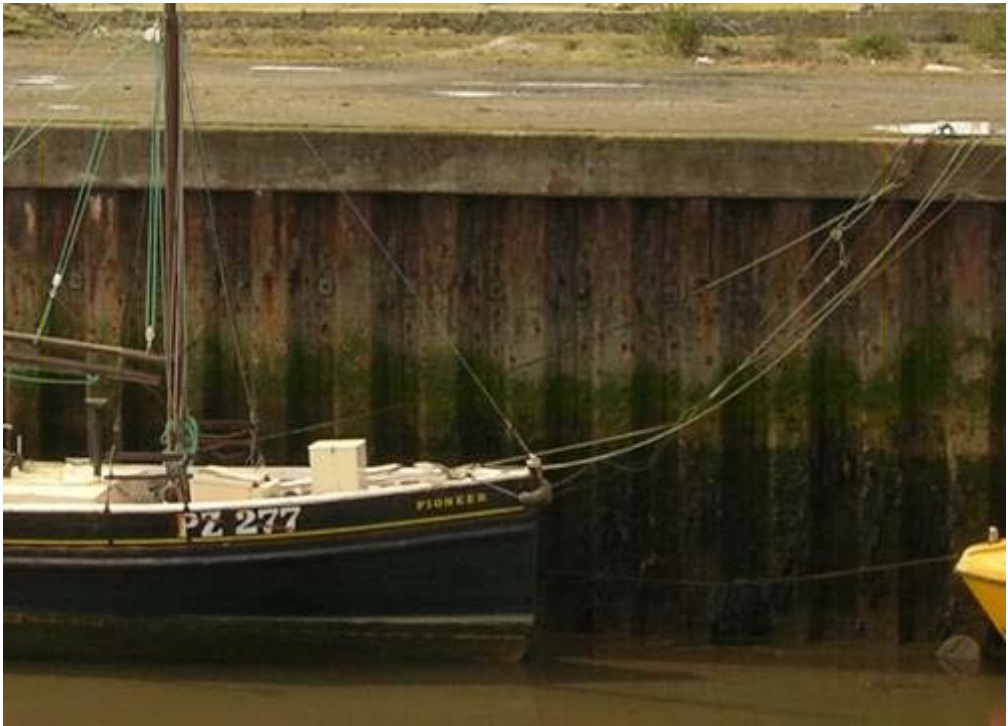
| Chainage | Item | Depth | Description |
|---|---|---|---|
| 380 – 383.70 | | | Vegetation crack below coping Small amount of vegetation. |
| 383.70 - 390 | | | Sheet piled wall No change |
| | | | Boat in front No change |

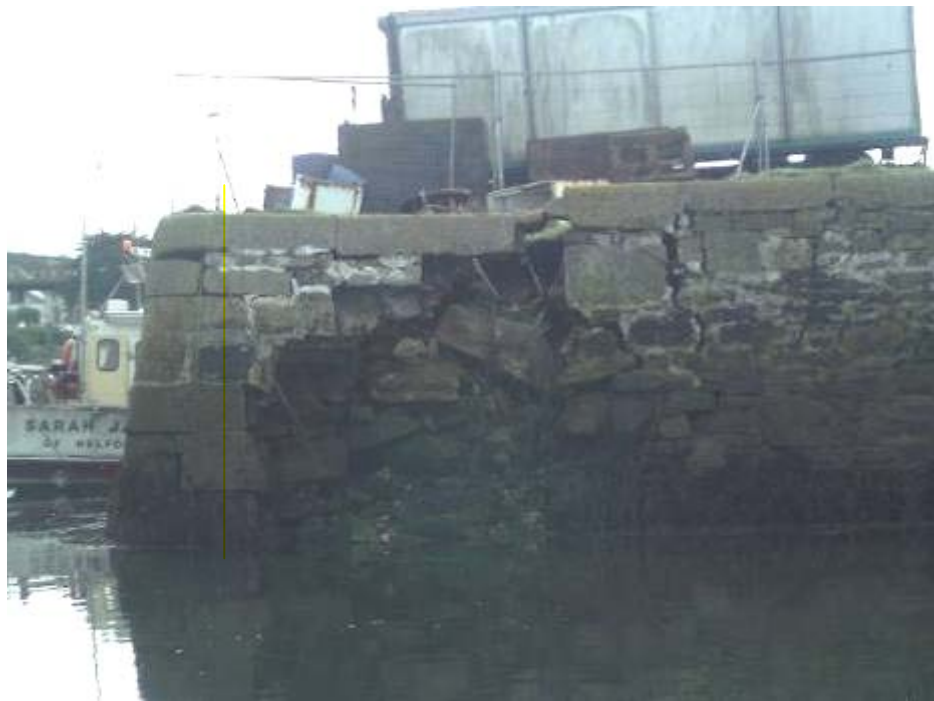
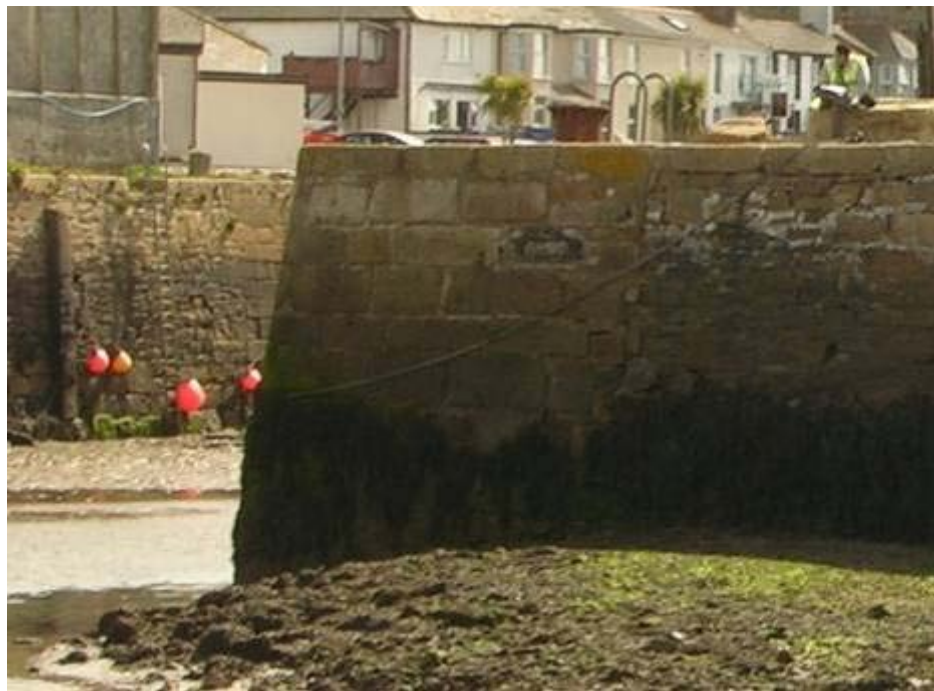
| Chainage | Item | Depth | Description |
|---|---|---|--|
| 470 - 480 | | | From ch.470m wall gets progressively worse – considerable movement. Blocks or large open joints under coping Large open vertical cracks Wall repaired well, blocks repointed. |
| 480 | | 2m | Rotation of wall, one small block missing Repaired. |
| 470-480 | | Around 3.0m | Seaweed growth line |

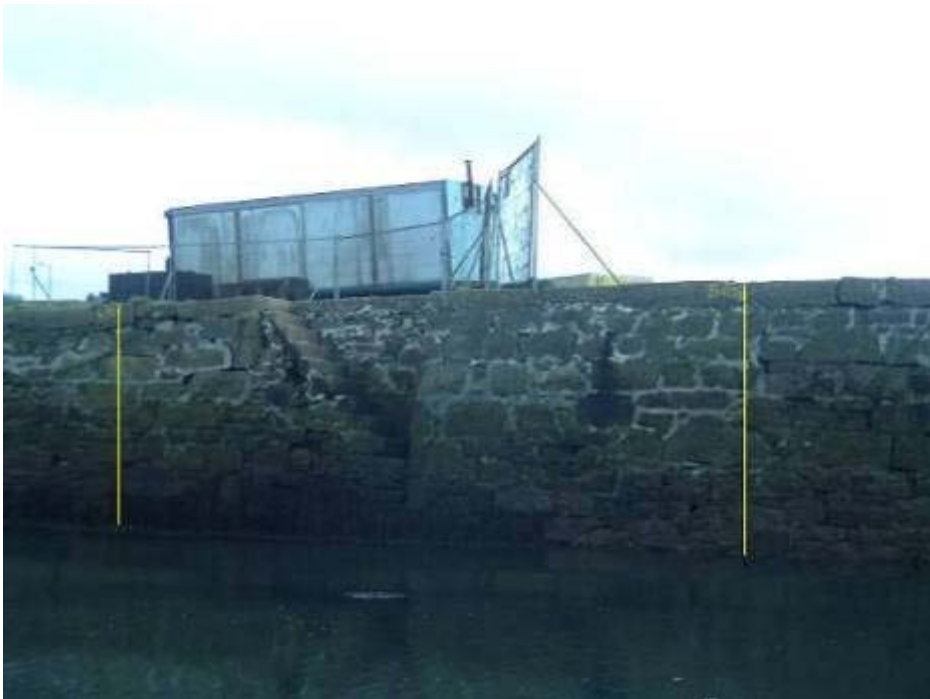
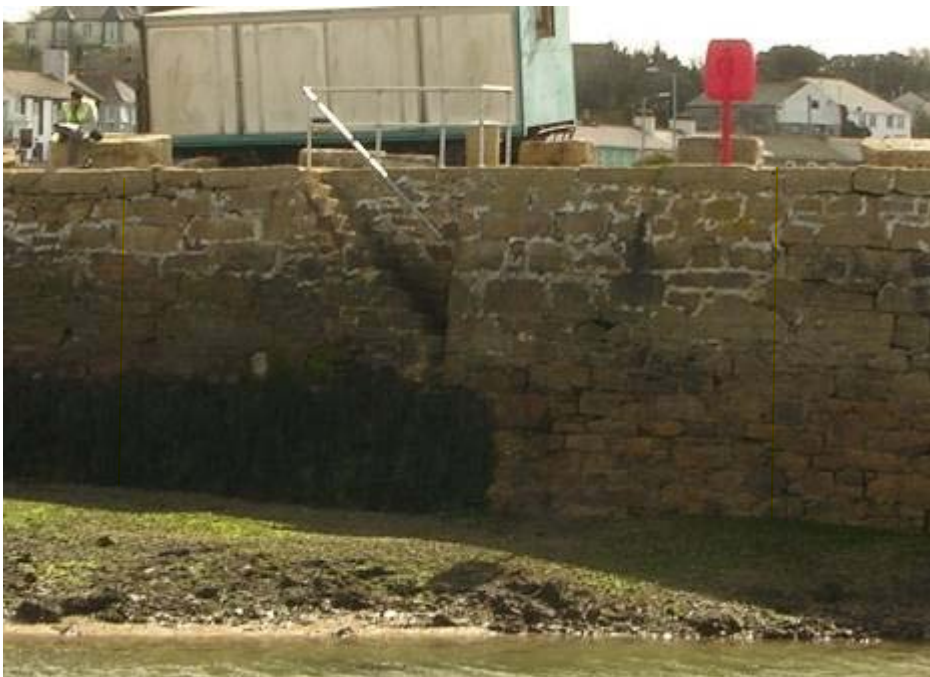
| Chainage | Item | Depth | Description |
|---|---|---|---|
| 485-486.5 | | | Wall just still in place but in dangerous condition. Wall bows at bottom |
| 489 | | 2.3 | Hole in wall Wall repaired with original blocks and now in good / safe condition. Blocks repointed. |

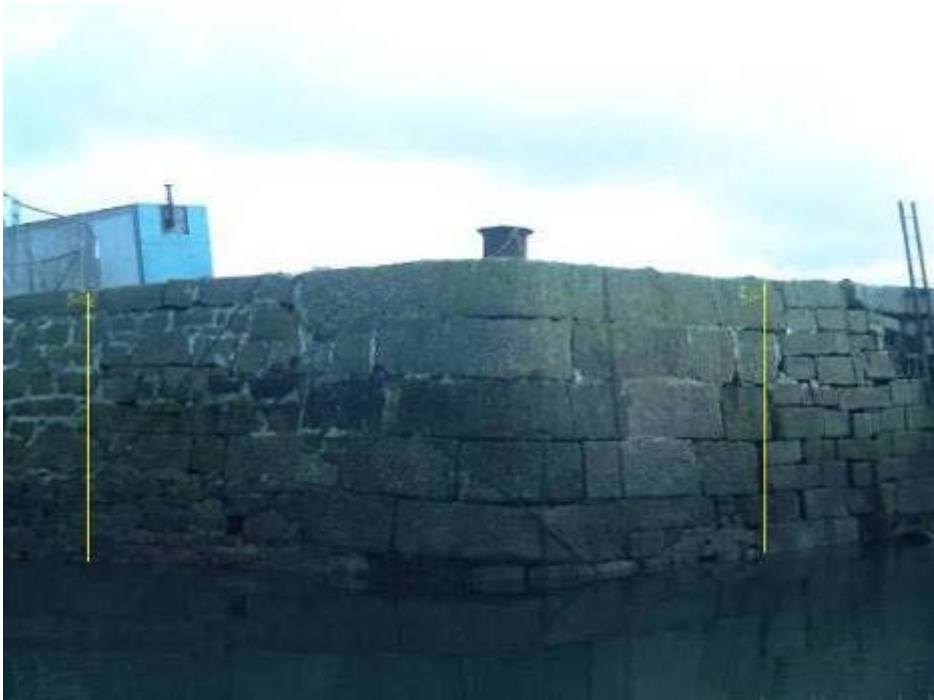
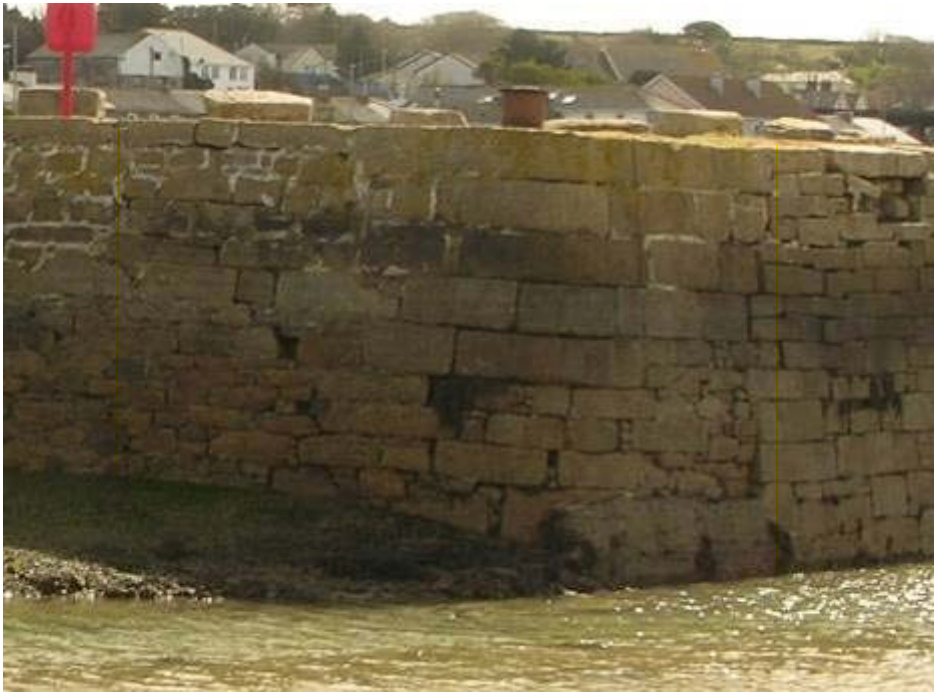
| Chainage | Item | Depth | Description |
|---|---|---|---|
| | | 2.3 – 4.6 | Generally open joints, No change |
| 490 - 500 | | | note wall generally over this section does not have a straight profile |

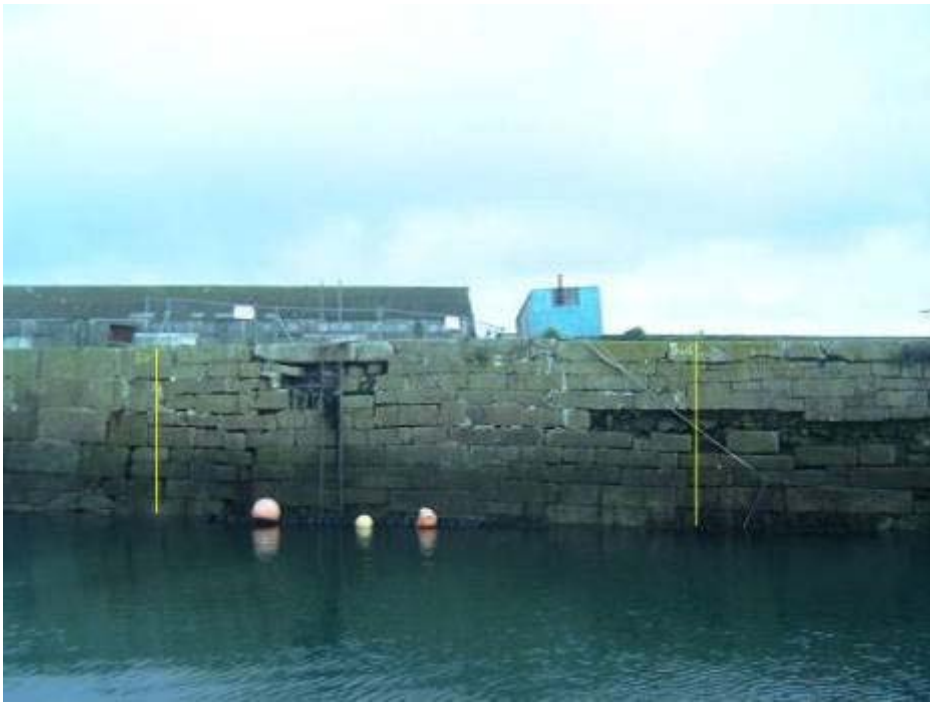
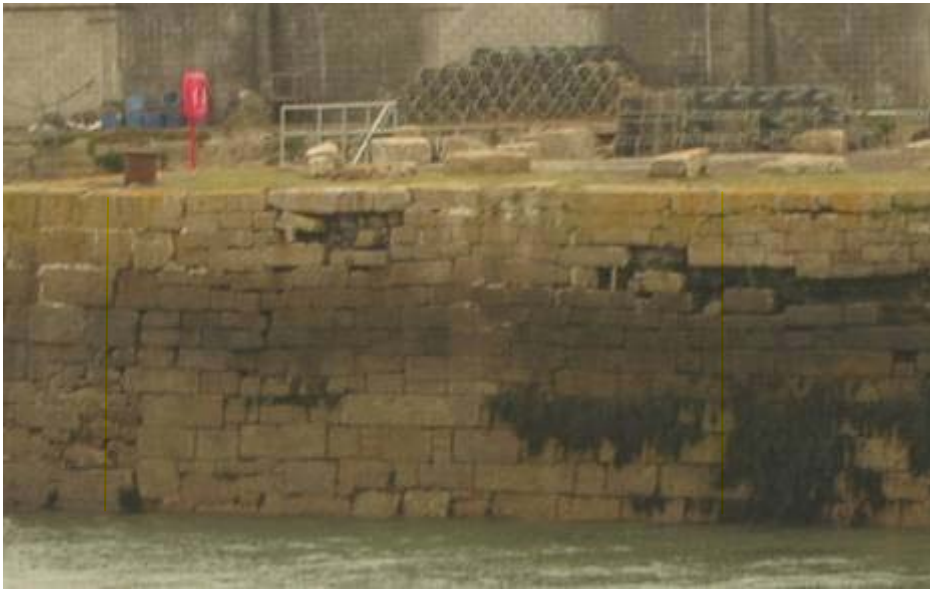
| Chainage | Item | Depth | Description |
|---|---|---|--|
| 506 - 510 | | 4.4 | Sill projects approx. 150 – 300 on return section Unclear |
| | | 1.2 – 4.4 | Displacement large open joints No change |

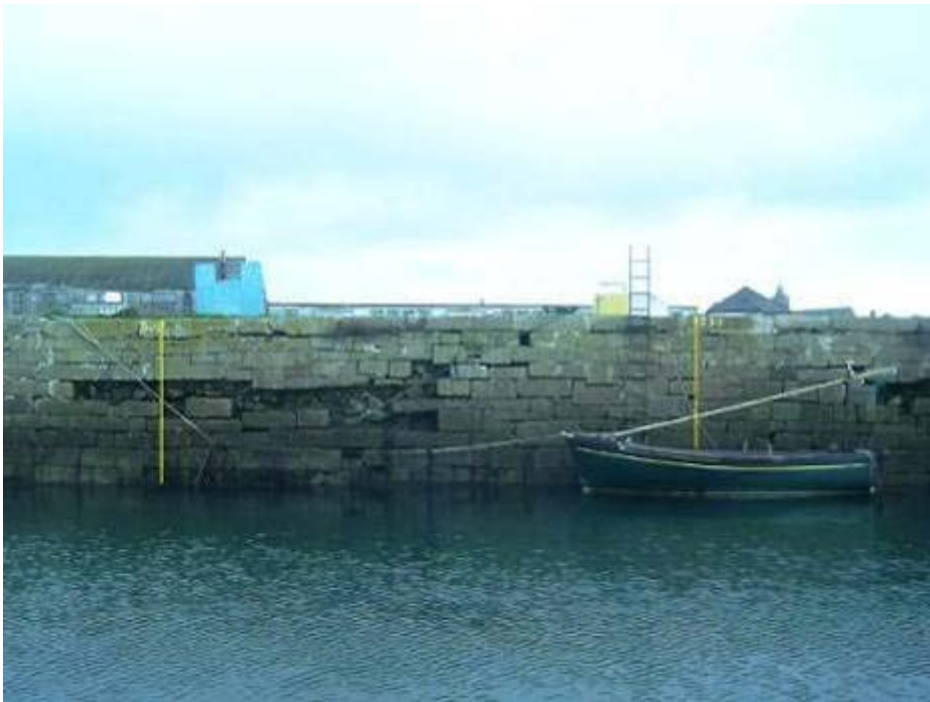
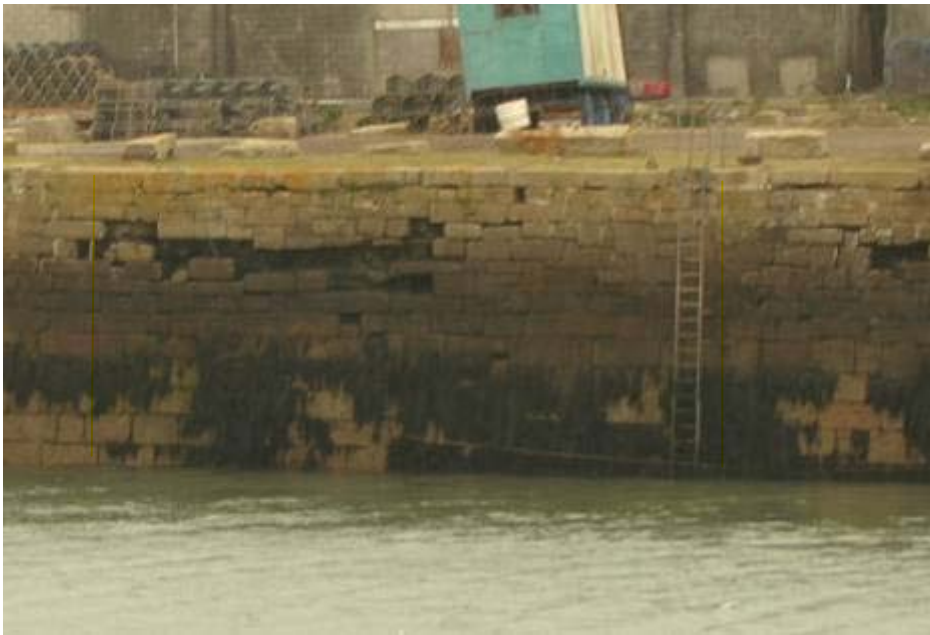
| Chainage | Item | Depth | Description |
|---|---|---|--|
| 518 - 520 | | 1.70 - 2 | Blocks missing, major voids |
| 513-520 | | Around 3.5m | Sea weed growth line |

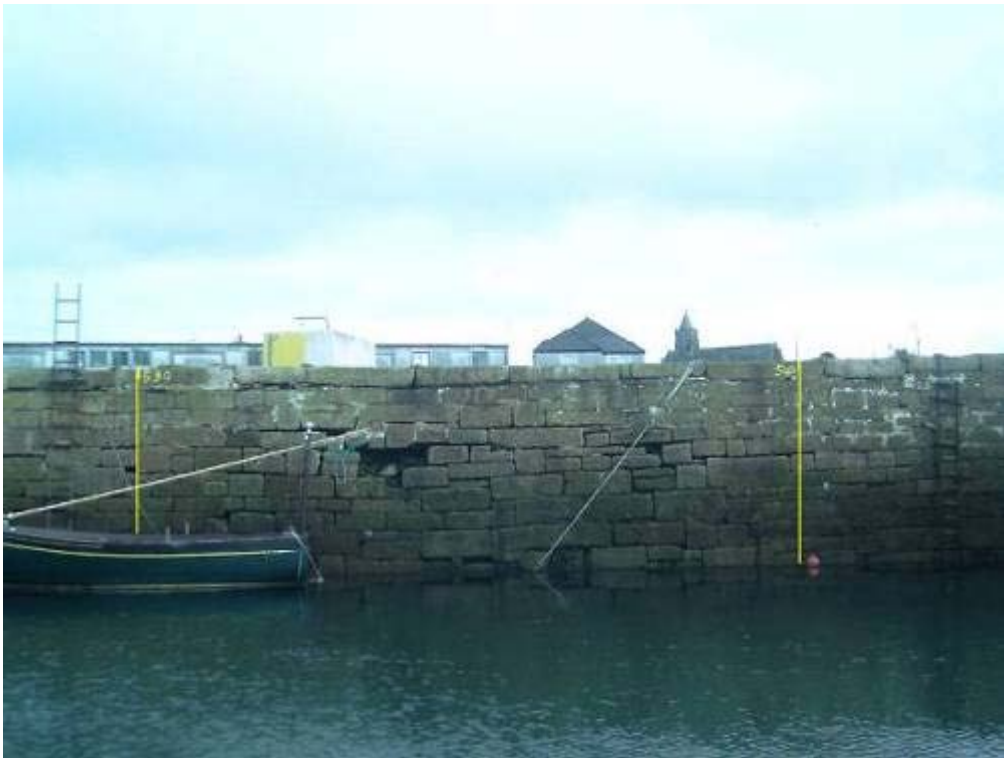
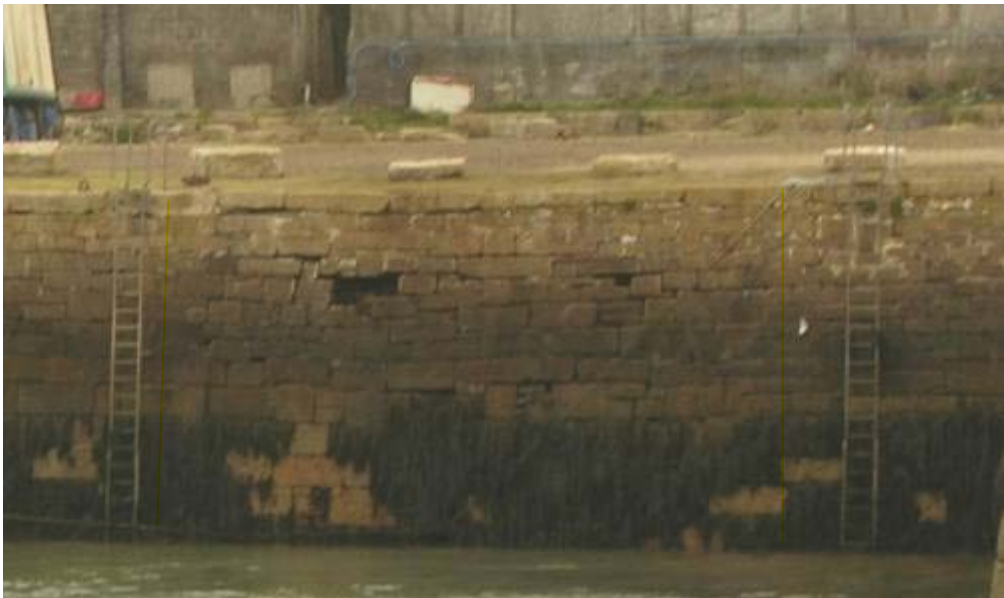
| Chainage | Item | Depth | Description |
|---|---|---|--|
| 525 - 526 | | 1.10 | Block dislodged and oversailing wall Unclear |
| 527 | | 0.5 | Hole / block missing No change Base of wall undercut by 300, Unclear Open joints for much of this wall, top to bottom No change |

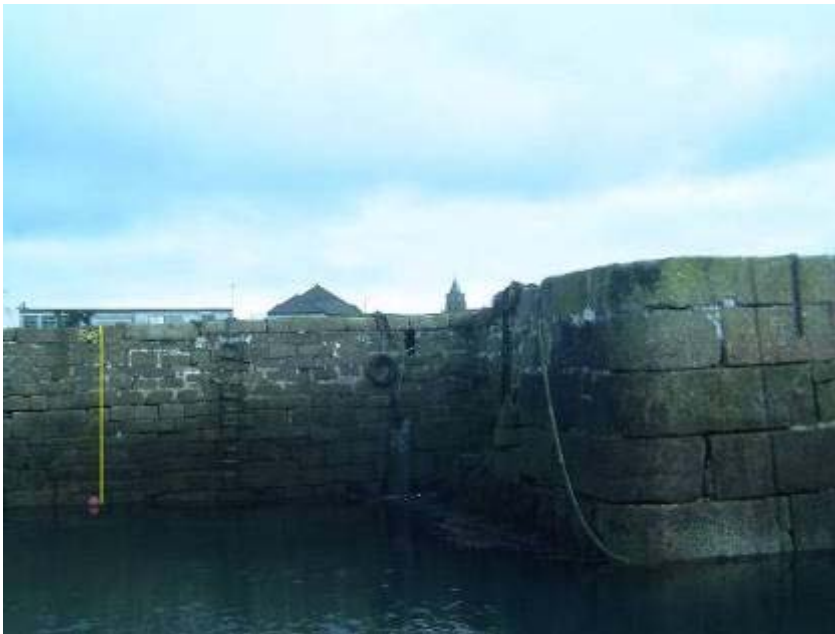
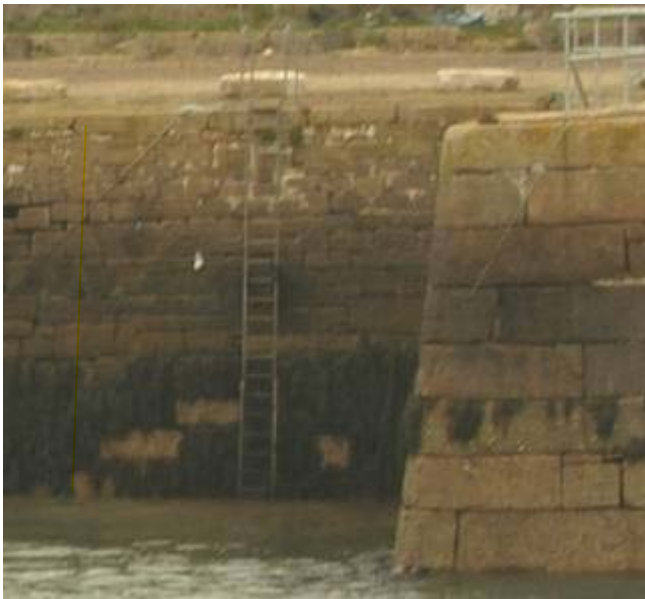
| Chainage | Item | Depth | Description |
|---|---|---|---|
| 536 - 539 | | 4.20 & 4.60 | Large open joints |
| 538 | | 1.40 | Missing block No change |

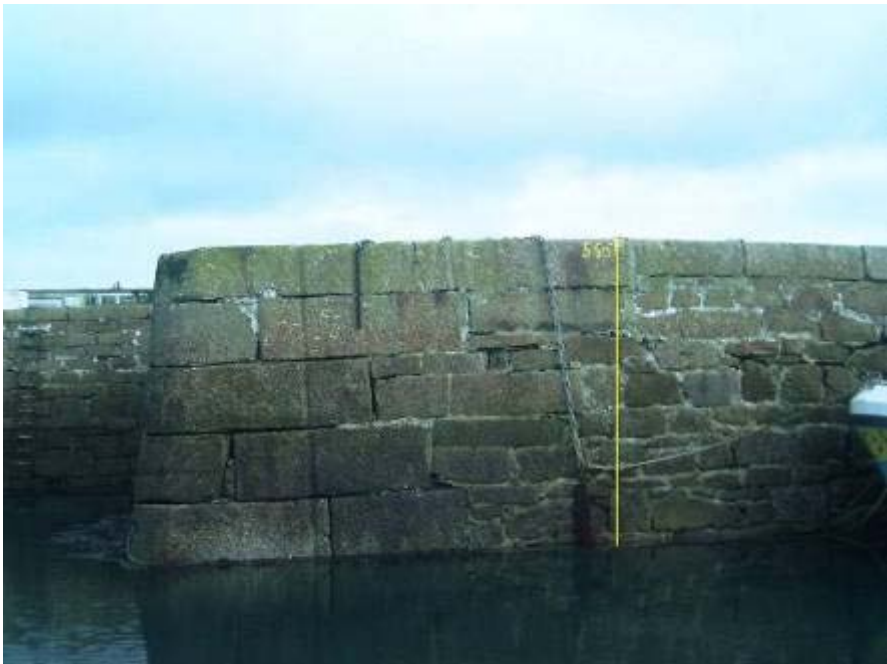
2004

| Chainage | Item | Depth | Description |
|---|---|---|--|
| 542 | | | Rusty broken steps (2004), replaced with new ladder (2009) |
| 546.7 | | | Coping cracked – possible drainage shoot underneath Not visible |

| Chainage | Item | Depth | Description |
|---|---|---|---|
| 540 - 547 | | 1.2 | Some recent repairs over top section of wall No change |
| 542 | | 0 – 1.60 | Vertical crack No change |
| 546 | | 0.30 | Man made gully, coping crack over top No change |
| 547 - 548 | | 3 – 4.20 | Steps dislodged, some on seabed Not visible |

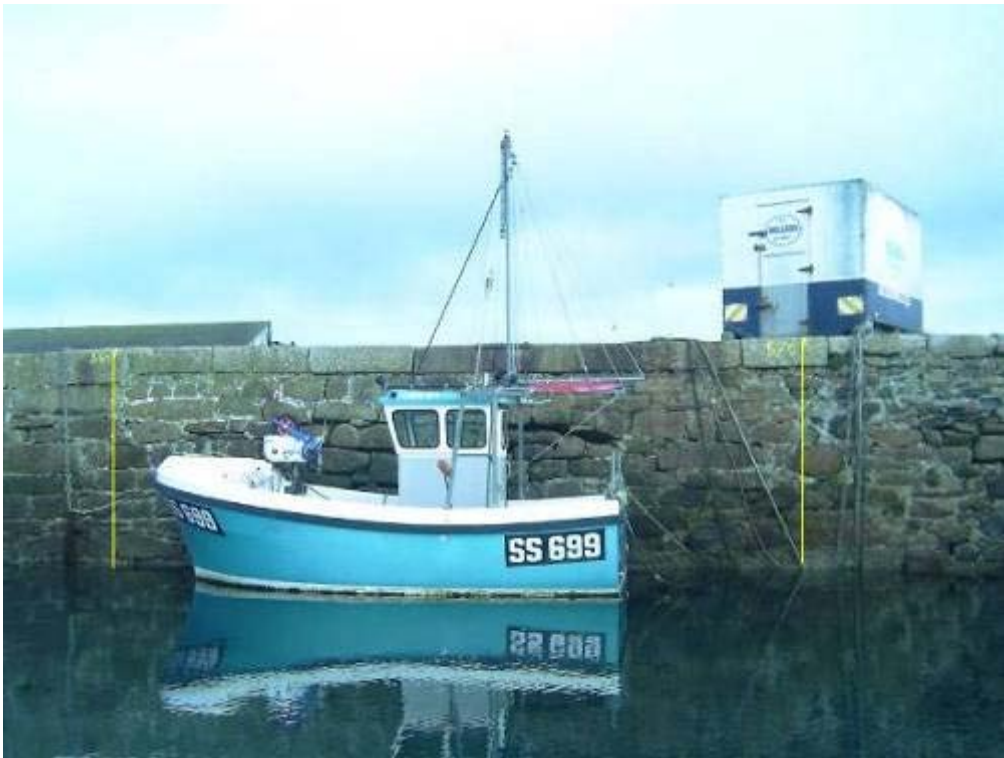
2004

| Chainage | Item | Depth | Description |
|---|---|---|---|
| 553.5 - 556 | | 2.50 | Very open large horizontal crack to corner Not visible Note: steps section shown considerable movement, dangerous, Not visible |
| 556 - 560 | | | Surface sunk towards seaward corner, considerable open joints – movement No change |
| 556-560 | | | Open joints throughout the section |

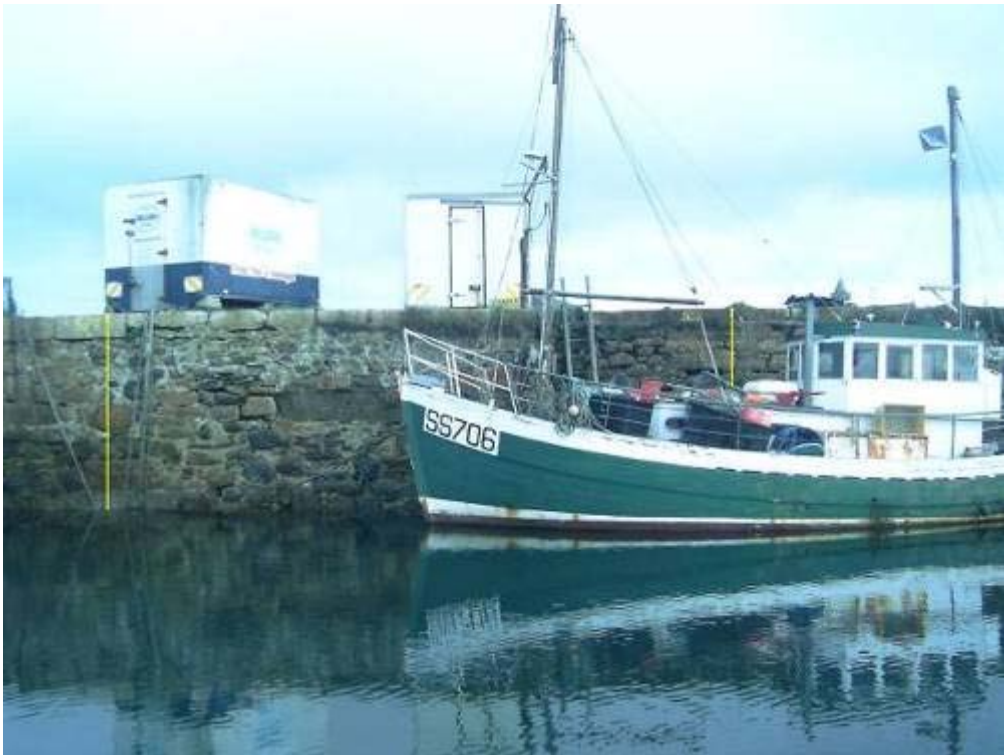
2004

| Chainage | Item | Depth | Description |
|---|---|---|--|
| 560 - 570 | | | Large open joints along bottom |
| 566-569 | | Around 3.5m | Sea weed growth |

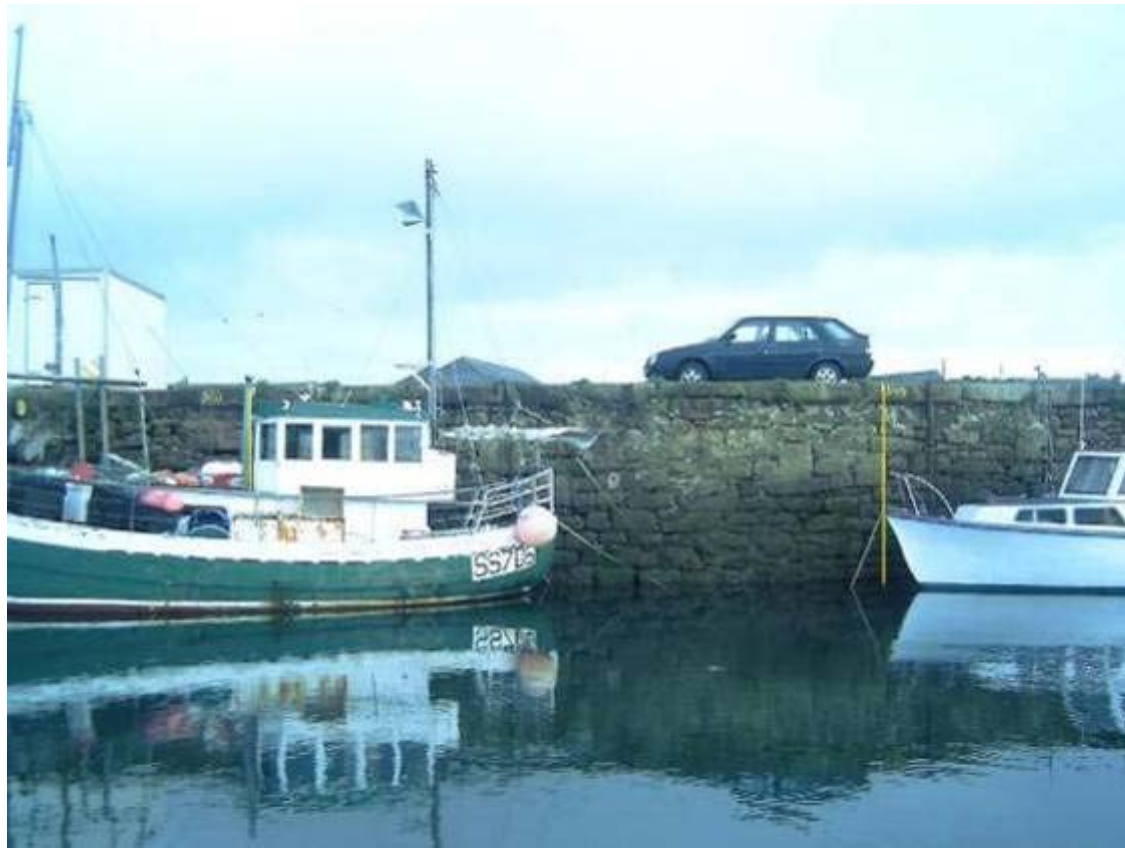
2004

| Chainage | Item | Depth | Description |
|---|---|---|---|
| 577.50 | | | Rotten wooden ladder with rusty metal steps New ladder with handrails at top. |

| Chainage | Item | Depth | Description |
|---|---|---|---|
| 570 – 575.5 | | 0 - 2.0 | More recent repairs to top section, very small stones / bricks No change |
| 575 - 580 | | 1.40 | Blocks missing No change |
| | | | General signs of movement / settlement in wall when viewed from other side of water Unclear |

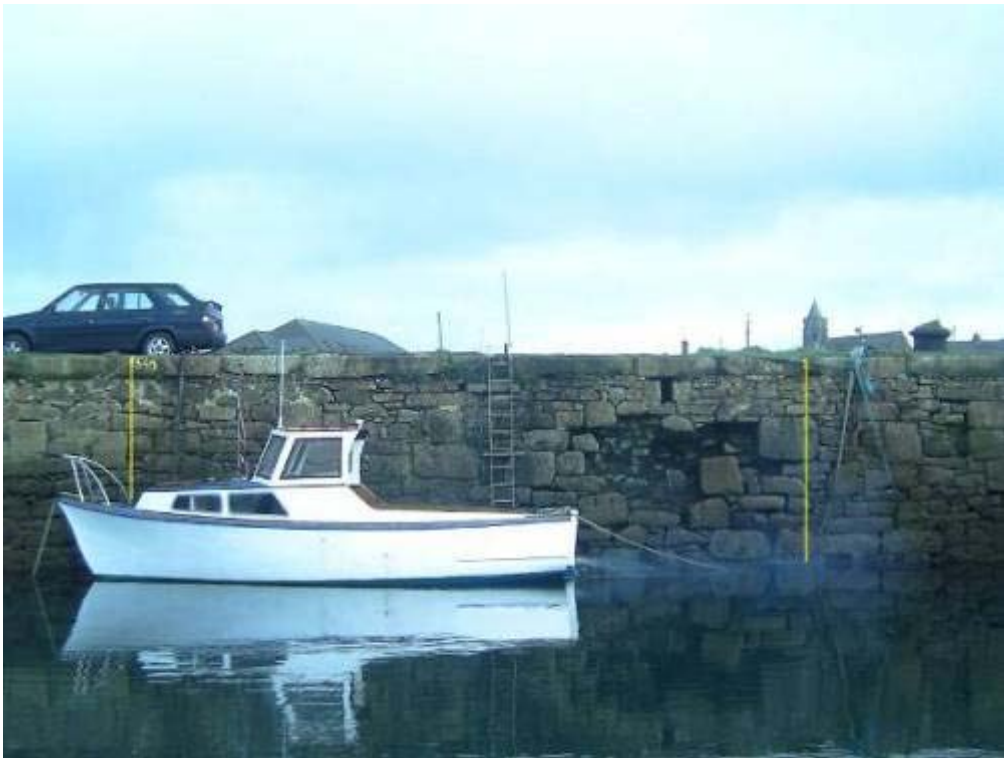
2004

| Chainage | Item | Depth | Description |
|---|---|---|--|
| | | | Some repairs over upper section, mainly just under coping, No change |
| Approx 590 | | | Vertical cracks and movement, generally open joints No change |

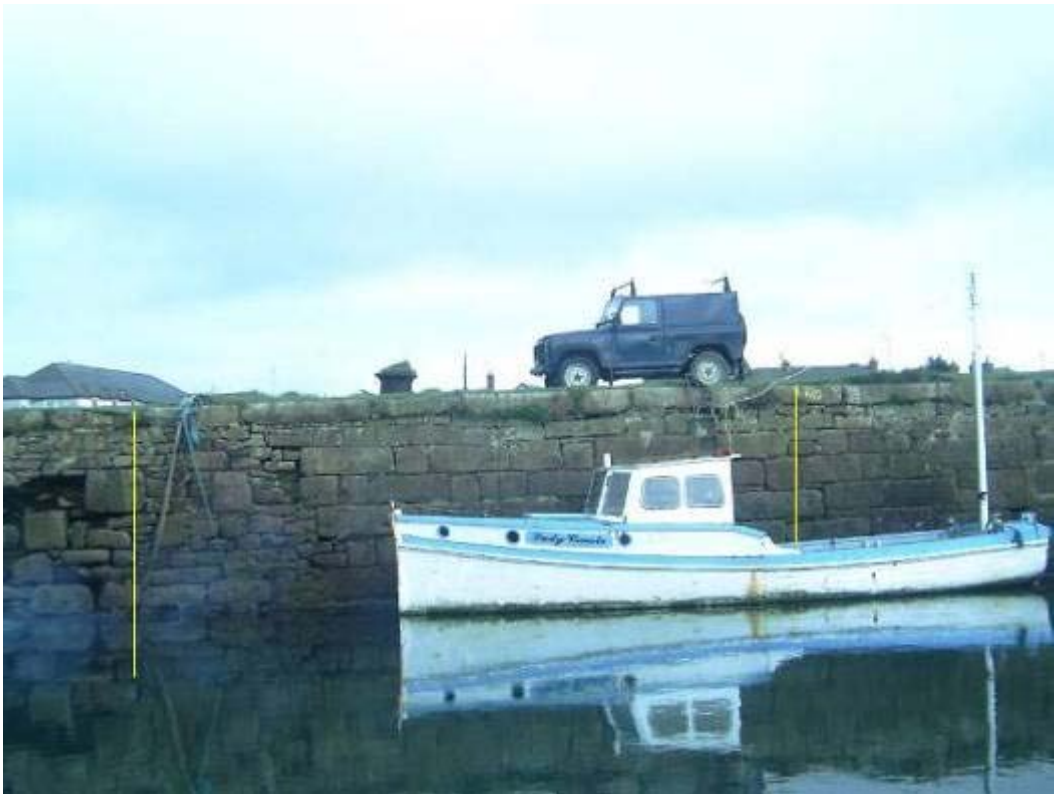
2004

| Chainage | Item | Depth | Description |
|---|---|---|---|
| 594.5 | | | Metal ladder Replaced with new ladder and handrails |

| Chainage | Item | Depth | Description |
|---|---|---|--|
| 598 - 600 | | 0.90 – 2.30 | Large gap, missing stones in wall No change |
| 599 | | 0.50 | Block missing, may be old drainage outlet No change |
| 590-600 | | Around 3.0m | Seaweed growth line, difficult to confirm condition |
