hayle harbour :: regeneration South Quay

Harbour Wall Condition Survey

Extract from Harbour Wall Condition Survey

Job no 027802 December 2010

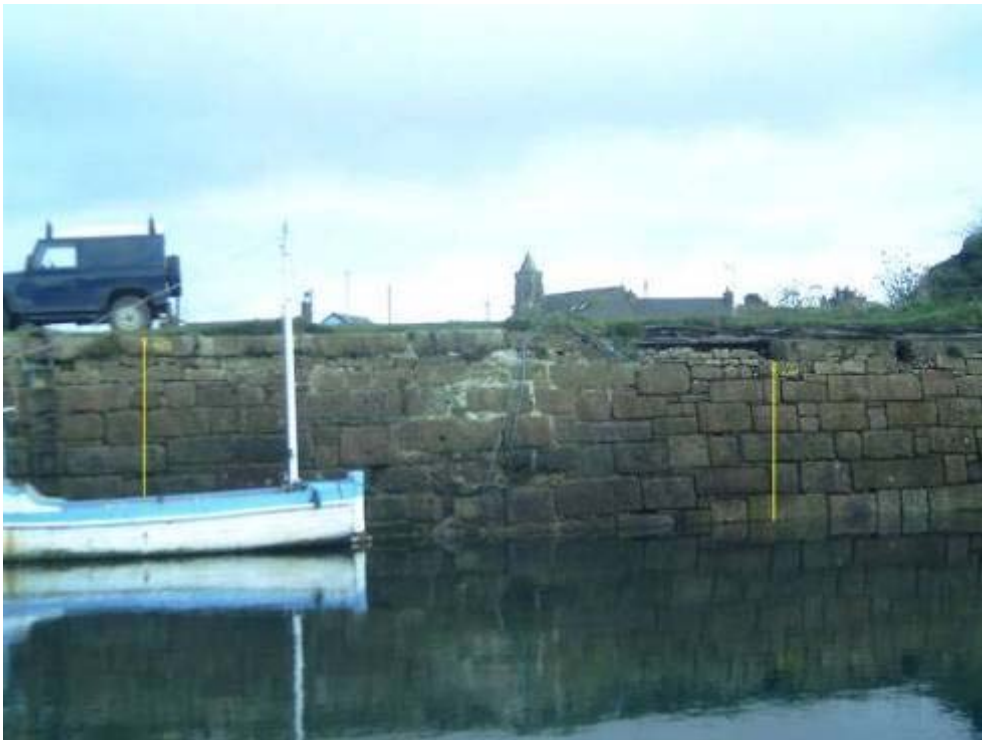
2004

| Chainage | Item | Depth | Description |
|---|---|---|---|
| 608.5 | | | Mild steel ladder replaced with new ladder and handrails |

| Chainage | Item | Depth | Description |
|---|---|---|---|
| 600 - 602 | | | Block missing no change |

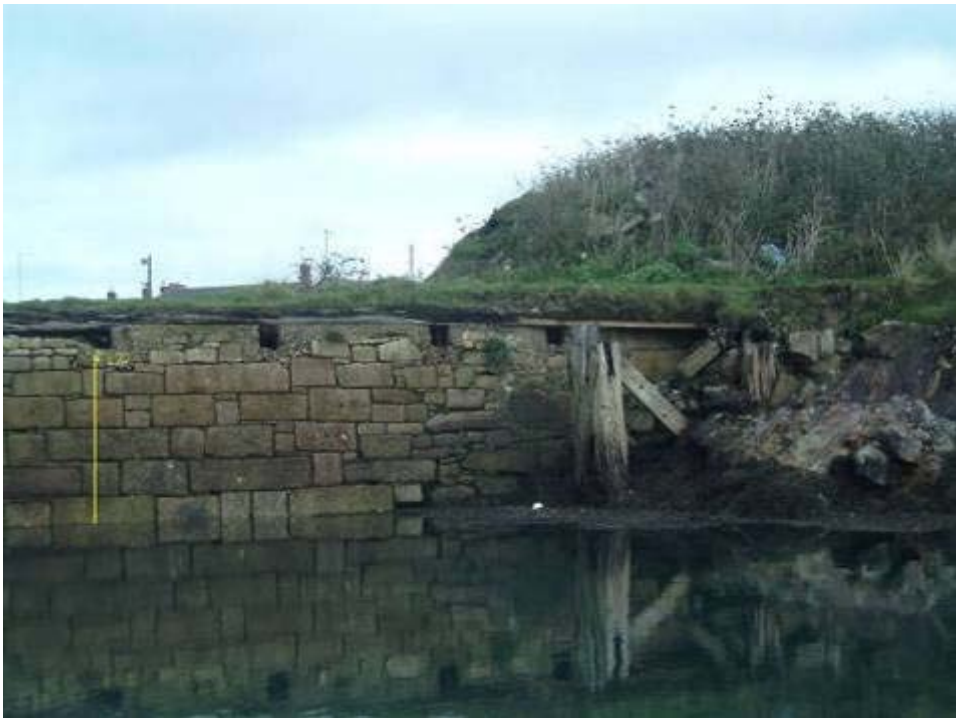
2004

| Chainage | Item | Depth | Description |
|---|---|---|--|
| 617 - 620 | | | Copings missing no change |

| Chainage | Item | Depth | Description |
|---|---|---|---|
| 615 - 617 | | 0 – 2.0 | Some recent repairs but these also in bad state No change |
| 613-614 | | 3.0 | Wall repaired with brick work |
