# hayle harbour :: regeneration South Quay

## Development Proposal for South Quay/Foundry Yard Hayle Harbour

## Harbour Wall Schedule of Works for Restoration of Quayside Walls

## **027802 Hayle Harbour, South Quay/Foundry Yard**

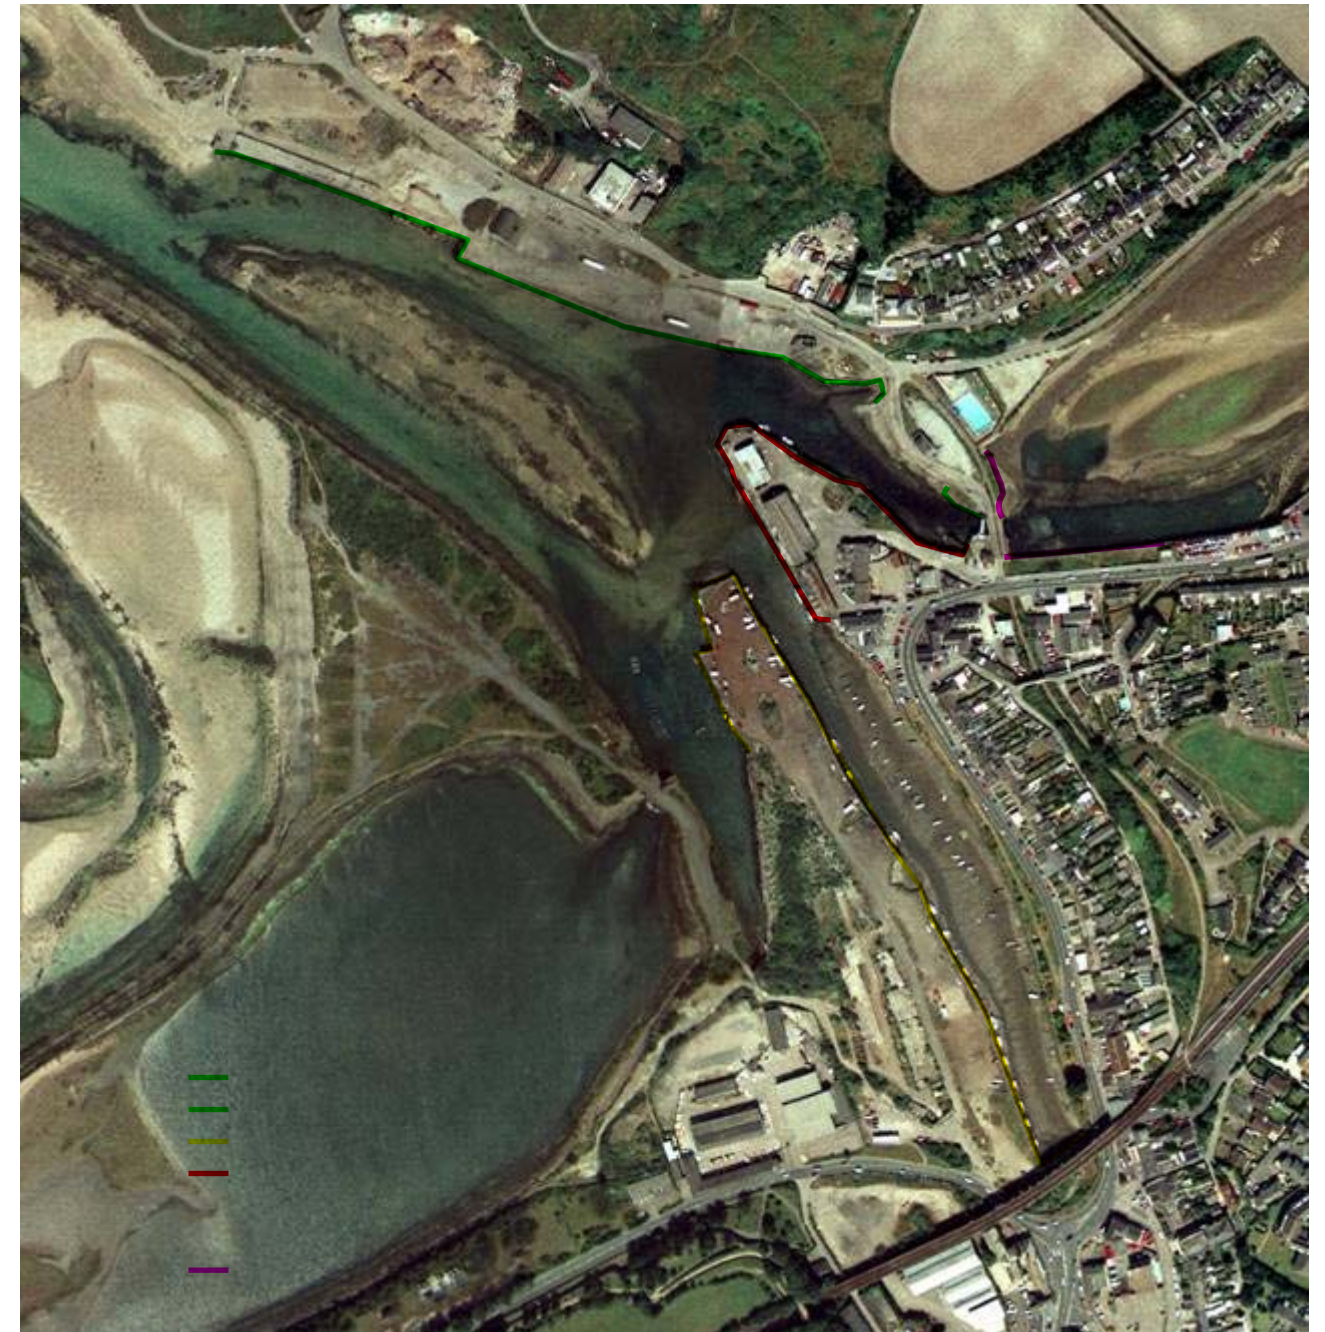
Reported delineation of Quay lengths

The recommended remedial work option is located within each of these sections by chainage and depth, where appropriate.
